SUBJECT **Periodic Inspection Report No. 9
Maintenance Deficiency Correction Period (MDCP) Update**

Periodic Inspection Report 9 (PI 9) Maintenance Deficiency Correction Period (MDCP) Plan Update

Trinity River Corridor Project Committee

August 18, 2009

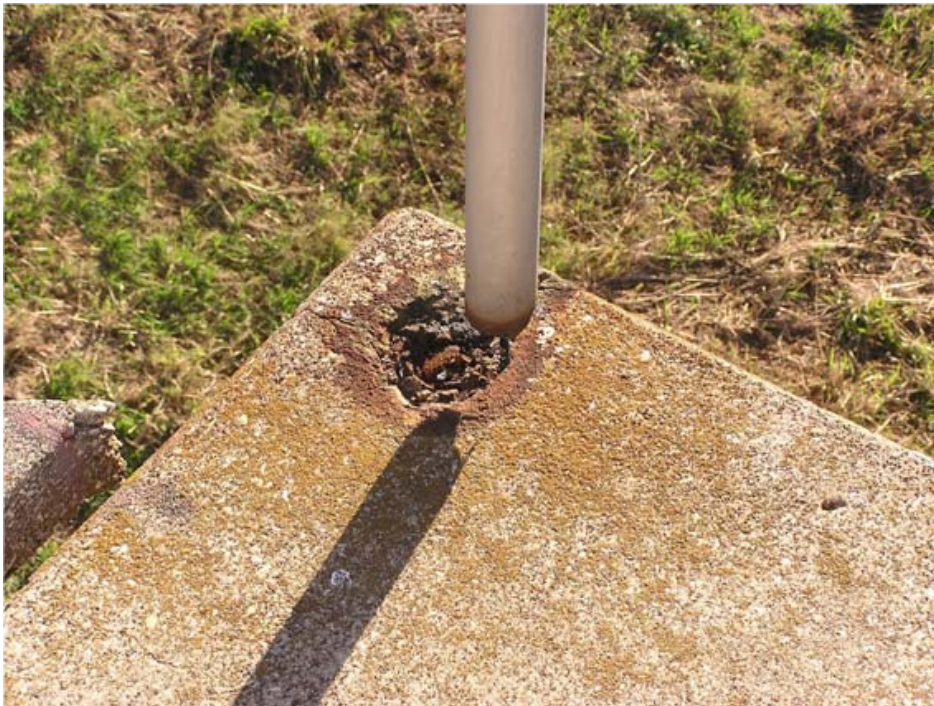
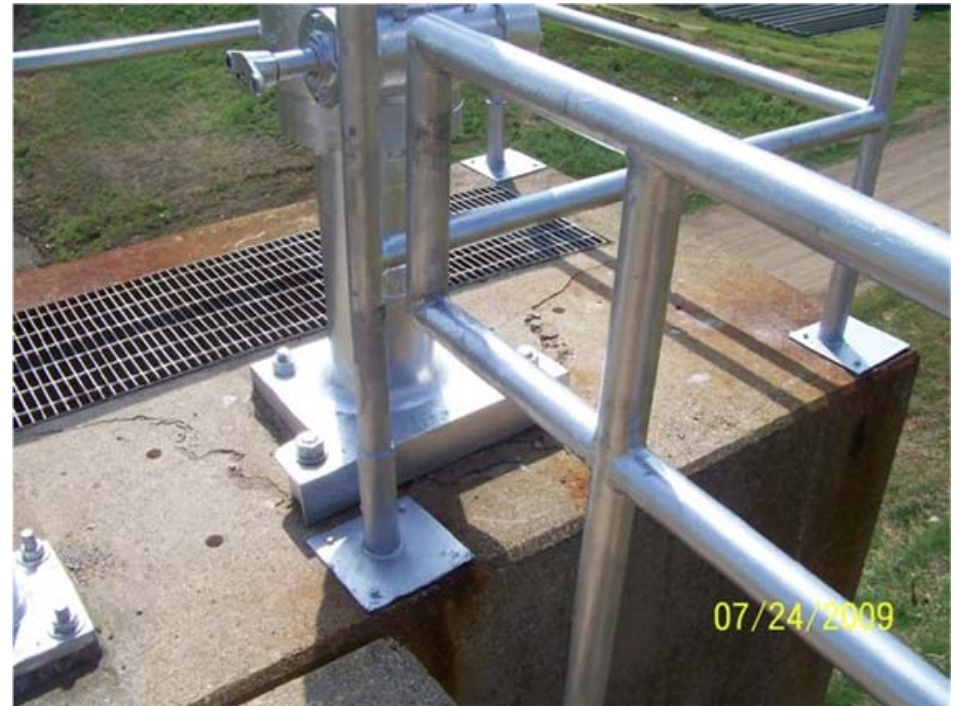
Dallas Branch Pressure Conduit, East Levee – On the gate tower, the bottom of two posts for the handrail at the left side of the operating deck have completely rusted out – safety issue.

The handrail was removed and replaced with a new unit.

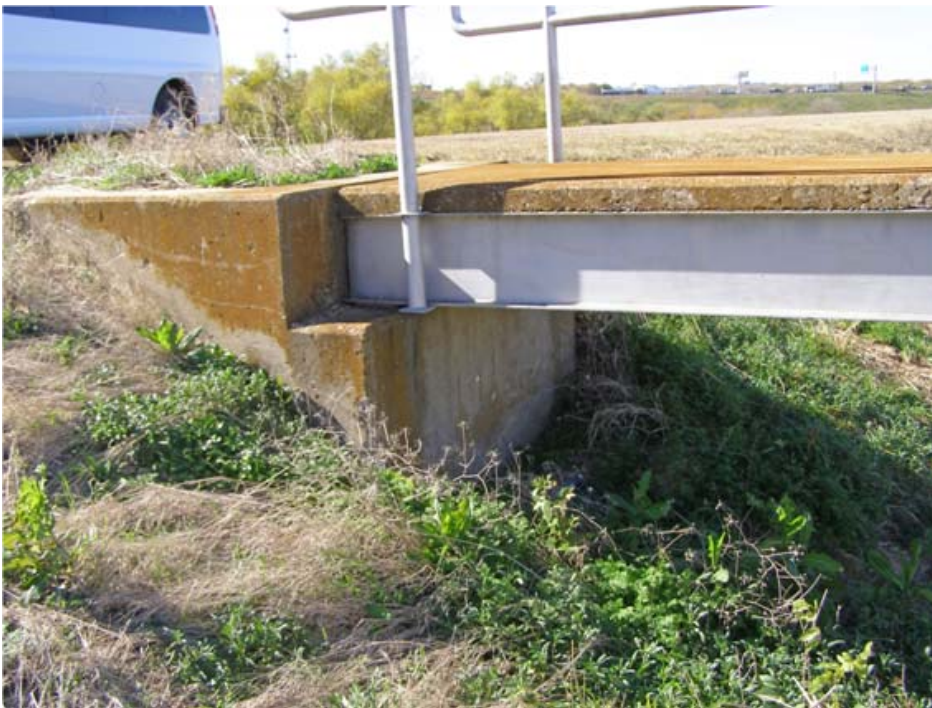
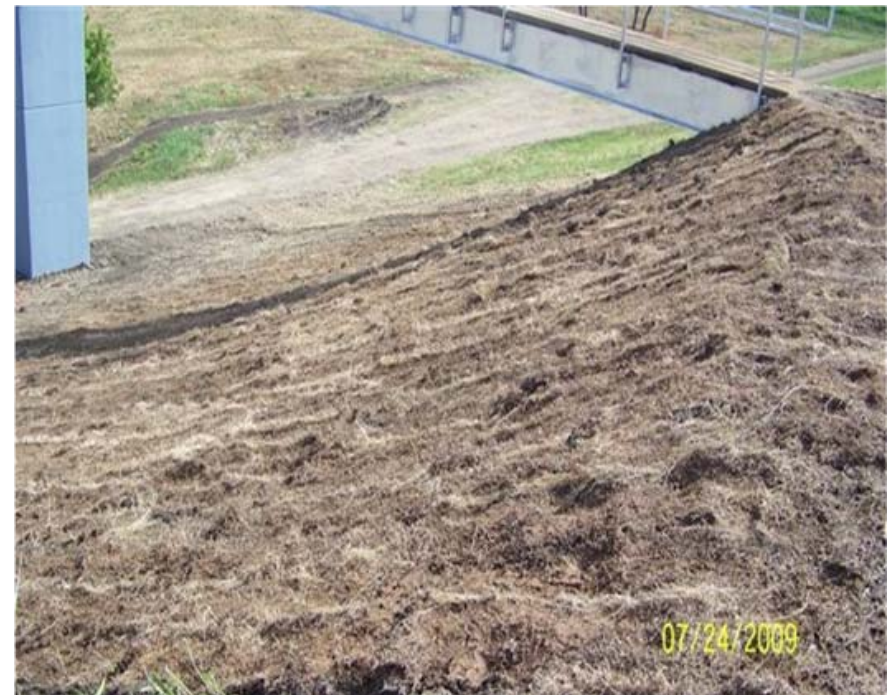
Elm Fork Sluice, East levee – The 8” erosion depression on the down slope side of the service bridge abutment to the levee was addressed using established levee slide repair procedures.

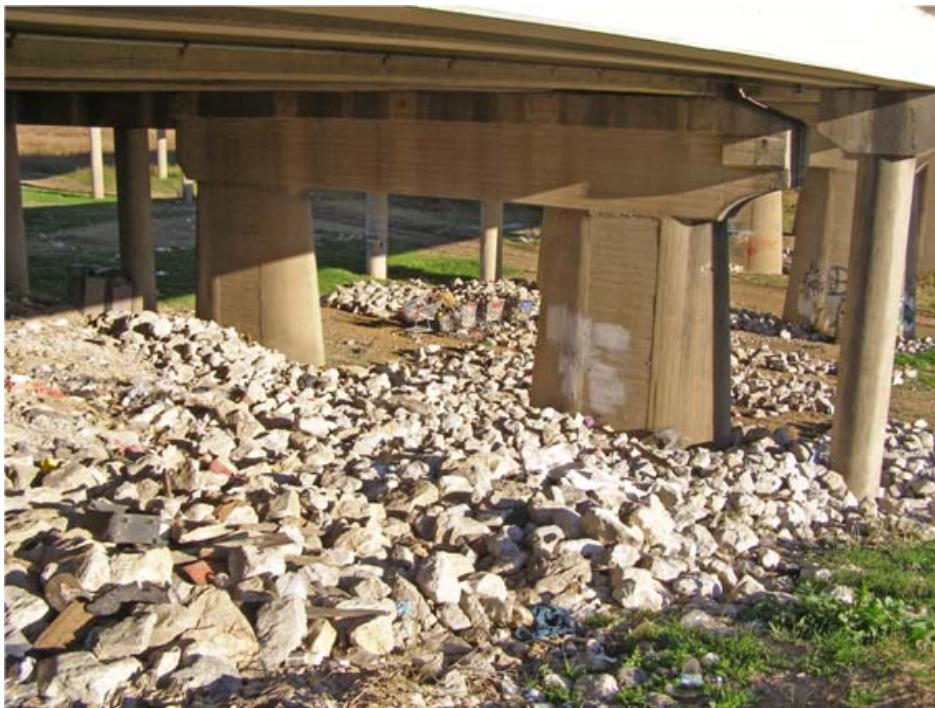
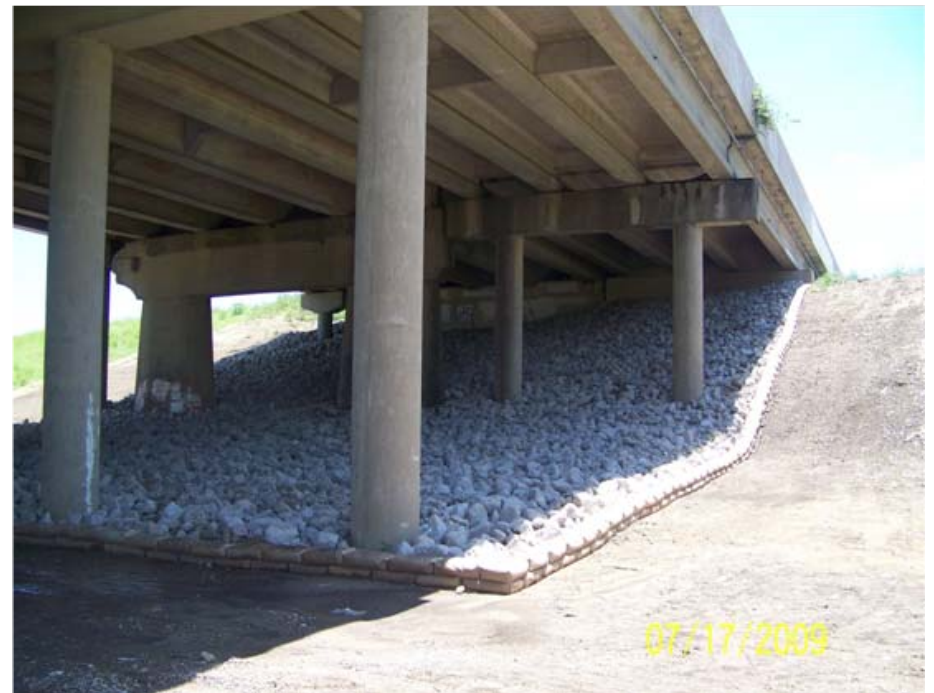
I-35 Northbound Bridge, West Levee - The riverside levee slope stone protection under the bridge displaced to just off the toe.
A stone riprap protection improvement was used to improve the site.

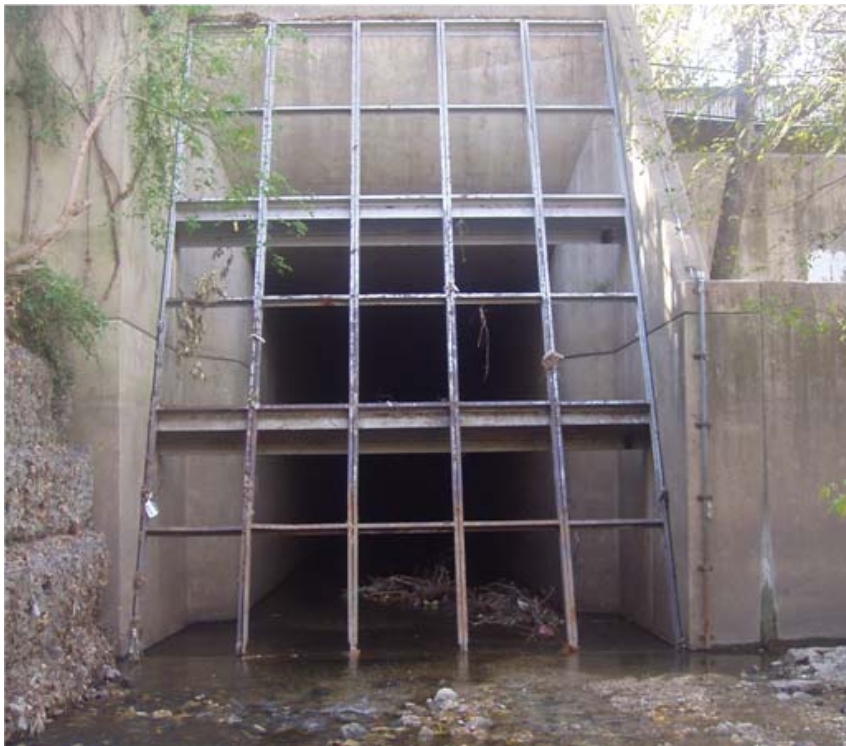
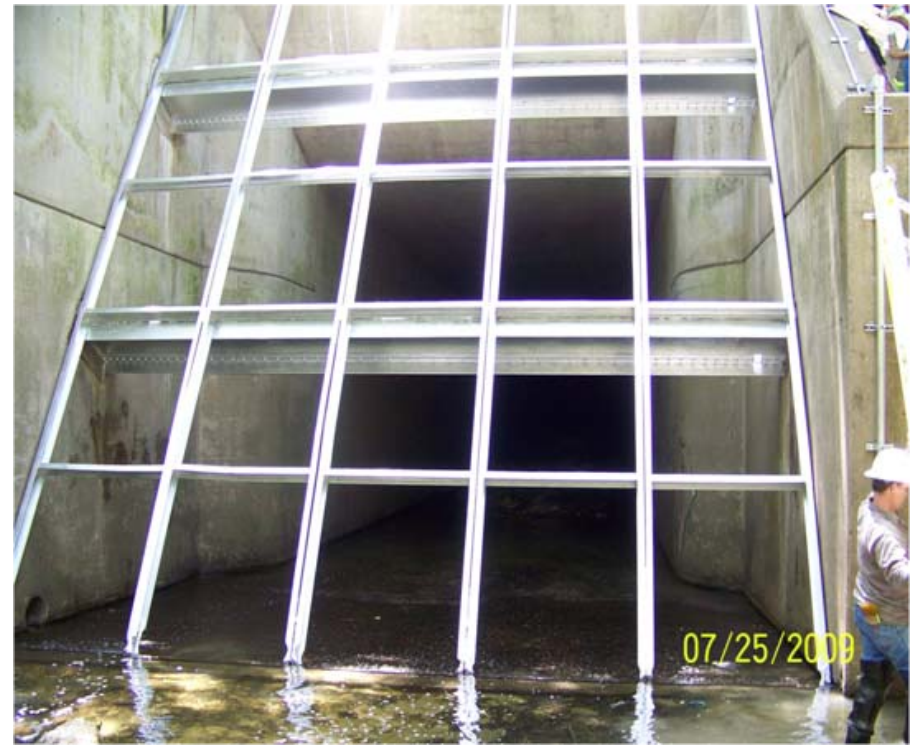
Turtle Creek Pressure Conduit, East Levee – The corrosion on the lower part of the intake trash rack was removed and metallic parts were painted

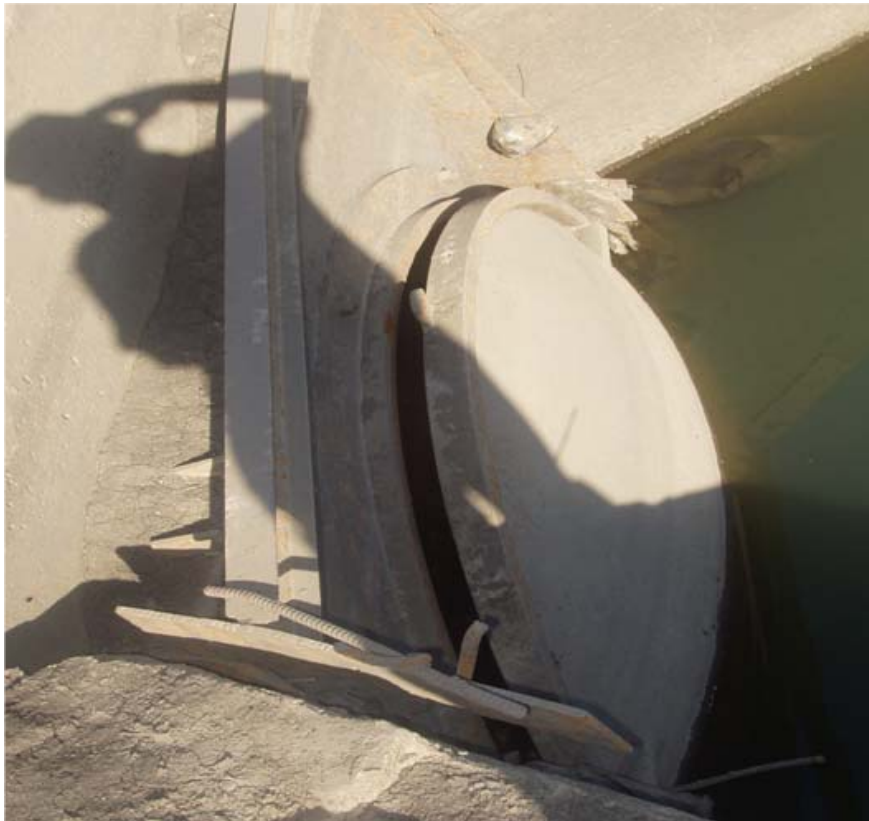
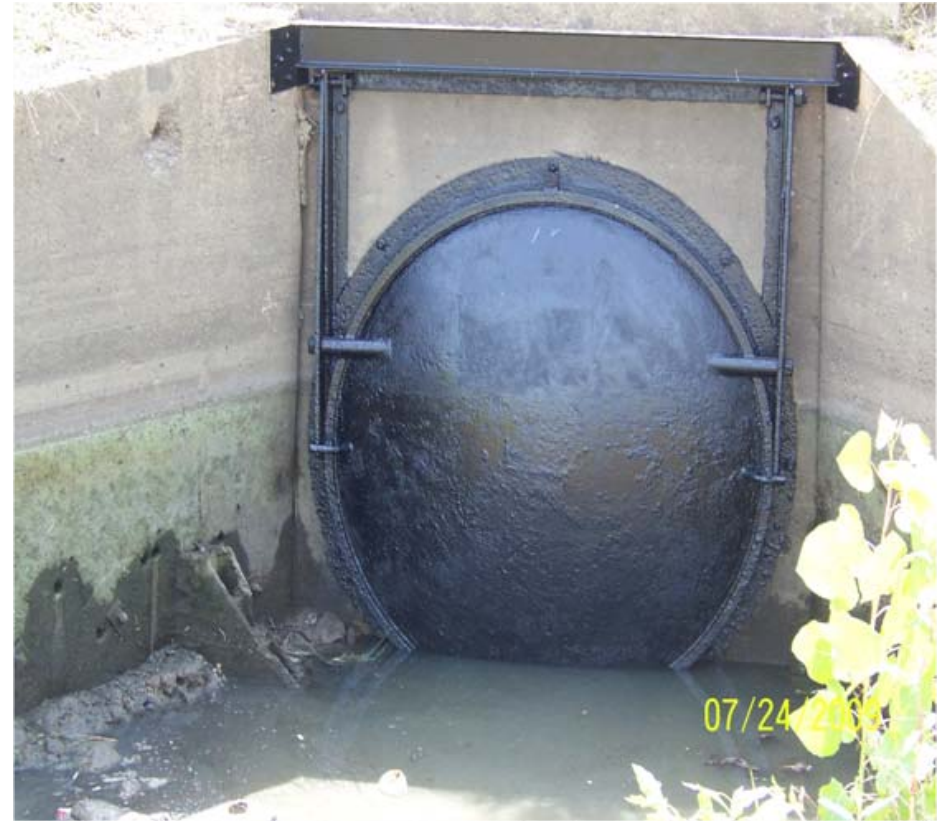
Little Coombs Creek Conduit, West Levee – The debris behind the flap Gate prevented it from sealing. The debris has been removed.

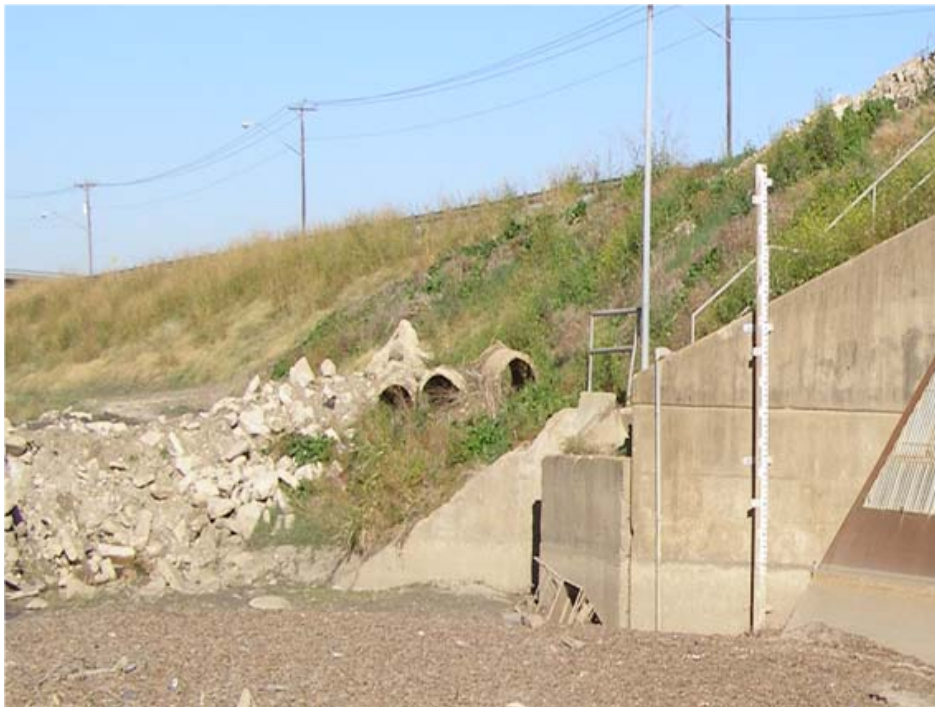
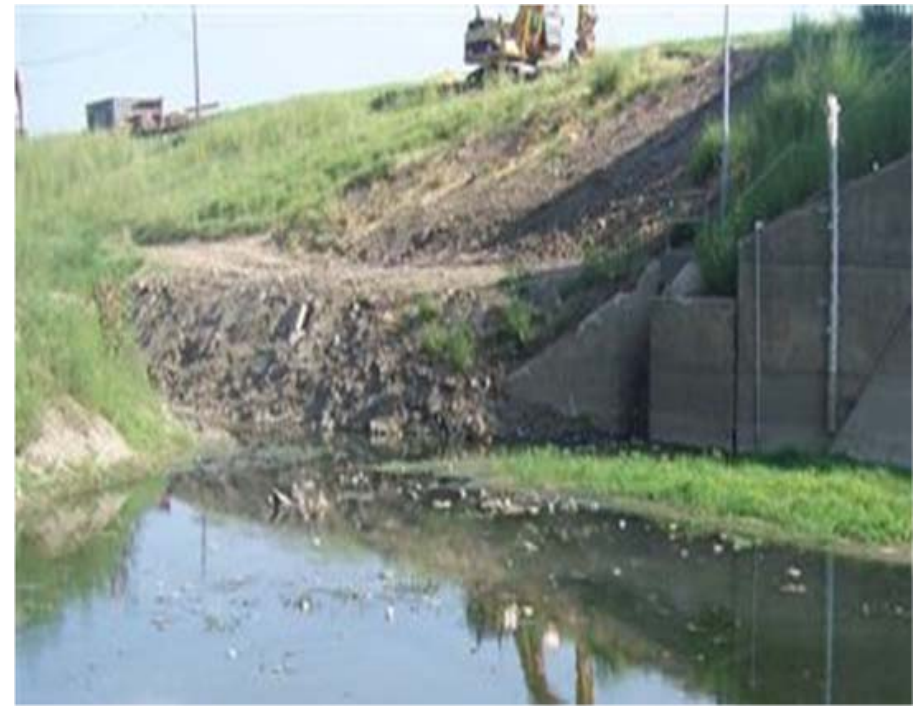
Pavaho Pump Station, West Levee – The three 36” pipes abandoned at the left side of the Pavaho Pump Station have been removed.
This item was submitted to the USACE for approval.
