CITY OF DALLAS

DATE September 18, 2009

SUBJECT **Periodic Inspection Report No. 9
Maintenance Deficiency Correction Period (MDCP) August 2009 Update**

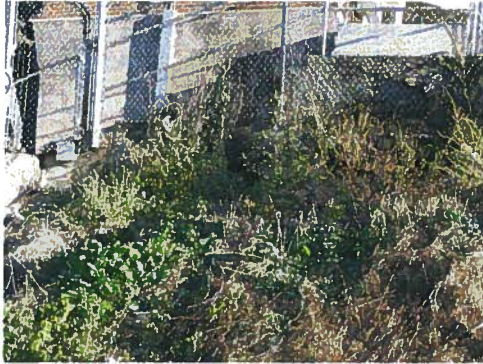
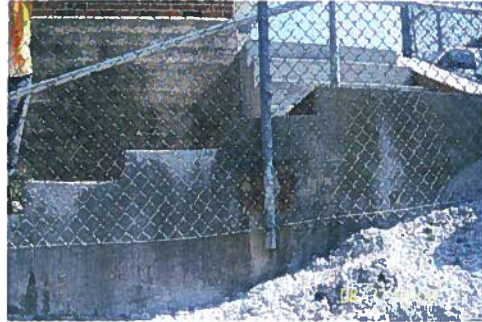
- 1.2 Corps. ID No. 175 – Charlie Pump Station, West Levee – There was an erosion void under the stairs next to the pump house on the west side of the building. It was unclear how far back the void goes.

The source of erosion was identified and the void was repaired and filled using established levee repair procedures.

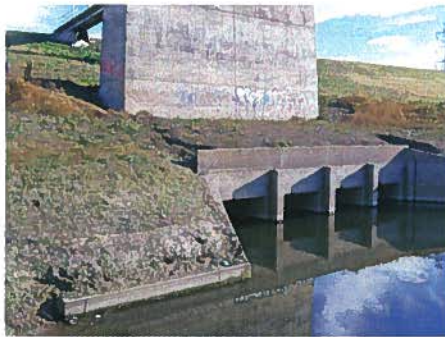
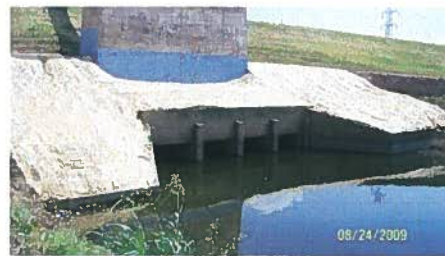
1.3.1 Corps. ID No. 063 – Turtle Creek Pressure Sewer, East Levee – There is erosion on both the right and left slope just above the corners of the discharge chute.

1.3 Nine of the addressed “M” (Minimally Acceptable) items fall into the category of erosion of slope or slides. These were all repaired using established levee slide repair procedures.

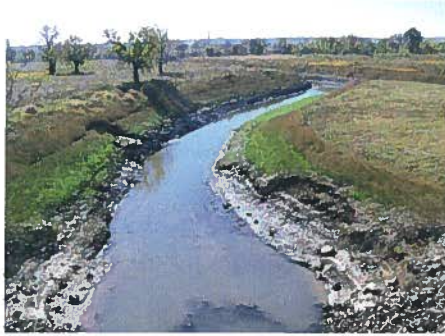
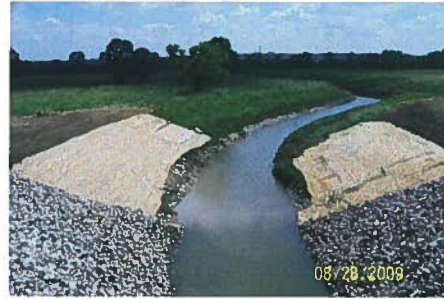
1.3.2 Corps. ID No. 074 – Hampton Pump Station, East Levee – There are slides on the right and left slopes downstream of the displaced riprap.

This item was repaired concurrently with the items in paragraph 2.1 and is further illustrated in the photos below.

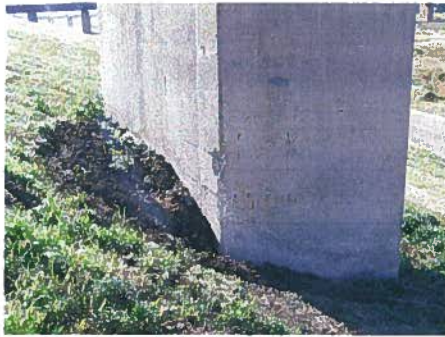
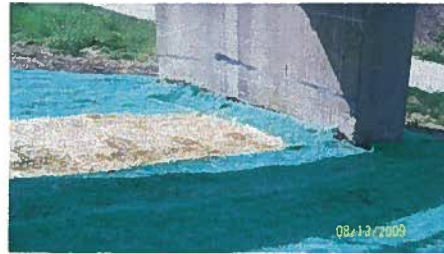
1.3.3 Corps. ID No. 106 – Dallas Branch Pressure Sewer, East Levee – There is a 12 inch erosion depression on the down slope side of the service bridge abutment and a six inch erosion depression on the right side of the control structure on the levee.

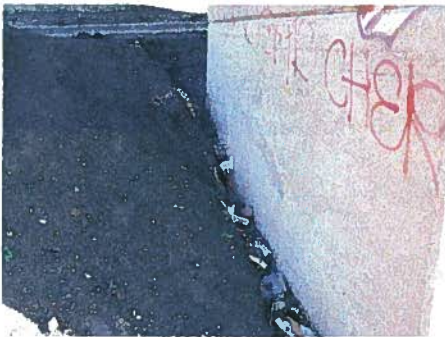
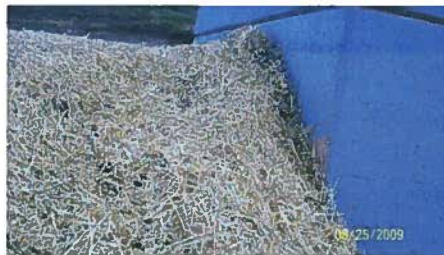
1.3.4 Corps. ID No. 109 – Turtle Creek Pressure Sewer, East Levee – There is erosion (6'W x 6' L x 6' D) on the right side of the control structure.

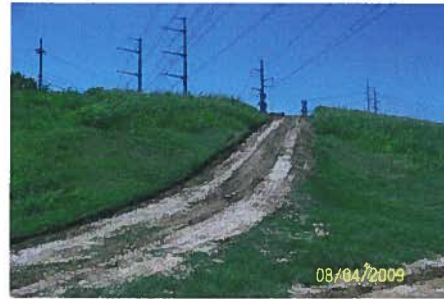
- 1.3.5 Corps. ID No. 143 – Station 134+20, West Levee – There is a 20 foot long erosion gully on the river side levee ramp.

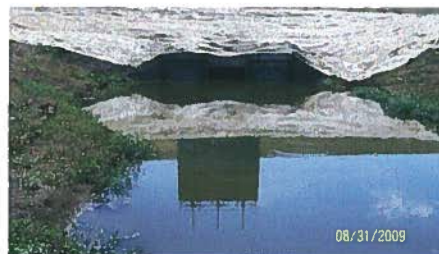
- 1.3.7 Corps. ID No. 168 – Lake Cliff Pressure Conduit, West Levee – There is erosion above the discharge chute (8'W x 40'L).

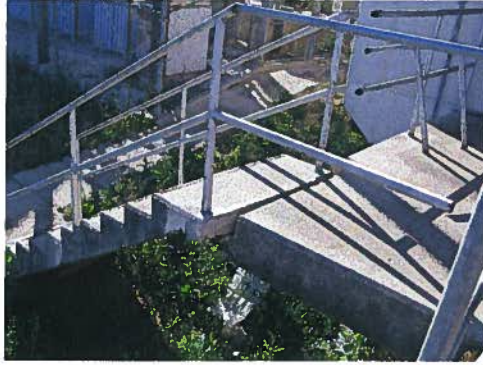
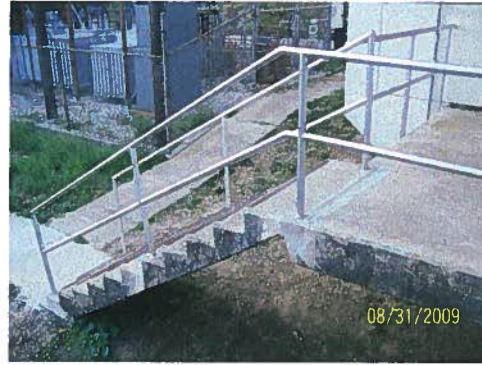
- 1.7 Corps. ID No. 104 – Baker Pump Station, East Levee – This “M” item notes that the hand rails at the top of the stairs behind the building are broken.
The handrail was removed and replaced.

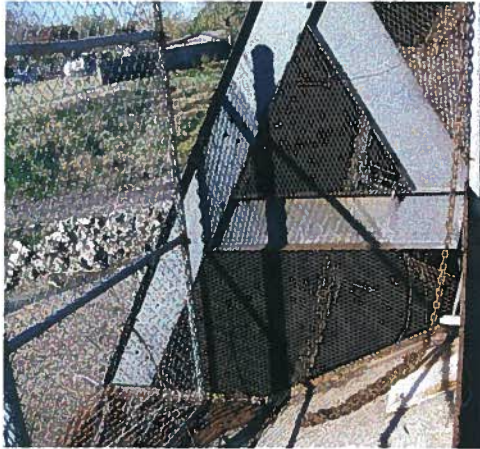
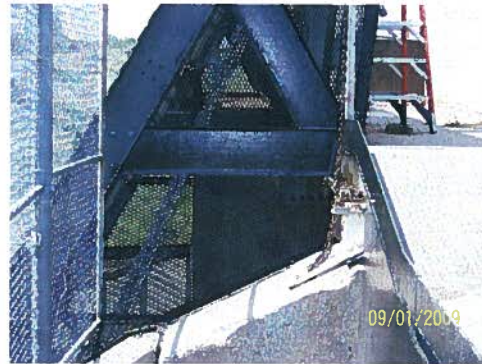
- 1.8 Corps. ID No. 238 – Pavaho Pump Station, West Levee – This item indicates there is 5"W x 8"L tear in the right side rail screen.
