Property Condition Assessment Report

Dallas City Hall Building and Parking Garage

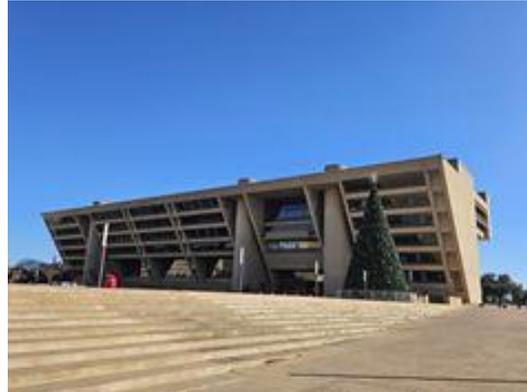
Location	1500 Marilla Street Dallas, Texas 75201
Building Purpose	Administrative
Construction Year	1977
Square Footage	771,000
Assessment Period	December 16, 2025, through January 10, 2026
Assessment Conditions	Partly sunny, 62 degrees Fahrenheit

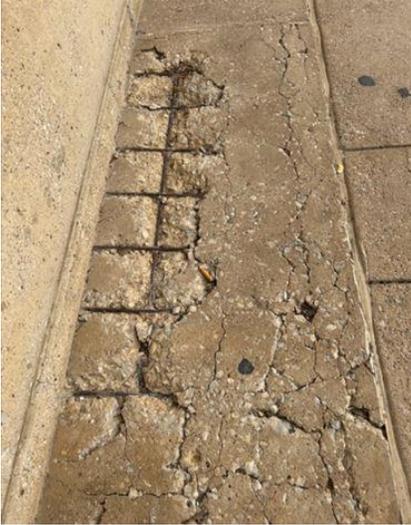
Photo Reference	Deficiency and Recommendation Overview

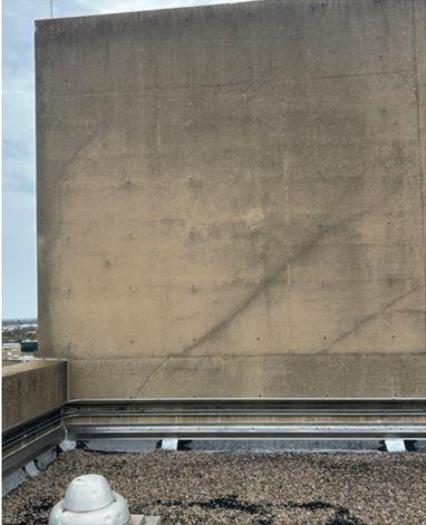
<p>Deficiency: Minor cracking was observed in the exterior concrete wall at the northern elevation, eastern end of the building near the roof level. Although the cracking was limited in extent, the affected area was exposed to weather and may be subject to continued movement, moisture intrusion, and progressive deterioration if left unaddressed.</p> <p>Recommendation: Seal and repair the observed cracking in the exterior concrete wall using materials compatible with exterior exposure conditions to limit moisture intrusion. Monitor the repaired area for signs of progression. If cracking increases or movement is observed, consider further evaluation by a qualified structural engineer to determine whether additional corrective measures are warranted.</p>

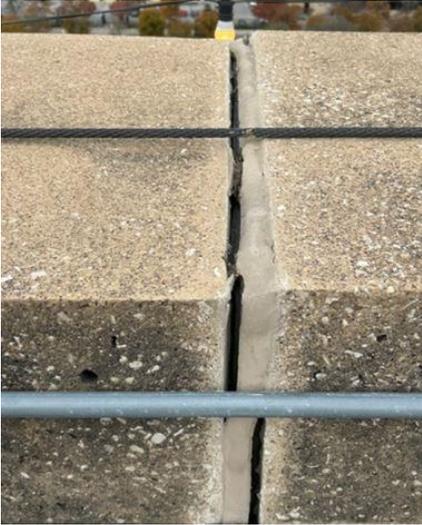
<p>Deficiency: Cracking was observed at an expansion joint located on the building roof. The joint appeared to have deteriorated and may no longer be performing as intended, increasing the potential for moisture intrusion and related deterioration of adjacent roofing and structural elements.</p> <p>Recommendation: Repair or replace the deteriorated roof expansion joint assembly to restore proper movement accommodation and weather resistance. Corrective work should include removal of failed joint materials, installation of a replacement system compatible with the existing roof assembly, and proper integration with adjacent roofing, flashing, and waterproofing components. Following repairs, monitor joint performance for indications of renewed distress or movement-related issues.</p>

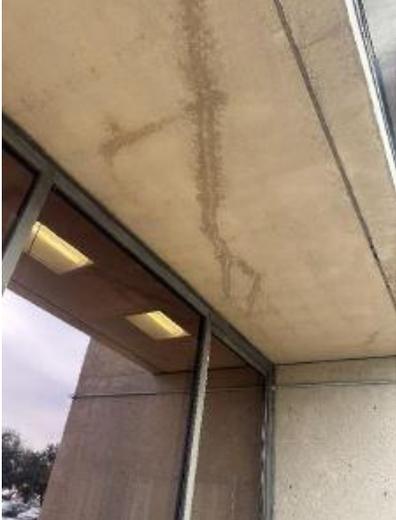
<p>Deficiency: Water staining was observed at the soffit of exterior concrete façade elements. Minor cracking was also observed at the soffit above the first-level storefront windows along the southern side of the building. These conditions suggest ongoing or intermittent moisture exposure and may contribute to continued deterioration of the concrete if left unaddressed.</p> <p>Recommendation: Evaluate adjacent façade elements, sealant joints, glazing interfaces, and drainage conditions to identify likely sources of moisture contributing to soffit staining. Clean and repair affected soffit areas by sealing minor cracks and addressing surface deterioration using materials compatible with the existing concrete. Where repairs are performed, apply protective coatings or sealers as appropriate to reduce moisture penetration and limit recurrence.</p>

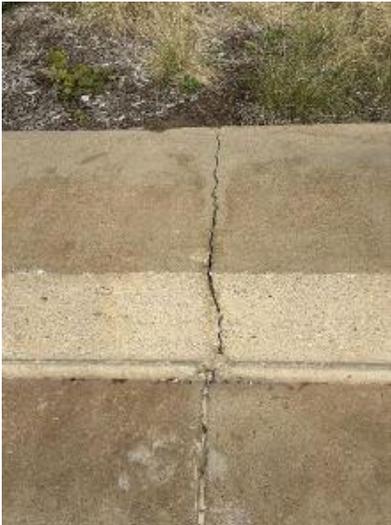
<p>Deficiency: Cracking was frequently observed in exterior planter bed walls and in the concrete step located at the first-level storefront windows along the southern side of the building. These conditions are indicative of age-related deterioration, environmental exposure, and potential movement or moisture-related distress.</p> <p>Recommendation: Perform localized repairs of cracked planter bed walls and concrete steps, including crack cleaning and sealing to limit moisture intrusion. Where cracking is more pronounced or recurrent, remove and replace affected concrete sections as necessary to restore surface integrity and serviceability. Evaluate planter bed drainage and waterproofing conditions to reduce ongoing moisture exposure and monitor repaired areas for future cracking.</p>
Exterior Windows

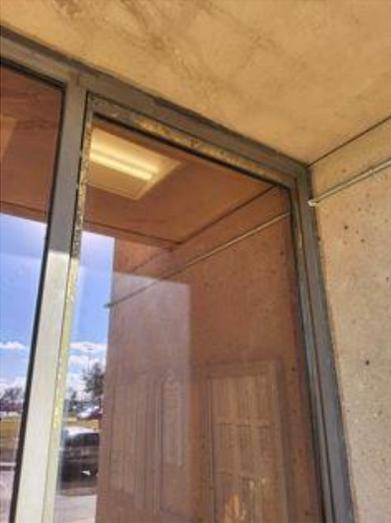
<p>Deficiency: Exterior glazing systems showed age-related degradation including seal failure, oxidation, reduced thermal performance, and ongoing water infiltration risk. Condition observations indicate systemic aging rather than isolated failures.</p> <p>Recommendation: Plan for replacement of exterior glazing systems, including strip windows, storefront assemblies, and clerestory glazing, with modern high-performance systems designed to align with applicable energy and performance requirements. Replacement should improve thermal performance, reduce air and water infiltration potential, and enhance long-term durability and maintainability.</p>

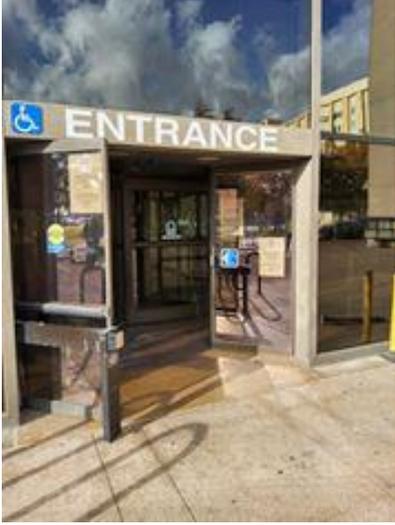
<p>Deficiency: Exterior door assemblies exhibited material deterioration, weathering, hardware wear, air and water infiltration issues, and declining operational reliability. The exterior doors are at or beyond typical service life.</p> <p>Recommendation: Plan for full replacement of exterior door systems, including door leaves, frames, hardware, and seals. Improve thermal, air, and moisture performance and coordinate with security, accessibility and historic preservation requirements as applicable.</p>
Roof

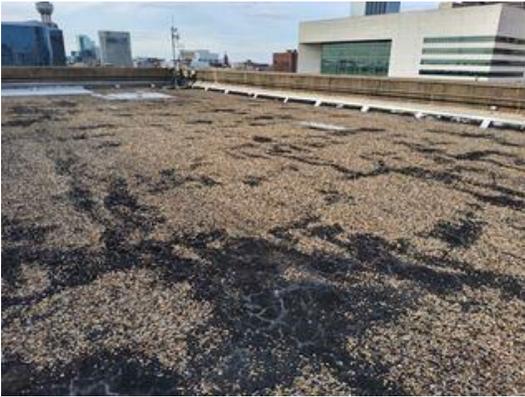
<p>Deficiency: The roofing systems exhibited widespread age-related deterioration consistent with systems that have reached or exceeded their expected service life. Observed conditions include deteriorated and open flashing seams, failing base flashings at penetrations and curbs, membrane blistering, localized membrane repairs, and evidence of asphaltic material migrating toward and into roof drains. Localized repairs have not resolved systemic performance issues.</p> <p>Recommendation: Plan for total roof replacement, including removal and replacement of all roof membranes, refurbishment or replacement of flashings and penetrations, and upgrades to drainage where feasible. Roof replacement should be coordinated with rooftop mechanical and electrical systems to support long-term watertight performance and system integration.</p>

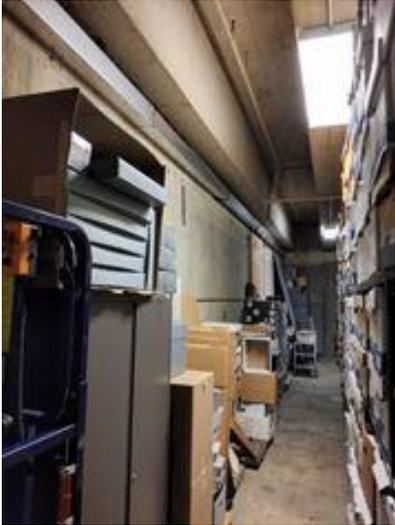
Photo Reference	Deficiency and Recommendation Overview
Interior Walls

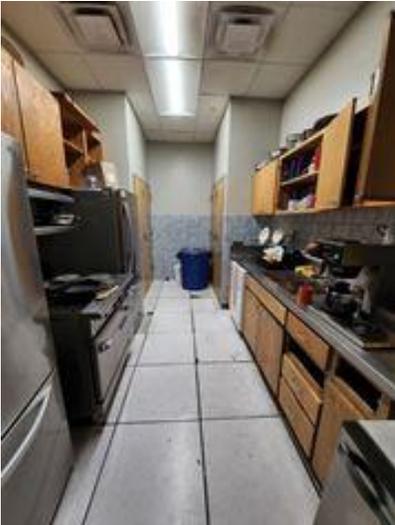
<p>Deficiency: The Fire Department Dispatch (L1 - Dispatch Area) kitchen area exhibited widespread deterioration, including heavily worn and displaced RAF, worn cabinet faces, damaged doors, and deteriorated finishes. Countertops showed significant wear.</p> <p>Recommendation: Plan for comprehensive renovation of the Fire Department Dispatch kitchen area, including replacement of worn finishes and fixed components. Scope should include removal and replacement of floor finishes, casework, countertops, wall and ceiling finishes, and coordination of plumbing, electrical, and HVAC systems as required to support the renovated layout.</p>

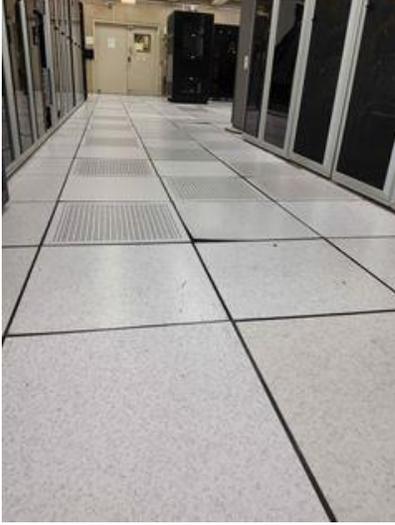
<p><u>Deficiency:</u> The RAF system in the level 3 data center areas exhibited visible deterioration, including stained/discolored panels and localized surface wear consistent with long-term use and maintenance activities. The observed condition suggests the RAF finish is no longer performing as intended for a critical Information Technology (IT) environment and may include localized panel damage and/or unevenness that can develop over time in high-traffic equipment aisles.</p> <p><u>Recommendation:</u> Replace deteriorated RAF panels throughout the data center footprint and re-level/adjust pedestals and stringers as needed to restore a uniform, stable walking surface.</p>

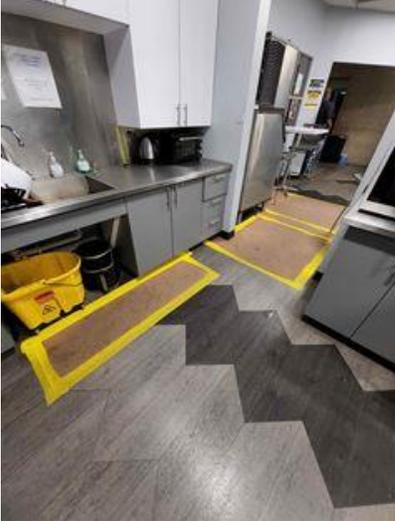
<p><u>Deficiency:</u> There were signs of water damage to the 911 dispatch break room vinyl flooring surrounding the ice machine and kitchen sink.</p> <p><u>Recommendation:</u> Replace the vinyl flooring in the 911 dispatch break room.</p>

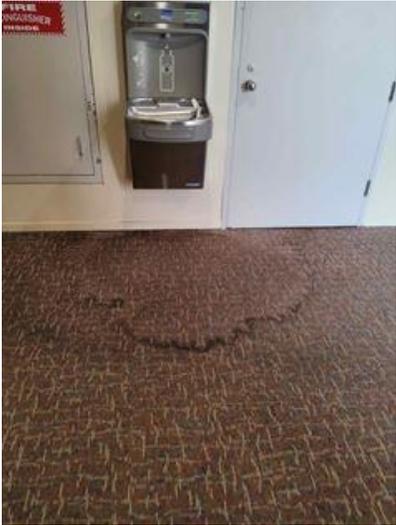
<p>Deficiency: Carpet flooring in Level 2 primary circulation areas was heavily worn, stained, and deteriorated due to sustained high foot traffic and stains from roof leaks and water intrusion.</p> <p>Recommendation: Replace deteriorated carpet flooring in identified circulation and office areas to restore durability, appearance, and functionality consistent with high-traffic use.</p>

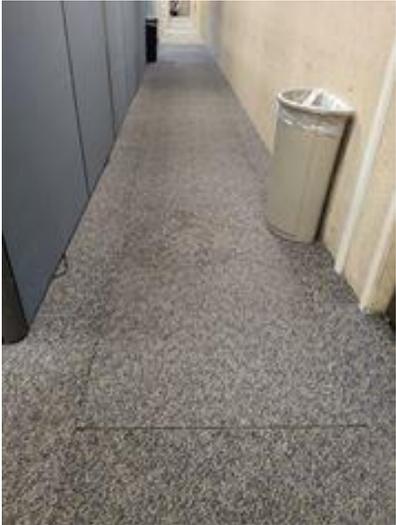
<p>Deficiency: Carpet flooring in 5A North was heavily worn, stained, and deteriorated due to sustained high foot traffic.</p> <p>Recommendation: Replace deteriorated carpet flooring in identified circulation and office areas to restore durability, appearance, and functionality consistent with high-traffic use.</p>

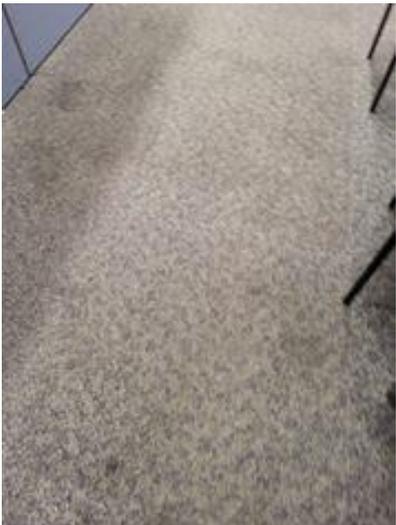
<p>Deficiency: Carpet flooring in 7A North was heavily worn, stained, and deteriorated due to sustained high foot traffic.</p> <p>Recommendation: Replace deteriorated carpet flooring in identified circulation and office areas to restore durability, appearance, and functionality consistent with high-traffic use.</p>

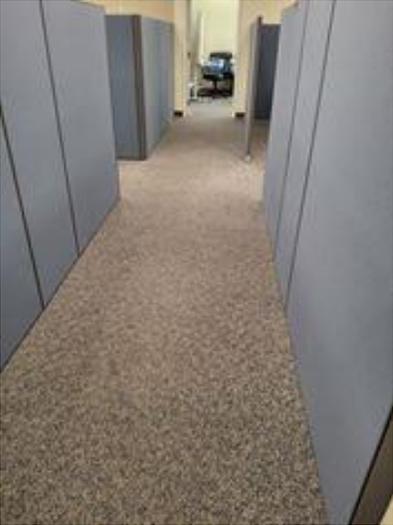
<p><u>Deficiency:</u> Carpet flooring in 4F North was heavily worn, stained, and deteriorated due to sustained high foot traffic.</p> <p><u>Recommendation:</u> Replace deteriorated carpet flooring in identified circulation and office areas to restore durability, appearance, and functionality consistent with high-traffic use.</p>

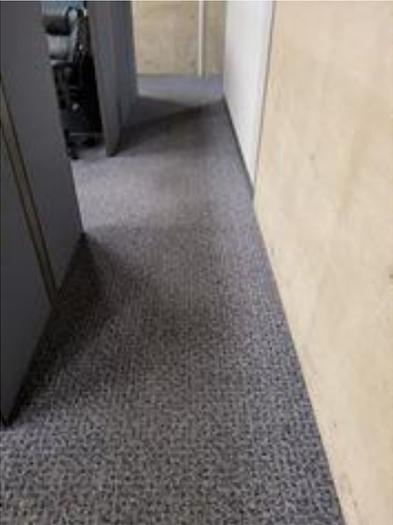
<p><u>Deficiency:</u> Carpet flooring in 2F North was heavily worn, stained, and deteriorated due to sustained high foot traffic.</p> <p><u>Recommendation:</u> Replace deteriorated carpet flooring in identified circulation and office areas to restore durability, appearance, and functionality consistent with high-traffic use.</p>

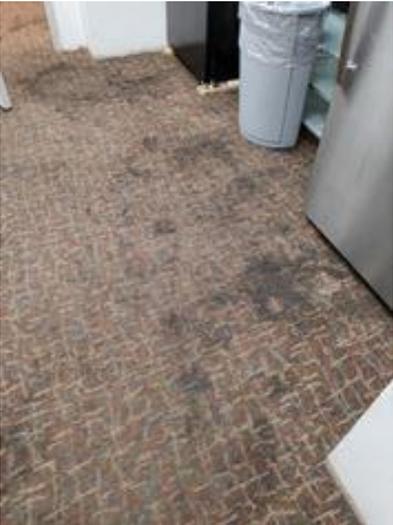
<p><u>Deficiency:</u> Carpet flooring in 2D South was heavily worn, stained, and deteriorated due to sustained high foot traffic.</p> <p><u>Recommendation:</u> Replace deteriorated carpet flooring in identified circulation and office areas to restore durability, appearance, and functionality consistent with high-traffic use.</p>

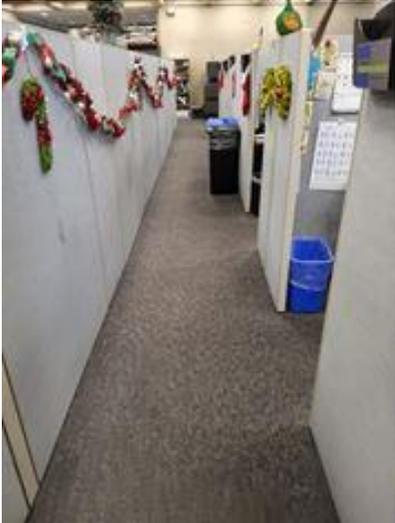
<p>Deficiency: Carpet flooring in 2A South was heavily worn, stained, and deteriorated due to sustained high foot traffic.</p> <p>Recommendation: Replace deteriorated carpet flooring in identified circulation and office areas to restore durability, appearance, and functionality consistent with high-traffic use.</p>

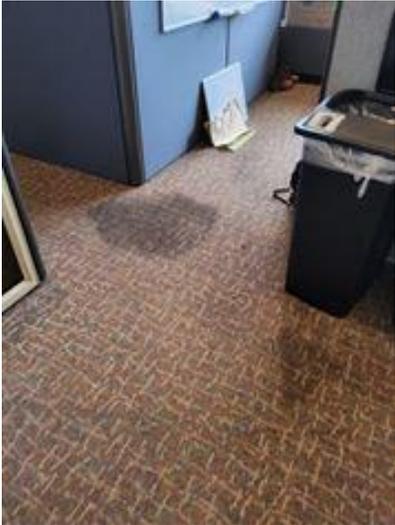
<p>Deficiency: Carpet flooring in 2B South was heavily worn, stained, and deteriorated due to sustained high foot traffic.</p> <p>Recommendation: Replace deteriorated carpet flooring in identified circulation and office areas to restore durability, appearance, and functionality consistent with high-traffic use.</p>

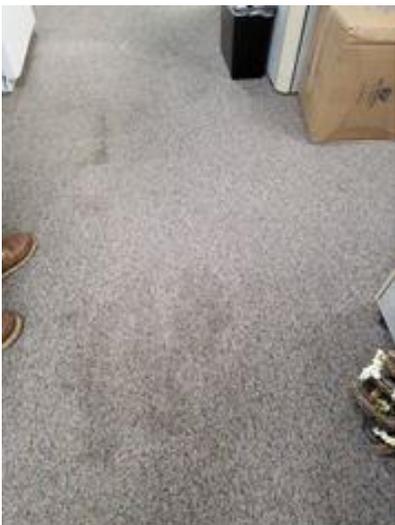
<p>Deficiency: Carpet flooring in L2E South was heavily worn, stained, and deteriorated due to sustained high foot traffic.</p> <p>Recommendation: Replace deteriorated carpet flooring in identified circulation and office areas to restore durability, appearance, and functionality consistent with high-traffic use.</p>

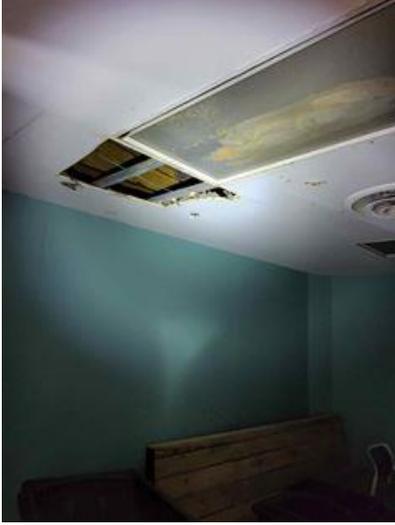
<p>Deficiency: Water damage was observed at the ceiling finish in the level 7 cafeteria vending machine room. Facility staff indicated that the roof leak contributing to this condition has been repaired; however, the ceiling materials and lighting components remain visibly stained and deteriorated due to prior moisture exposure.</p> <p>Recommendation: Remove and replace damaged ceiling finish materials in the level 7 cafeteria vending machine room. Replace lighting fixtures and verify proper electrical operation. Prior to reinstallation, confirm that no residual moisture or concealed damage is present above the ceiling plane or to other interior finishes.</p>

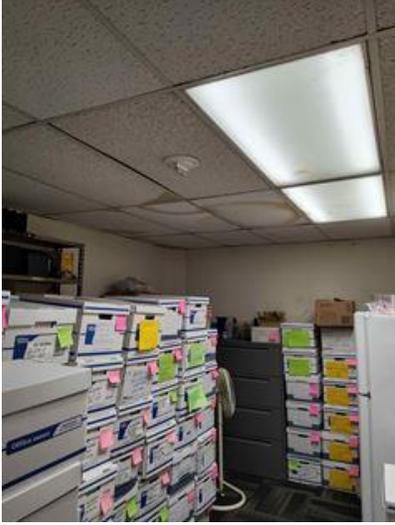
<p>Deficiency: Stained and moisture-damaged acoustic ceiling tile (ACT) was observed in the level 3 north document storage room. The staining is indicative of prior water intrusion and has resulted in reduced aesthetic quality and potential material degradation in the document storage room.</p> <p>Recommendation: Remove and replace the affected ACT ceiling tiles in the level 3 north document storage room. Inspect the ceiling plenum for signs of ongoing moisture or leaks prior to replacement. Coordinate repairs to ensure that any contributing sources of water intrusion are fully resolved to prevent recurrence.</p>

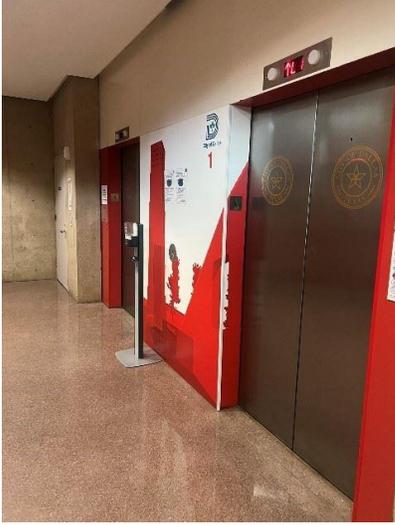
<p>Deficiency: Twelve passenger elevators were modernized in 2021 and generally perform well; however, recurring door-related operational failures persist, including jamming and nuisance trips. Cab interiors were not included in the modernization and show cosmetic wear.</p> <p>Recommendation: Perform targeted modernization of passenger elevator doors, sensors, and associated hardware to address recurring operational issues. Refresh cab interiors as appropriate to improve appearance and functionality.</p>

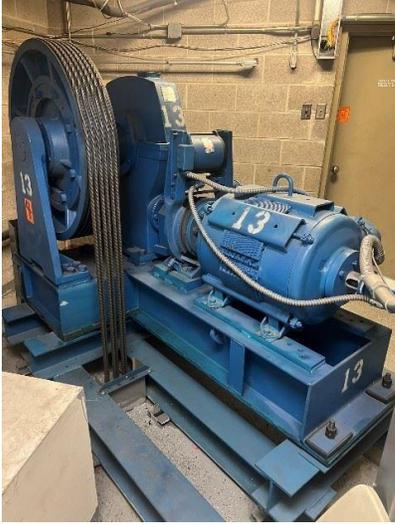
<p>Deficiency: Freight elevator (vintage, installed in approximately 2001) has not been modernized and remains in poor condition, with aging controls, mechanical components, and cab interiors at or beyond typical service life.</p> <p>Recommendation: Plan for full modernization or replacement of the freight elevator, including controls, mechanical systems, cab interiors, doors, and associated hardware, to restore reliable service and meet current operational expectations.</p>

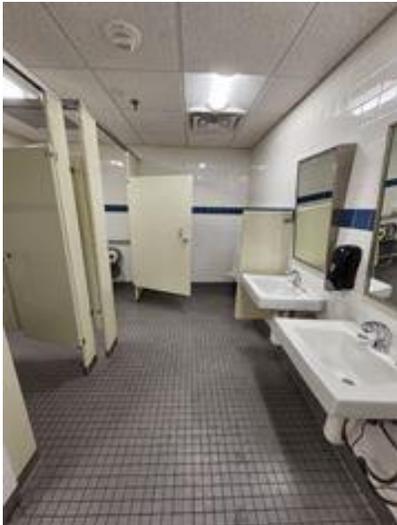
Photo Reference	Deficiency and Recommendation Overview
Plumbing Fixtures

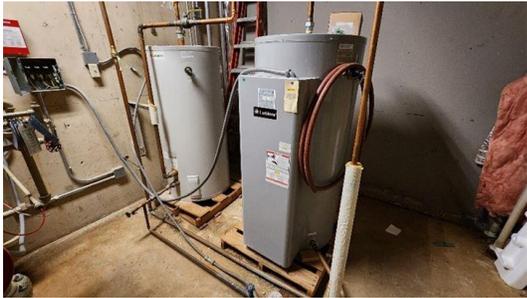
<p>Deficiency: Domestic water heaters located on level 1 were observed to be installed on temporary shipping pallets rather than permanent equipment supports. In addition, hot water distribution piping lacked insulation. These conditions did not reflect permanent installation practices and contributed to increased energy loss, reduced system efficiency, and potential long-term maintenance concerns.</p> <p>Recommendation: Provide permanent, code-compliant equipment supports for the domestic water heaters, such as concrete equipment bases. Install insulation on hot water distribution piping to improve energy efficiency, reduce heat loss, and support long-term system performance and maintainability.</p>

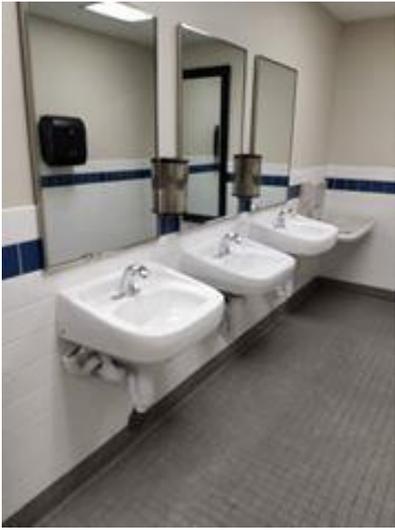
<p>Deficiency: Building staff reported inadequate domestic water pressure serving restrooms on the upper levels. A pressure gauge observed on an upper level indicated low system pressure, which was insufficient to support plumbing fixture operation at higher elevations. These conditions affected restroom functionality and indicated limitations in the existing domestic water distribution system.</p> <p>Recommendation: Evaluate the domestic water distribution system to confirm pressure deficiencies and system limitations. Provide a domestic water booster system, as necessary, to maintain adequate water pressure for restroom fixtures on upper levels and to support reliable operation under normal building demand conditions.</p>
Other Plumbing

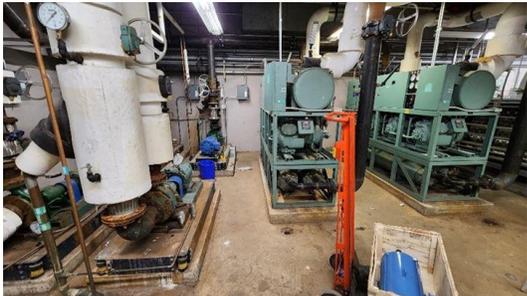
<p>Deficiency: The backup chillers serving the data center were observed to be beyond their typical service life and in need of replacement. The age and condition of this equipment increase the risk of failure and reduce the reliability of cooling for mission critical data center operations.</p> <p>Recommendation: Plan for replacement of the chillers. Currently Chiller Units 4 and 5 are used only as a backup to the main chillers in case of power failure. When these chillers are replaced, they need to</p>

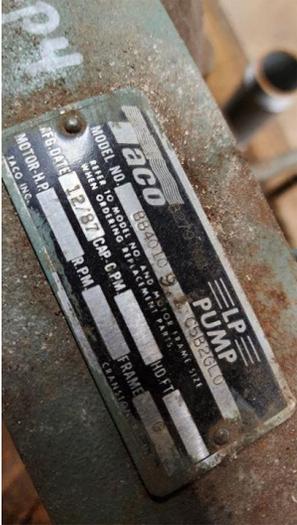
<p>be configured so that they can run at any time and be able to supplement the primary larger chillers. This configuration will provide additional redundancy and efficient low-load capacity for the building.</p> <p>Deficiency: Chilled water pumps associated with Chillers Units 4 and 5 were observed to be in need of replacement.</p> <p>Recommendation: Plan for replacement of chilled water pumps associated with Chiller Units 4 and 5 to restore reliability and support continued system operation.</p>

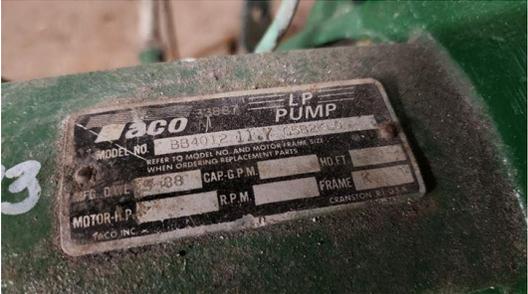
<p>Deficiency: The condenser water pumps associated with Chiller Units 4 and 5 were observed to be in need of replacement.</p> <p>Recommendation: Plan for replacement of the condenser water pumps associated with Chiller Units 4 and 5 to restore reliability and support continued system operation.</p>

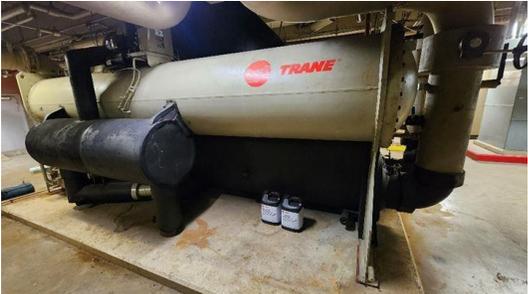
<p>Deficiency: The primary Chiller Units 1, 2, and 3 serving the building were approaching the end of their typical service life and were anticipated to require replacement within the next 5 years.</p> <p>Recommendation: Plan for replacement of the primary building Chiller Units 1, 2 and 3 that are approaching the end of their typical service life to maintain long-term cooling reliability.</p>

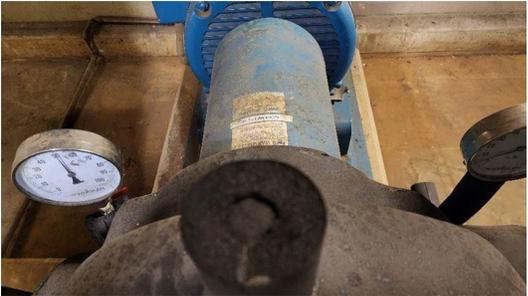
<p>Deficiency: Chilled water pumps associated with Chiller Units 1, 2, and 3 were observed to need replacement. An additional chilled water pump is provided for redundancy.</p> <p>Recommendation: Plan for replacement of the chilled water pumps associated with Chiller Units 1, 2 and 3.</p>

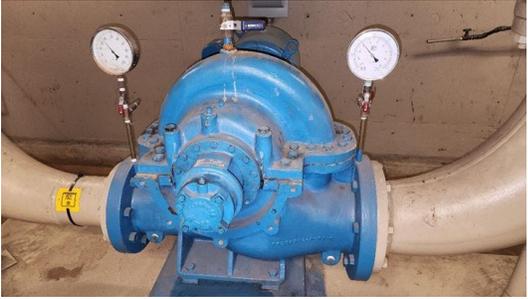
<p>Deficiency: Condenser water pumps associated with Chiller Units 1, 2 and 3 were observed to be in need of replacement.</p> <p>Recommendation: Replace the condenser water pumps associated with Chiller Units 1, 2, and 3.</p>

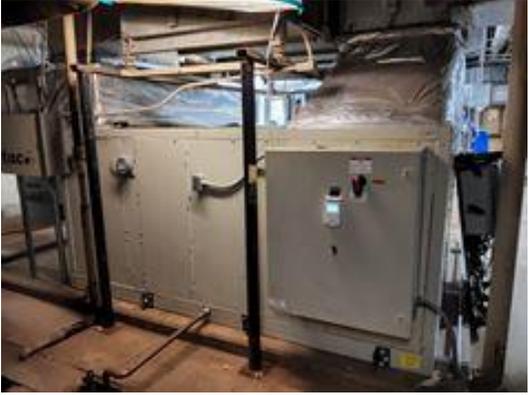
<p>Deficiency: Original AHUs and controls were present. These AHUs need to be, at a minimum, replaced; ideally, the systems need to be re-designed in their entirety.</p> <p>Recommendation: Plan for replacement of the AHUs and pneumatic controls. Replacement efforts should consider system-level evaluation to determine whether reconfiguration or modernization of air distribution systems is warranted to improve performance, efficiency, and long-term reliability.</p>

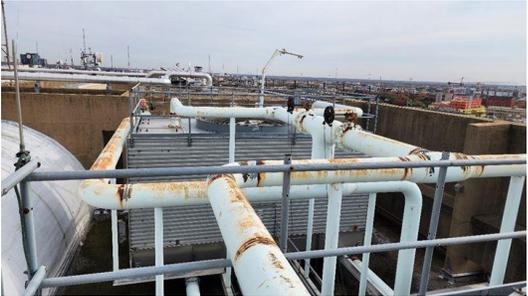
<p>Deficiency: Portions of the condenser water distribution piping were original to the building and exhibited severe corrosion. The observed condition reflected advanced age-related deterioration, increasing the risk of leaks, reduced system efficiency, and unplanned system outages.</p> <p>Recommendation: Plan for replacement of remaining original condenser water piping. Replacement should be coordinated with chiller and condenser water system upgrades to improve reliability, reduce operational risk, and support long-term system performance.</p>

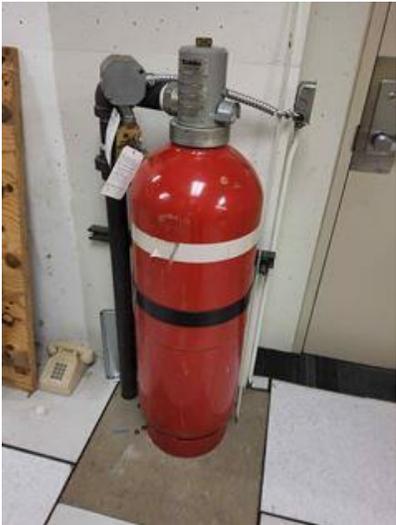
Photo Reference	Deficiency and Recommendation Overview
Fire Protection/Suppression

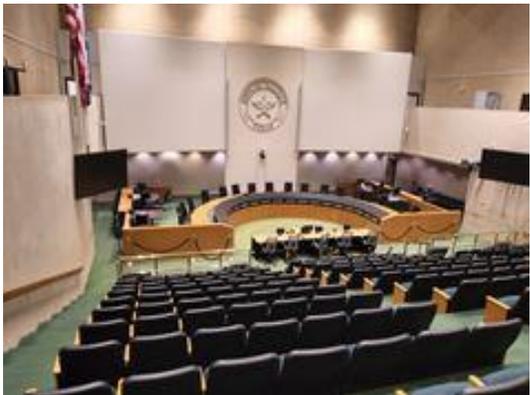
<p>Deficiency: Electrical circuits serving the City Council Chambers experience frequent tripping due to overload from occupant equipment and portable heaters. Existing branch circuits are embedded in floor slabs, limiting flexibility for expansion.</p> <p>Recommendation: Provide additional electrical capacity to the City Council Chambers, including new circuits and distribution as required. Anticipate invasive in-floor construction to access slab-embedded electrical systems.</p>

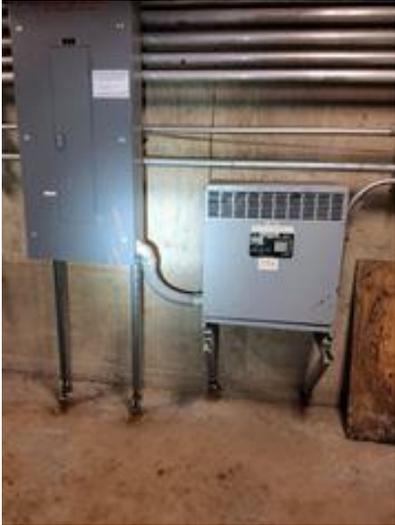
<p>Deficiency: Approximately 130 Federal Pacific panelboards and transformers remain in service. This equipment is obsolete, no longer manufactured, and associated with known safety and reliability concerns.</p> <p>Recommendation: Plan for full replacement of all Federal Pacific panelboards, including associated breakers, feeders, and reconnection of branch circuits.</p>

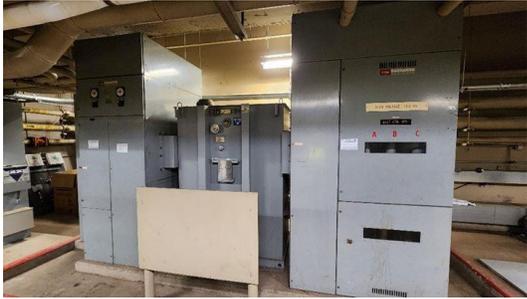
<p>Deficiency: The Federal Pacific electrical switchgear serving the building was observed to be beyond its typical service life and no longer supported by the original manufacturer. The age and obsolescence of this equipment increase maintenance challenges, limit availability of replacement parts, and elevate the risk of failure affecting building operations and life safety systems.</p> <p>Recommendation: Plan for replacement of all Federal Pacific electrical switchgear with modern, code-compliant equipment.</p>

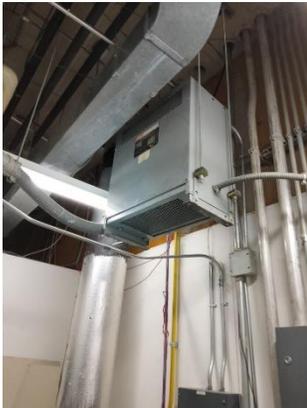
<p>Deficiency: Multiple subtransformers within the building have been confirmed by the City to contain polychlorinated biphenyl (PCB) containing oil. The presence of PCB-containing equipment introduces environmental, regulatory, disposal, and contractor availability risks and complicates future electrical system upgrades and maintenance activities.</p> <p>Recommendation: Plan for evaluation and replacement of PCB-containing transformers, including appropriate hazardous material handling, abatement, and compliant disposal in accordance with applicable regulatory requirements.</p>

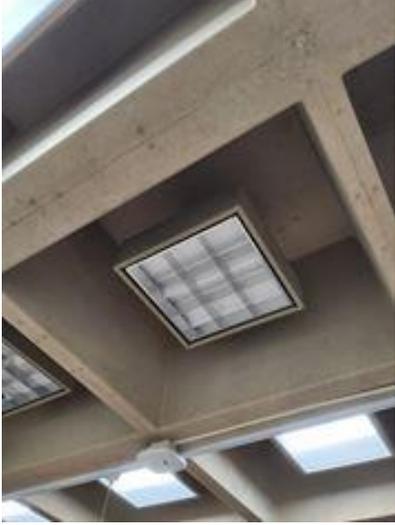
<p>Deficiency: Interior lighting systems throughout the building consisted largely of older, inefficient fixture types. While some fixtures and lamps had been selectively upgraded over time, the overall lighting system exhibited inconsistent performance, reduced energy efficiency, and increased maintenance demands due to reliance on reactive, failure-based replacement.</p> <p>Recommendation: Develop and implement a proactive, phased lighting replacement program rather than continuing replacement upon failure. A structured approach, such as replacing lighting systems on a level-by-level basis, should be used to improve energy efficiency, lighting quality, and long-term maintainability while minimizing operational disruption.</p>
Communications & Security

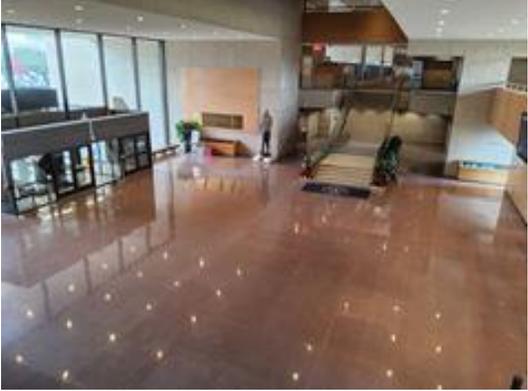
<p>Deficiency: Dallas City Hall does not have a comprehensive, building-wide public address or mass notification system.</p> <p>Recommendation: Provide a facility-wide, code-compliant public address and mass notification system serving all occupied areas of Dallas City Hall. The system should include distributed speakers, control panels, amplification equipment, network integration, and interfaces with existing fire alarm and security systems, as appropriate.</p>

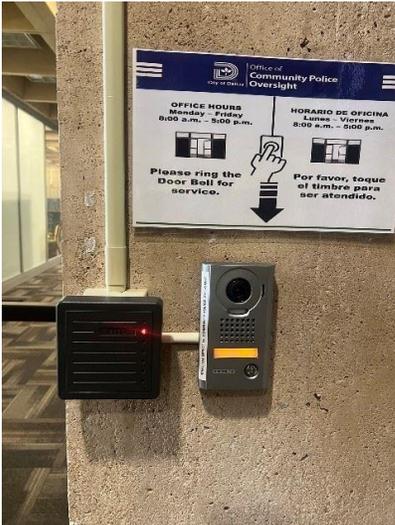
<p>Deficiency: The security system was generally functional; however, it exhibited minor deficiencies related to system configuration, aging components, and overall performance optimization. These conditions limit the system's effectiveness, reliability, and ability to fully support current operational and security needs.</p> <p>Recommendation: Implement targeted upgrades and system optimization measures to modernize the existing security system. Improvements should include selective replacement of outdated components, refinement of system programming and controls, and enhancement of integration with related building systems. The scope of work should focus on improving reliability, operational efficiency, and long-term maintainability while accommodating future security requirements.</p>

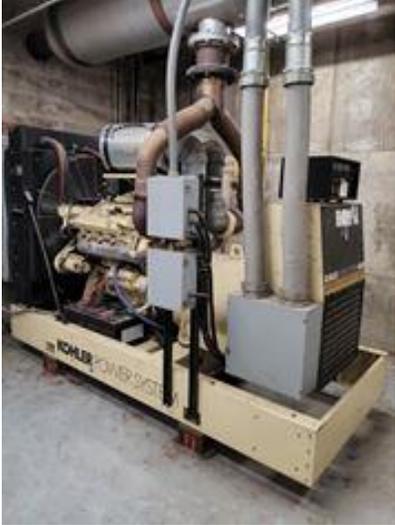
Photo Reference	Deficiency and Recommendation Overview
Other Electrical Systems

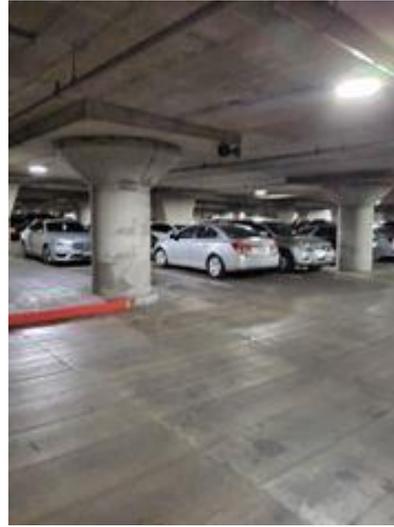
Location	1500 Marilla Street Dallas, Texas 75201
Building Purpose	Parking
Construction Year	1977
Square Footage	752,000
Assessment Period	December 16, 2025, through January 10, 2026
Assessment Conditions	Partly sunny, 62 degrees Fahrenheit

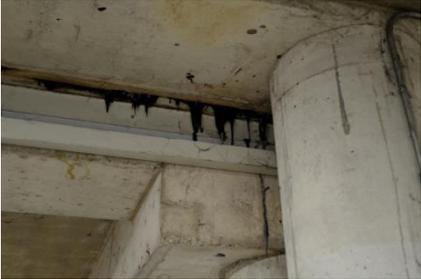
Photo Reference	Deficiency and Recommendation Overview

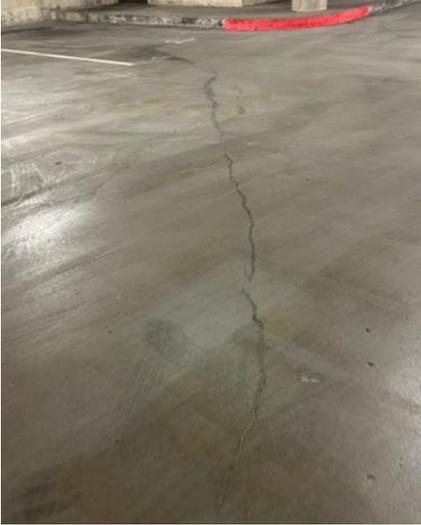
<p>Deficiency: Cracking of the slab-on-ground was observed on level 2 in various locations at the northwestern corner of the parking garage.</p> <p>Recommendation: Monitor observed slab cracking and perform localized concrete crack repairs using epoxy injection or cementitious crack repair methods as appropriate. Evaluate affected areas for signs of differential movement or moisture intrusion during repairs. Continue monitoring to confirm that cracking is non-progressive.</p>

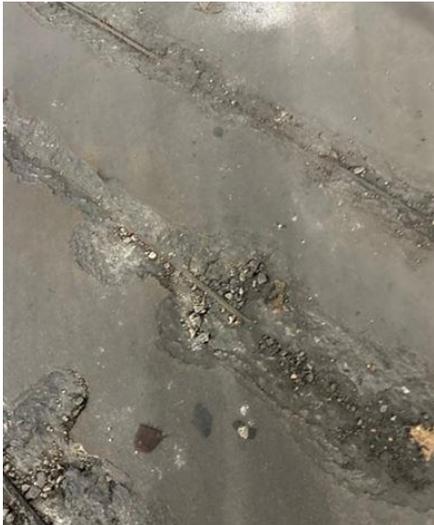
<p>Deficiency: Spalling of the level 2 slab-on-ground was observed with exposed reinforcement.</p> <p>Recommendation: Remove unsound concrete. Clean and treat exposed reinforcing steel and restore affected areas with compatible structural repair mortar. Apply protective coatings or sealers at repaired areas to reduce future moisture intrusion and corrosion, particularly in high-traffic vehicular zones.</p>

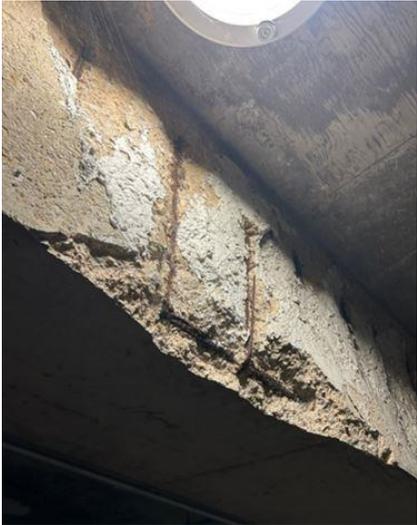
<p>Deficiency: Spalled concrete with exposed stirrups and longitudinal bars was observed at a beam supporting the southwestern entrance ramp. The rebar was corroded and unprotected. Longitudinal bars and stirrups are critical for the structural integrity of the beam.</p> <p>Recommendation: Perform immediate structural repair of the affected beam. Remove deteriorated concrete. Evaluate and treat exposed reinforcing steel. Install supplemental reinforcement if required and restore using structural repair materials.</p>

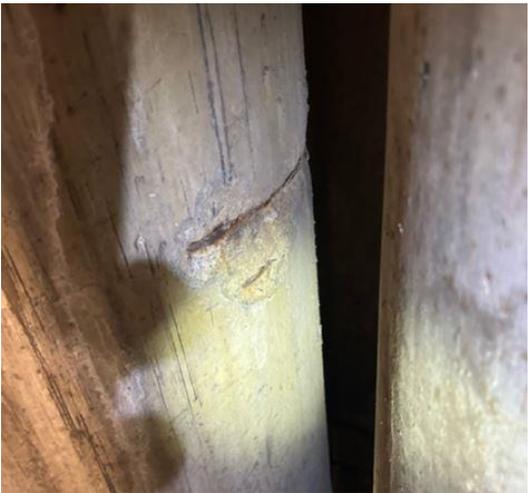
<p>Deficiency: A concrete column was observed to have an exposed stirrup where the concrete had spalled near the northwestern corner of the building on level 1 of the parking garage.</p> <p>Recommendation: Repair the column by removing delaminated concrete, cleaning and protecting exposed reinforcement, and restoring the column section with structural repair materials. Evaluate the column for any reduction in load-carrying capacity and confirm adequacy following repair.</p>

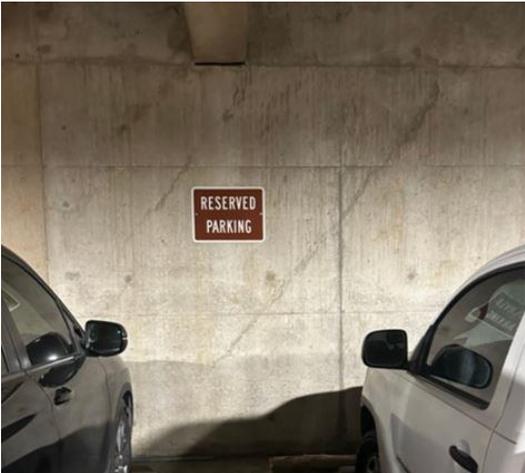
<p>Deficiency: Cracking basement walls with multiple instances along northern and western walls was observed. The cracks were minor but may increase over time and become water intrusion issues.</p> <p>Recommendation: Seal observed cracks using appropriate injection- or surface-applied crack repair systems. Coordinate with the waterproofing consultant to evaluate whether crack repairs should be integrated with broader waterproofing or joint remediation measures. Continue monitoring to identify any progression or water infiltration.</p>

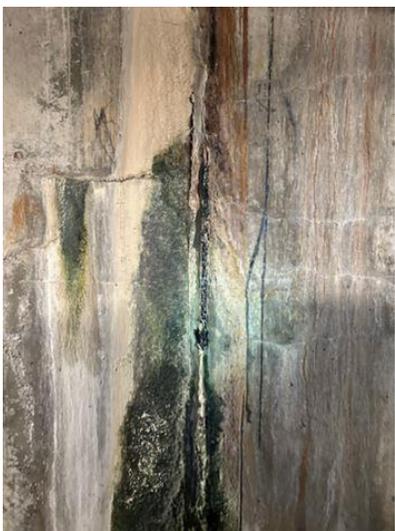
<p>Deficiency: Leaking wall expansion joints were observed at the northern wall of the parking garage.</p> <p>Recommendation: Replace or rehabilitate deteriorated expansion joint assemblies using compatible waterproof expansion joint systems designed for below-grade conditions. Coordinate repairs with waterproofing recommendations to ensure continuity of the parking garage envelope protection.</p>

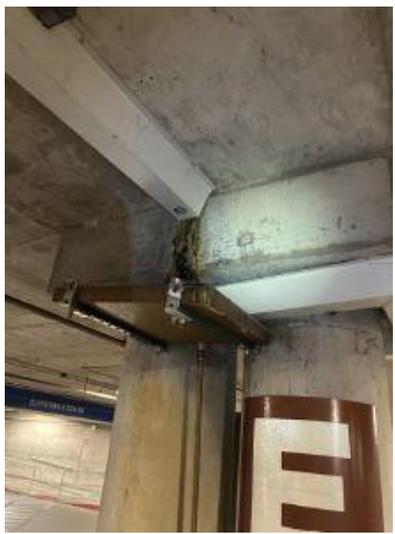
<p>Deficiency: The expansion joints along the majority of the parking garage are allowing water to enter the below-grade parking. Drip pans have been installed along expansion joints, both in the parking area and at entrances to the building to prevent water from dripping on occupants.</p> <p>Recommendation: Reconfigure or replace existing drip pan assemblies to positively drain to approved floor drains or sump systems, if necessary. Eliminate conditions where collected water is discharged uncontrolled onto garage floors.</p>

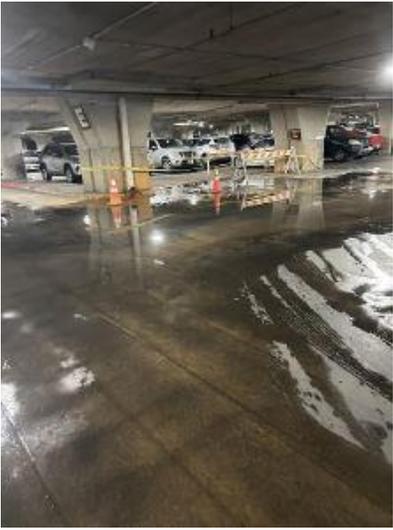
<p>Deficiency: This pictured gutter system was observed to run to the northern end of the parking garage, terminating at a downspout that empties onto the driving surface, resulting in a large area of standing water. No drains were observed. This issue needs to be addressed immediately.</p> <p>Recommendation: Reconfigure or replace existing drip pan assemblies to positively drain to approved floor drains or sump systems, if necessary. Eliminate conditions where collected water is discharged uncontrolled onto garage floors.</p>

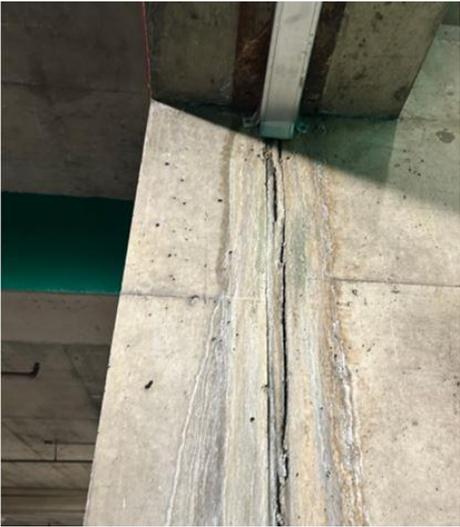
<p>Deficiency: Expansion joint between building and garage structure is deteriorated.</p> <p>Recommendation: Replace or rehabilitate the joint assembly to accommodate differential movement while maintaining watertight integrity. Coordinate with both structural and waterproofing consultants to ensure long-term performance at this critical interface.</p>

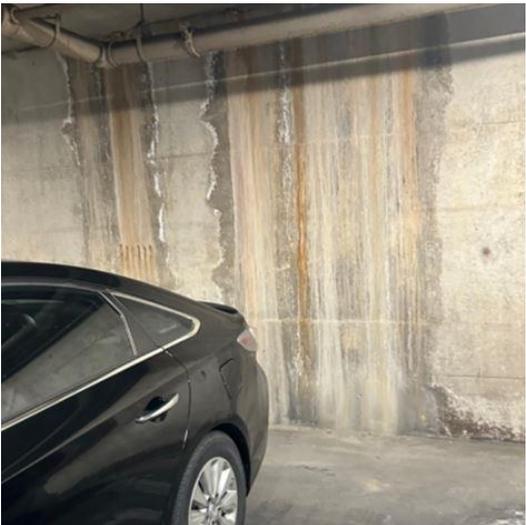
<p>Deficiency: Efflorescence is present on the parking garage walls.</p> <p>Recommendation: Clean affected wall surfaces and evaluate underlying moisture sources. Address contributing water intrusion pathways through joint repairs, crack sealing, and waterproofing improvements. Treat efflorescence as an indicator of ongoing moisture migration rather than a cosmetic issue alone.</p>

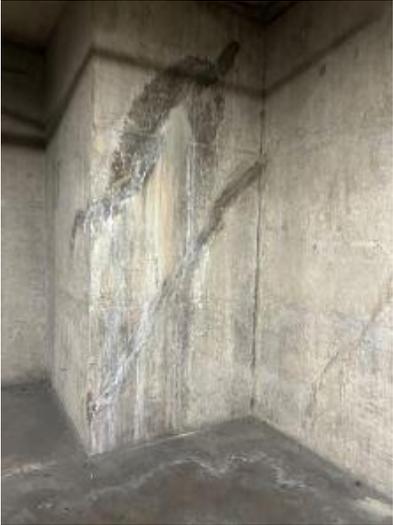
<p>Deficiency: Diagonal cracks with efflorescence were observed on levels 1 and 2 of the parking garage along the western wall adjacent to the convention center. The presence of efflorescence likely indicates that water is migrating through the basement wall and that the waterproofing membrane behind the wall is not functioning properly.</p> <p>Recommendation: Perform structural and waterproofing repairs at retaining walls and ramp slabs, including crack repair, concrete restoration, and replacement or rehabilitation of waterproofing systems. Repair to address both structural integrity and moisture migration to prevent continued deterioration and water infiltration.</p>

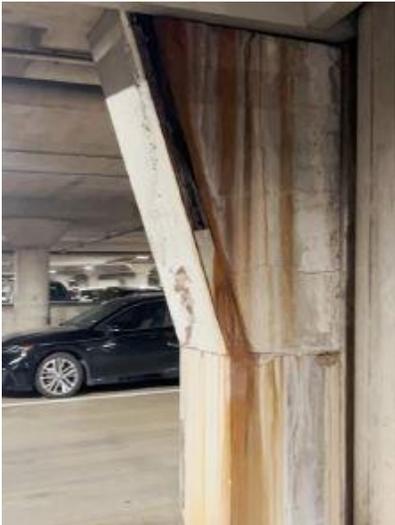
<p>Deficiency: Near the northwestern corner of the building on level 1 of the parking garage, it appeared the concrete column was furred out previously with a lath system. Water from the drip pan system was entering this fur-out area. This condition appeared to be repeated on other similar columns throughout the parking garage.</p> <p>Recommendation: The fur-out lath material should be removed to further investigate the water infiltrating the column cavity. Clean affected wall surfaces and evaluate underlying moisture sources. Address contributing water intrusion pathways through joint repairs, crack sealing, and waterproofing improvements. Treat efflorescence as an indicator of ongoing moisture migration rather than a cosmetic issue alone.</p>
Exterior Walls

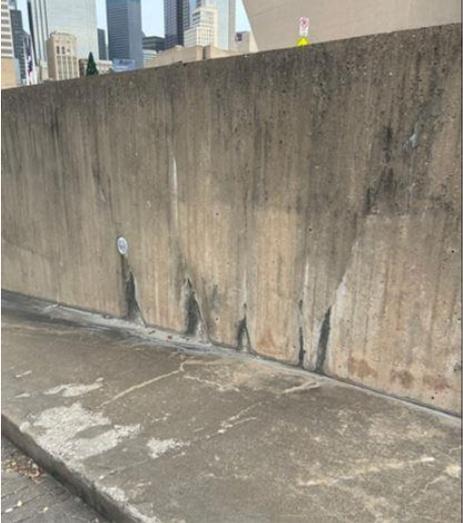
<p>Deficiency: Vertical cracks with efflorescence and water staining were observed at retaining walls at each ramp.</p> <p>Recommendation: Perform structural and waterproofing repairs at ramp retaining walls, including crack repair, concrete restoration, and replacement or rehabilitation of waterproofing systems. Repair to address both structural integrity and moisture migration and prevent continued deterioration and water infiltration.</p>

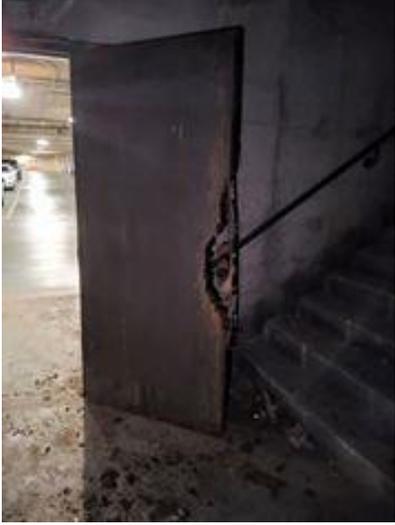
<p><u>Deficiency:</u> The steel doors of the parking garage interior stairwells were severely damaged, corroded, and beyond their expected service life.</p> <p><u>Recommendation:</u> Replace the parking garage interior stairwell metal doors.</p>
Exterior Stairs

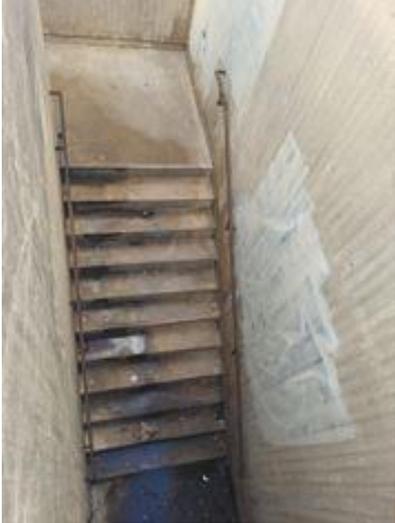
<p><u>Deficiency:</u> The exterior concrete stairwells leading from the plaza to the level 1 parking garage were dirty and showed evidence of poor drainage. Debris and sediment were present on the treads, and standing water/pooling was visible at the lower landing, indicating the service drains may be clogged or not functioning properly.</p> <p><u>Recommendation:</u> Remove debris, and thoroughly clean all exterior stairwells, including landings and stair treads. Inspect, clean out, and restore service drains to proper operation, repairing or replacing damaged drain components as needed. After repairs, verify drainage is functioning correctly, and eliminate any areas of standing water to reduce slip hazards and prevent recurring buildup.</p>

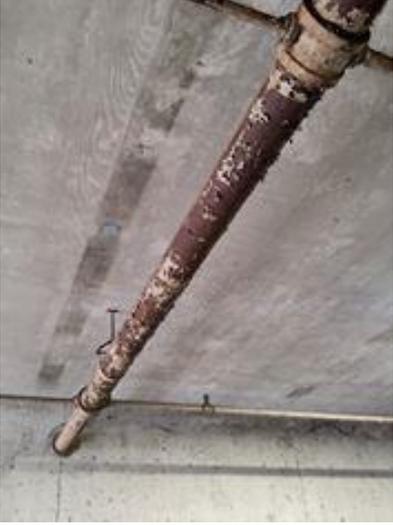
<p>Deficiency: Facility maintenance staff report ongoing nuisance fire alarms in the parking garage associated with routine water movement in the fire suppression distribution system. These events indicate deterioration and failure of the fire suppression piping, resulting in unreliable system performance and false alarm conditions. The recurring nature of the alarms suggests the issue is systemic rather than isolated and reflects aging infrastructure in the parking garage fire suppression distribution network.</p> <p>Recommendation: Plan for replacement of the fire suppression distribution piping serving the parking garage, including associated valves, fittings, and alarm devices as required.</p>
Electrical Distribution

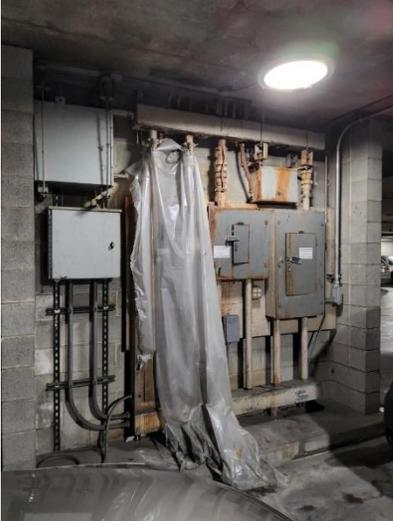
<p>Deficiency: Multiple subtransformers within the building have been confirmed by the City to contain polychlorinated biphenyl (PCB)-containing oil. The presence of PCB-containing equipment introduces environmental, regulatory, disposal, and contractor availability risks and complicates future electrical system upgrades and maintenance activities.</p> <p>Recommendation: Plan for evaluation and replacement of PCB-containing transformers, including appropriate hazardous material handling, abatement, and compliant disposal in accordance with applicable regulatory requirements.</p>

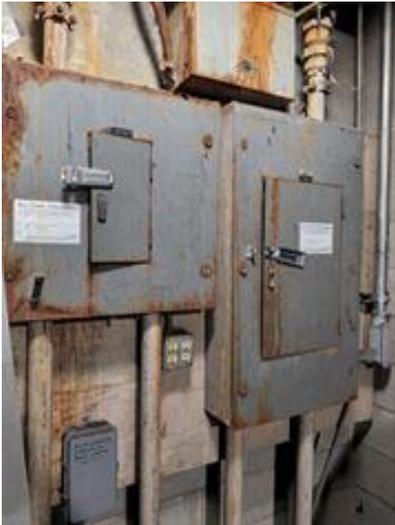
<p>Deficiency: Electrical equipment located in the parking garage and select service areas shows visible deterioration, including corrosion and rusting enclosures. Environmental exposure and moisture intrusion in these areas appear to be accelerating equipment degradation and reducing long-term reliability.</p> <p>Recommendation: Replace deteriorated electrical distribution equipment and provide improved environmental protection, including corrosion-resistant equipment, sealed enclosures, and improved moisture mitigation. Coordinate repairs with garage water intrusion remediation efforts where applicable.</p>
Other Electrical Systems
