Property Condition Assessment Report

Dallas City Hall Building and Parking Garage

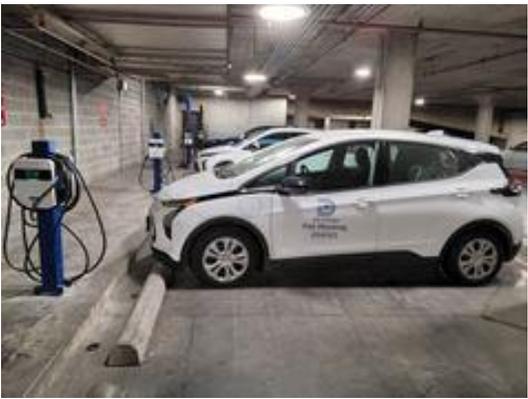
<p>Deficiency: There are 14 charging stations located in L-2 of the parking garage for EV fleet charging. Existing electrical infrastructure supports a limited number of EV charging stations; however, anticipated future expansion (i.e., 200 to 300 chargers) exceeds current electrical capacity.</p> <p>Recommendation: Include allowances for major electrical infrastructure upgrades to support future EV charging expansion, including service upgrades, feeders, panels, and distribution systems.</p>
