JLL Valuation Advisory Property Condition Assessment

Property: 7800 Ricchi Tower - 7800 North Stemmons Freeway, Dallas, Texas 75247

Report Date: July 21, 2022

JLL VA # VA-22-187206

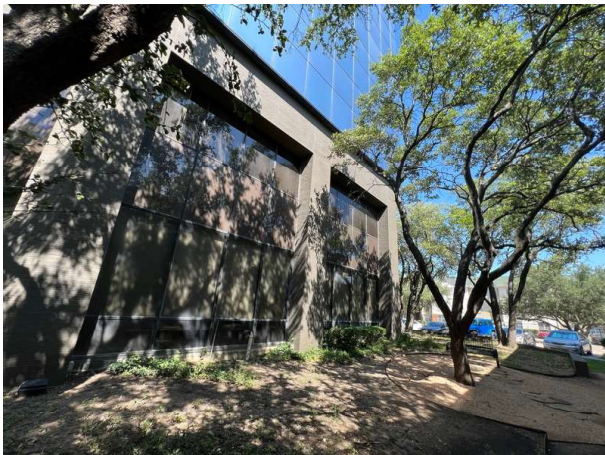
However, bared areas with no grass, distressed plantings and a general poor landscape appearance was observed. JLL VA recommends installing and maintaining the landscape around the Property. An opinion of costs is included in the cost tables.

Landscaping condition

Cost Recommendation	EUL	EFF AGE	RUL	Year	Cost
Landscaping installation and maintenance	-	-	-	Immediate	\$15,000
Total					\$15,000

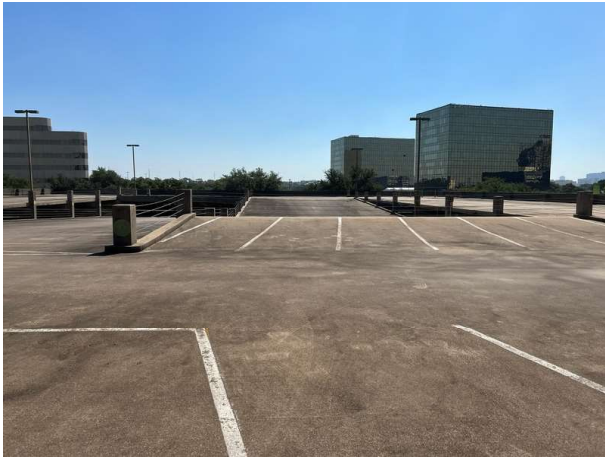
Parking garage concrete structure

In addition, based on the observed condition and EUL, JLL VA recommends budgeting for sealing and cleaning the parking garage every 5 years to avoid water penetrating the structural system. An opinion of cost is included in the tables.

Cost Recommendation	EUL	EFF AGE	RUL	Year	Cost
Concrete pavement striping	5	5	0	Immediate	\$13,660
				5	\$13,660
				10	\$13,660
Parking garage sealing and maintenance	5	5	0	Immediate	\$20,000
				5	\$20,000
				10	\$20,000
Total					\$100,980

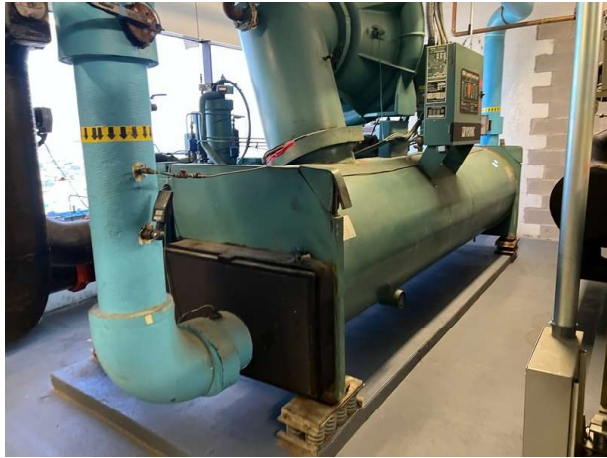
The chillers are in good to fair condition. air-cooled chillers are located at the lower level. They were manufactured by Trane and York. One chiller was replaced in 2015, and the other one is from original construction. Based on the EUL, replacement of the original chiller is recommended. An opinion of cost for this work is included in the cost tables.

Chiller

Cost Recommendation	EUL	EFF AGE	RUL	Year	Cost
HVAC: central AHU overhaul	25	20	5	2	\$30,000
				4	\$30,000
				6	\$30,000
HVAC: chiller unit replacement, original unit	40	35	5	5	\$250,000
HVAC: fan boxes overhaul, allowance	25	20	5	1	\$8,000
				2	\$8,000
				3	\$8,000
				4	\$8,000
				5	\$8,000
				6	\$8,000
				7	\$8,000
				8	\$8,000
				9	\$8,000
				10	\$8,000
				11	\$8,000
				12	\$8,000
Total					\$436,000

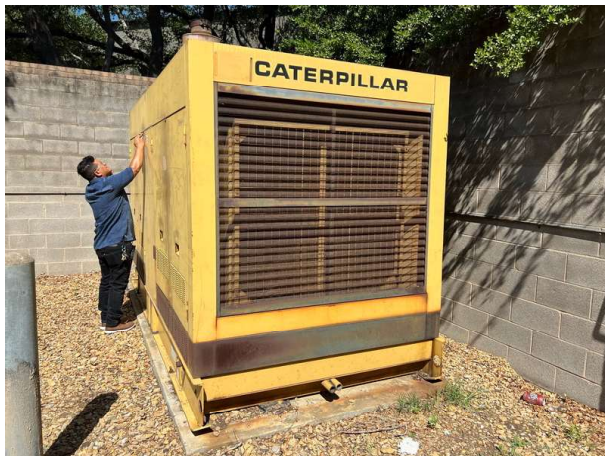
Emergency generator

Cost Recommendation	EUL	EFF AGE	RUL	Year	Cost
Electrical generator replacement	40	37	3	3	\$60,000
Total					\$60,000

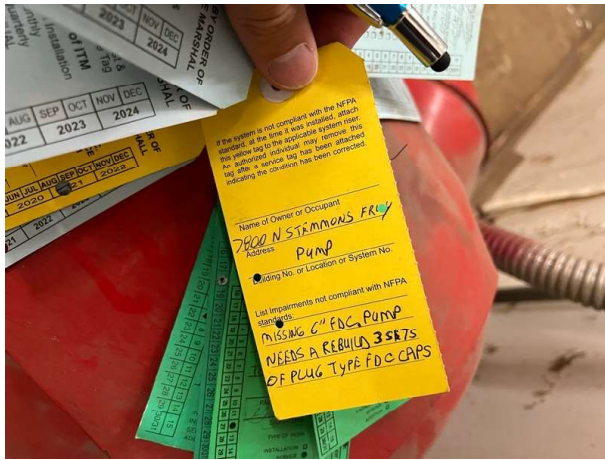
Yellow tags at fire sprinkler system

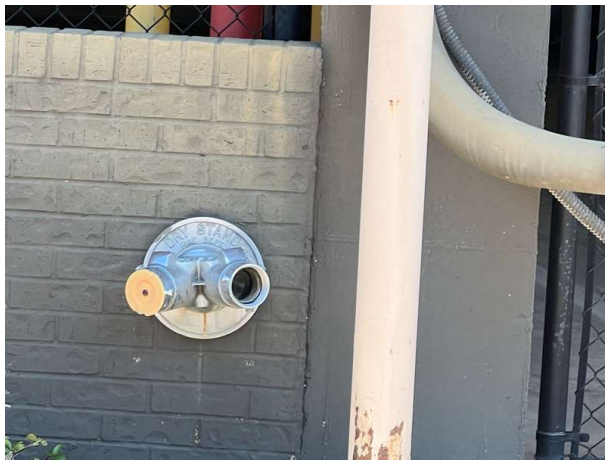
Missing FDC caps

Cost Recommendation	EUL	EFF AGE	RUL	Year	Cost
FDC caps are missing	-	-	-	Immediate	\$5,500
Total					\$5,500

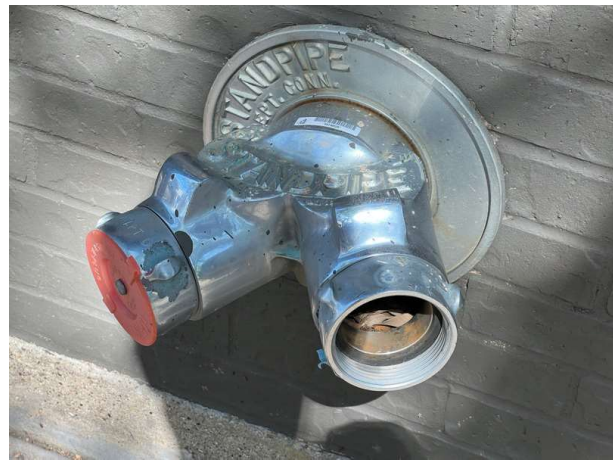
Missing FDC caps

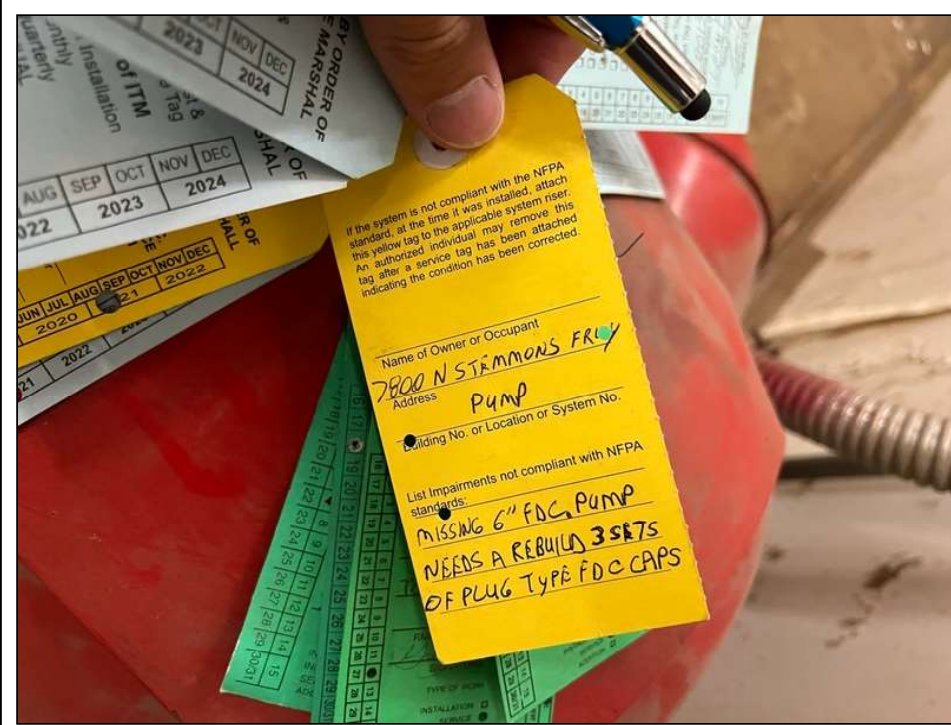
79. Yellow tags at fire sprinkler system

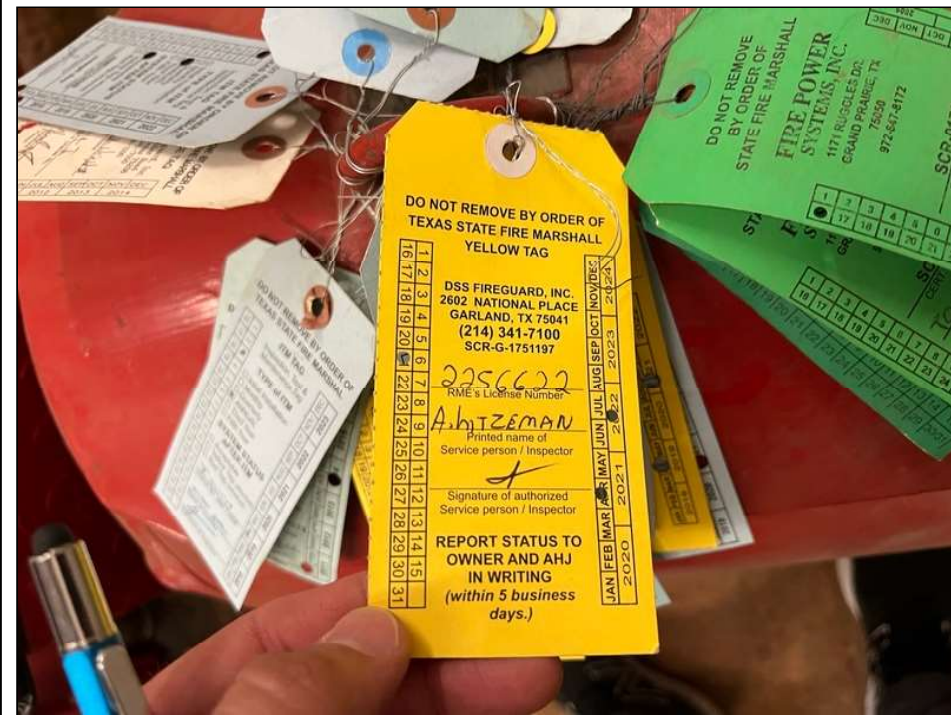
80. Yellow tags at fire sprinkler system

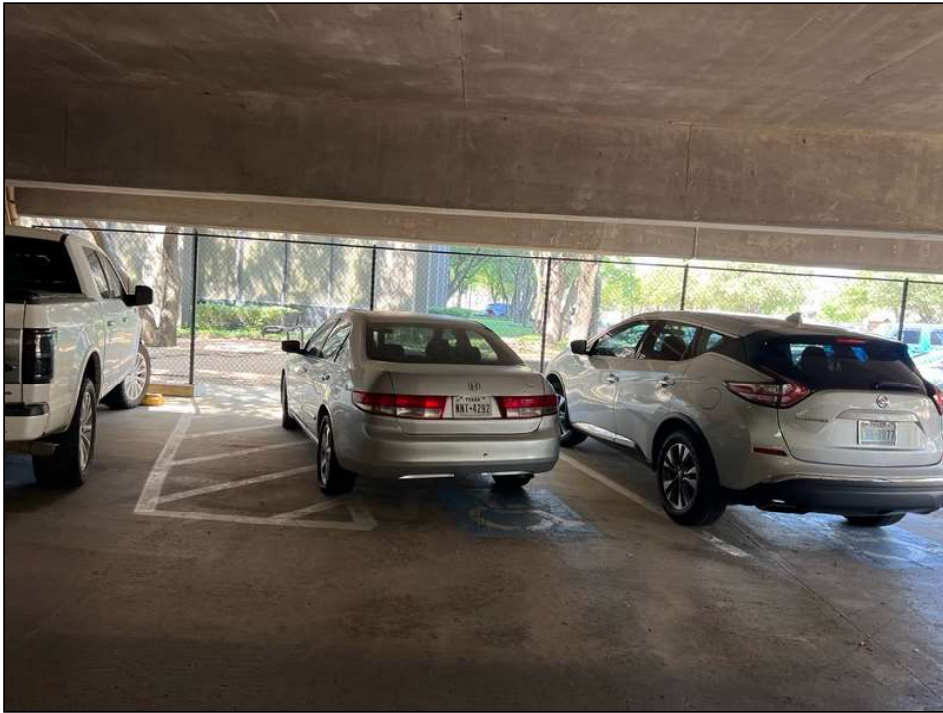
81. Missing accessible parking signs

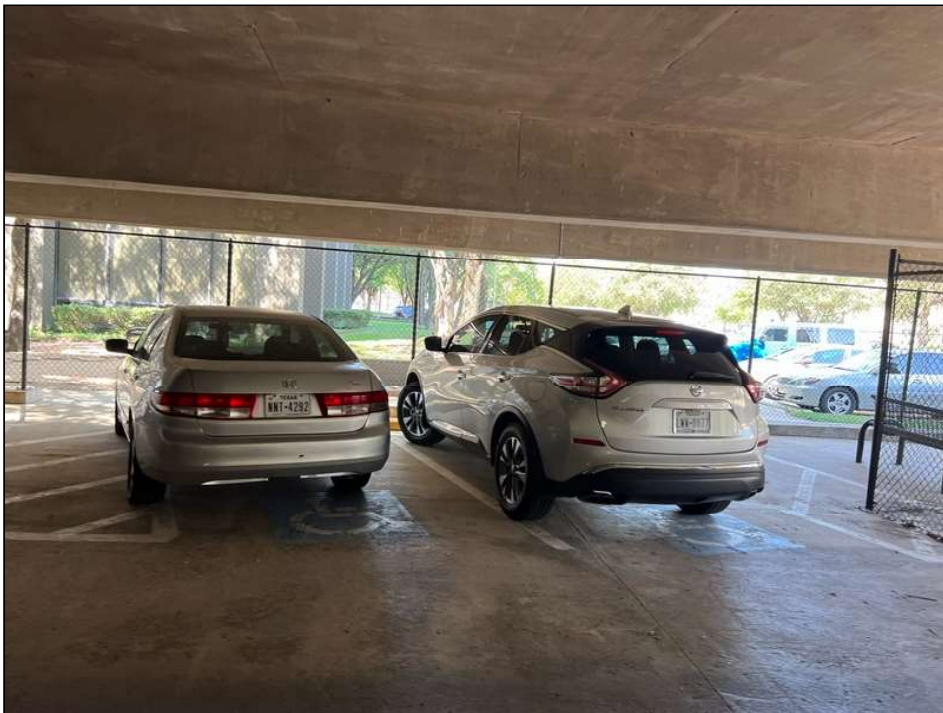
82. Missing accessible parking signs

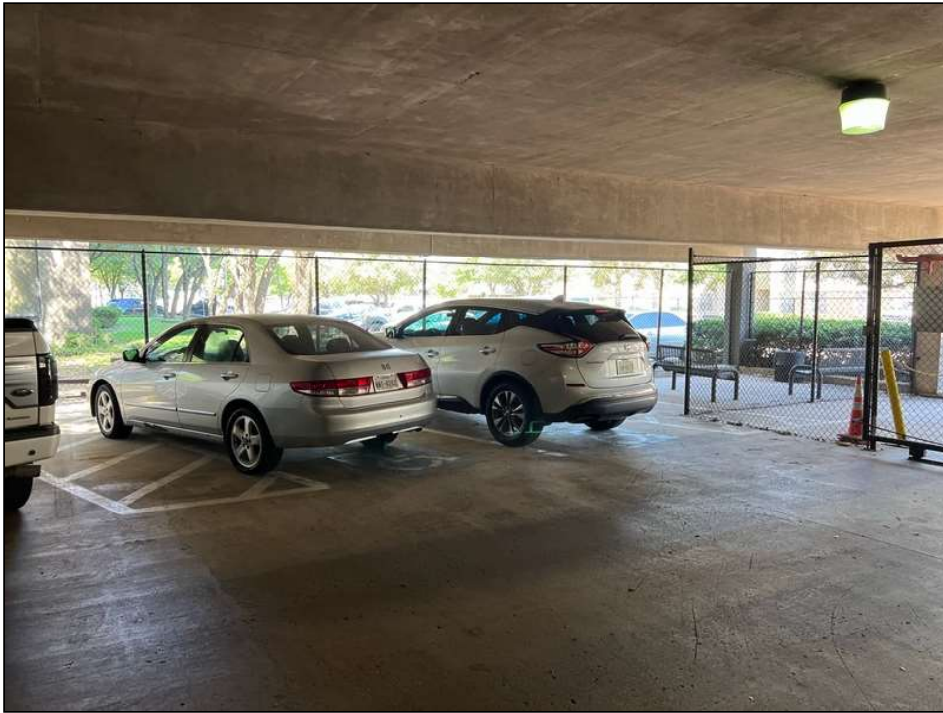
83. Missing accessible parking signs

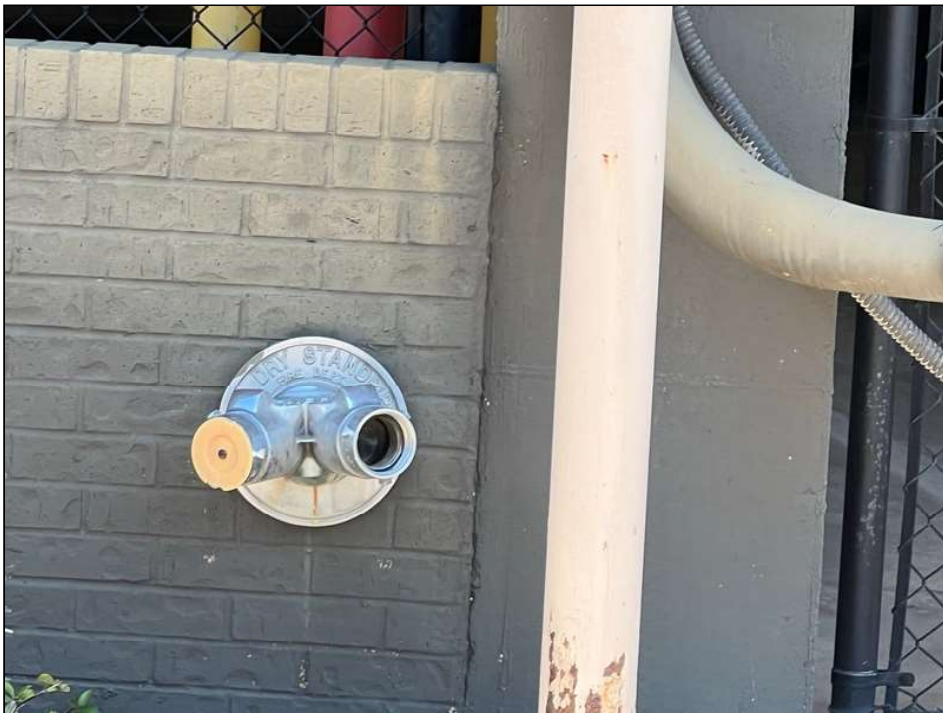
84. Missing FDC caps

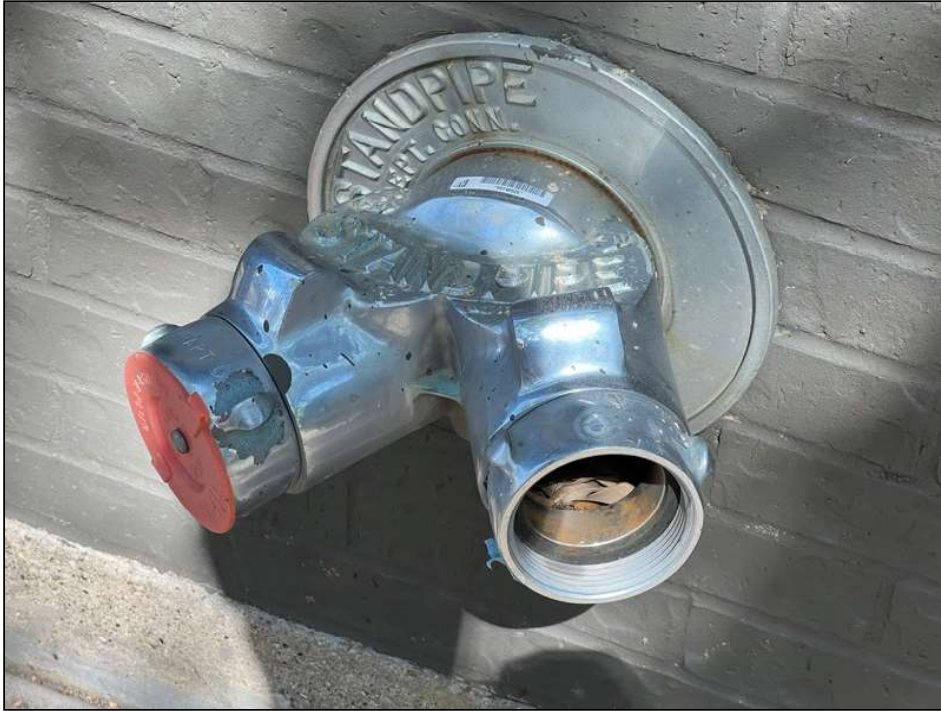
85. Missing FDC caps

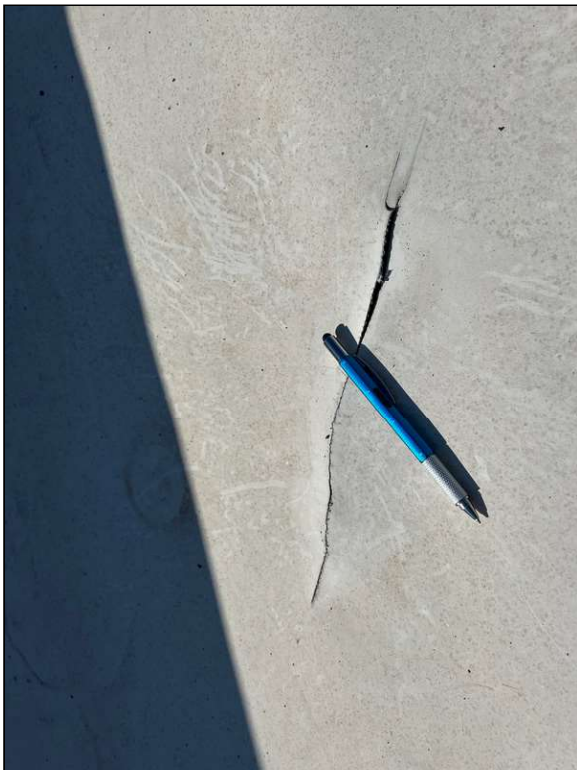
Roofing appeared to be in overall good condition. However, JLL VA noted that the membrane appears to be delaminating at some of the sections, and a 12 inch tear was observed at the southeast corner of the building. JLL VA recommends repairing these issues at this time. An opinion of cost is included in the tables.

86. Roof tear

Cost Recommendation	EUL	EFF AGE	RUL	Year	Cost
Roof repairs	-	-	-	Immediate	\$10,000
Roof replacement	15	6	9	9	\$315,000
Total					\$325,000

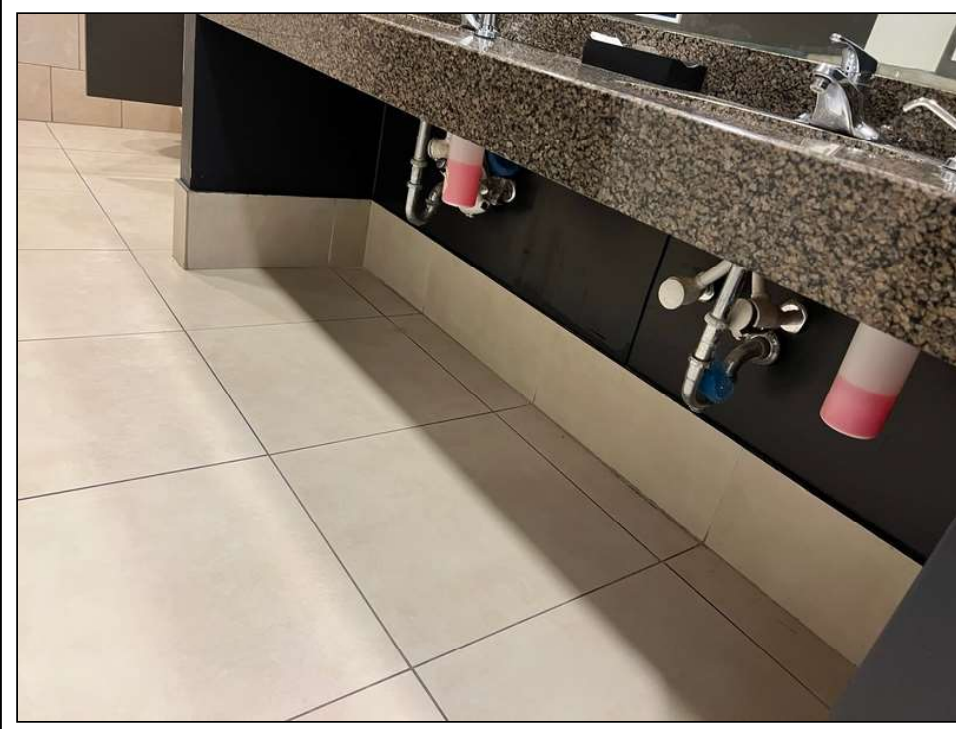
89. Sink pipe protection is needed
