# EcoSystems Environmental, Inc.

**Re: Pre-Renovation/Demolition Asbestos Survey  
Hotel Miramar  
1950 Fort Worth Avenue; Dallas, Texas 75208  
ESEI Project No. 21021499**

### **Hotel Miramar**

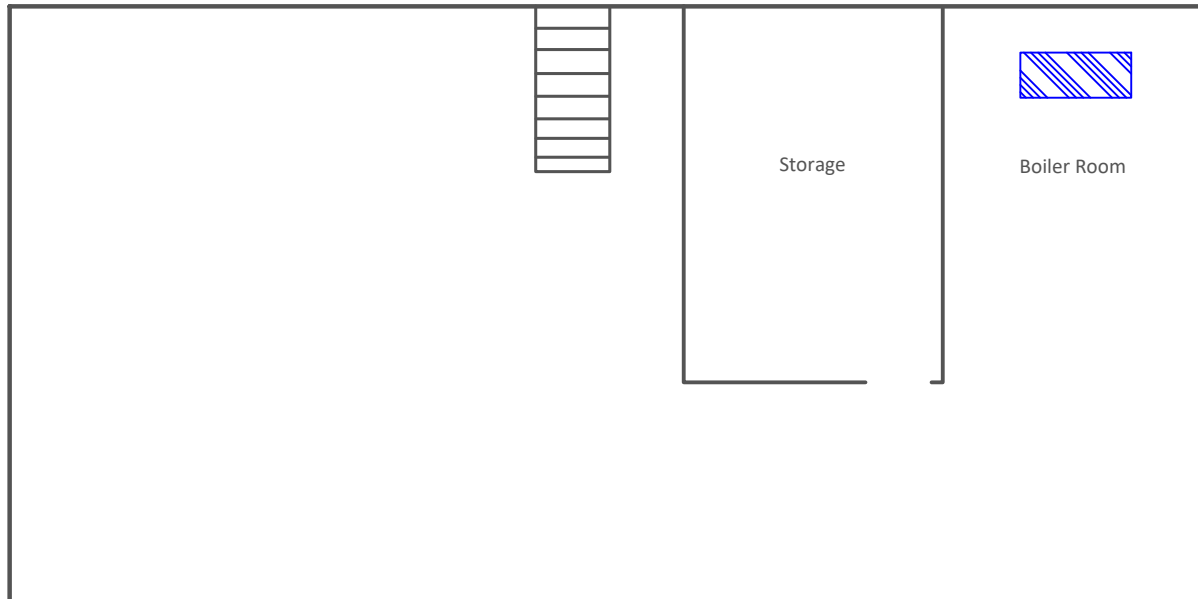
1. All Pipe Insulations throughout Wet Walls, Mechanical Areas and Crawlspace are ACM
2. All Ceramic Tile Flooring is presumed to have ACM Floor Tile and/or Floor Tile Mastic underneath, including Individual Room Restrooms, Public Restrooms and Common Areas.
3. If Floor Tile or Black Mastic is uncovered on unlisted Flooring Areas during renovations, this must be treated as ACM.

Asbestos Containing Material (ACM) Boiler Tank Insulation

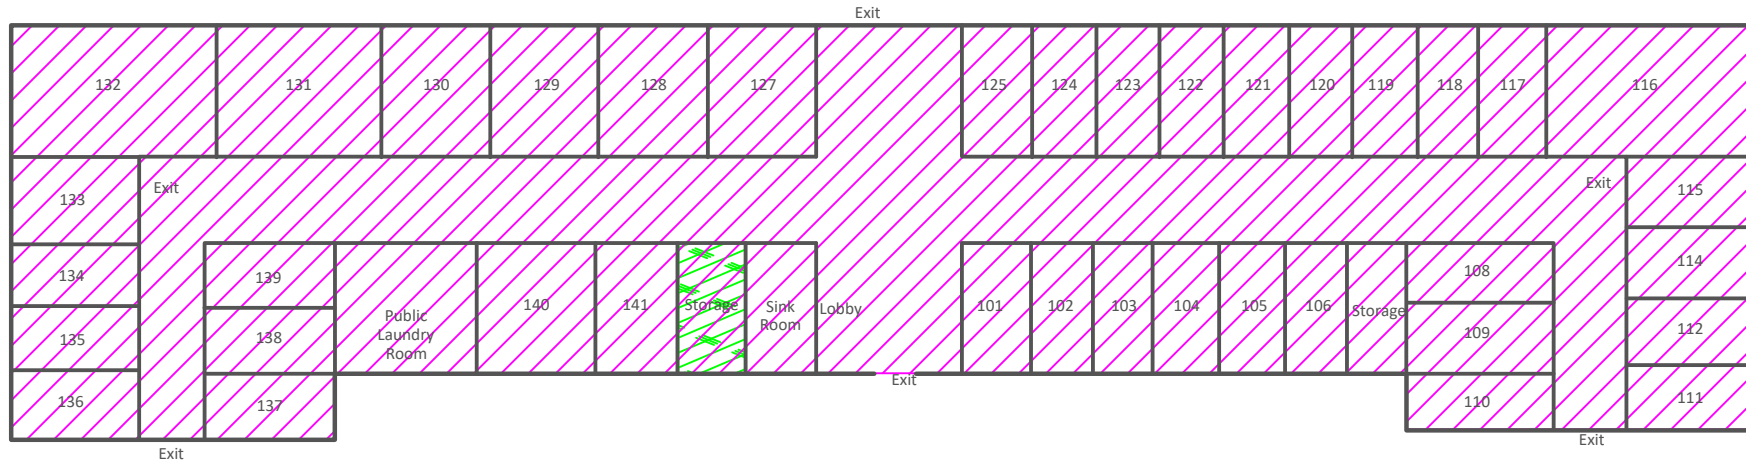
1. All pipe insulation throughout wet walls, mechanical areas and crawlspace are ACM
2. All ceramic tile flooring is presumed to have ACM floor tile and/or floor tile mastic underneath, including Individual unit bathrooms, public restrooms and common areas
3. If floor tile and/or black mastic is uncovered in areas not previously identified, this material must be treated as ACM

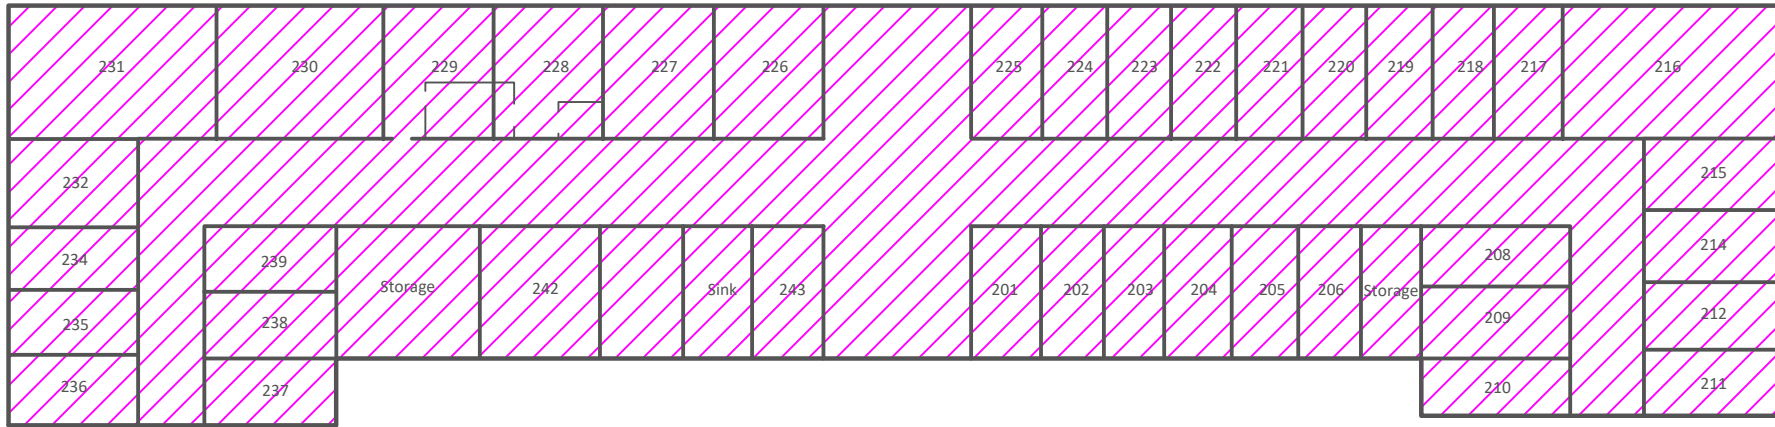
- 1. All pipe insulation in attic, throughout wet walls, and mechanical areas are ACM
- 2. All ceramic tile flooring is presumed to have ACM floor tile and/or floor tile mastic underneath, including Individual unit bathrooms, public restrooms and common areas
- 3. If floor tile and/or black mastic is uncovered in areas not previously identified, this material must be treated as ACM

All Wallboard Walls and Ceiling Systems are Asbestos Containing Material (ACM) throughout
