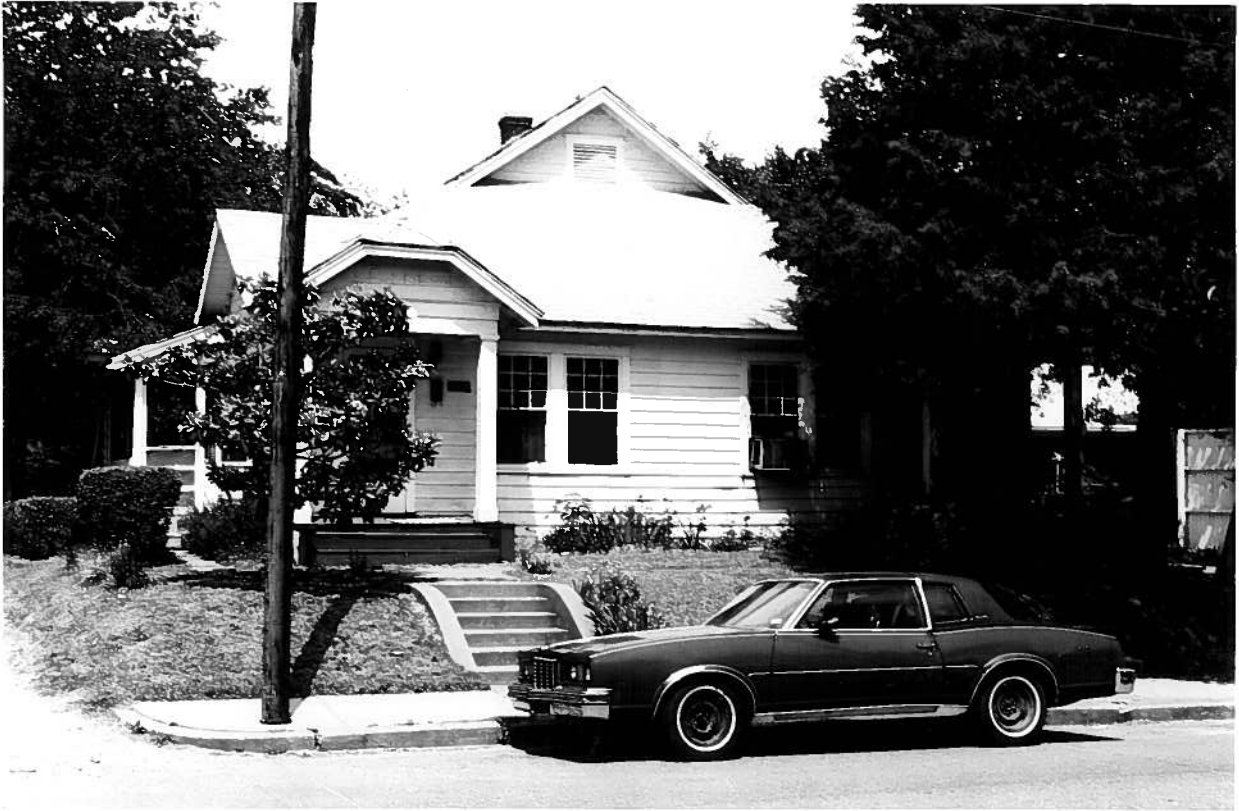
No. 21 - 2308-10 Routh

Description: Craftsman, hip roof with large gablet, central chimney, 9/1 windows, 2 gable porch roof extensions with hiplets, heavy square porch posts, wide plain trim, paired front windows, original wood porch and stairs.

Condition: Excellent.

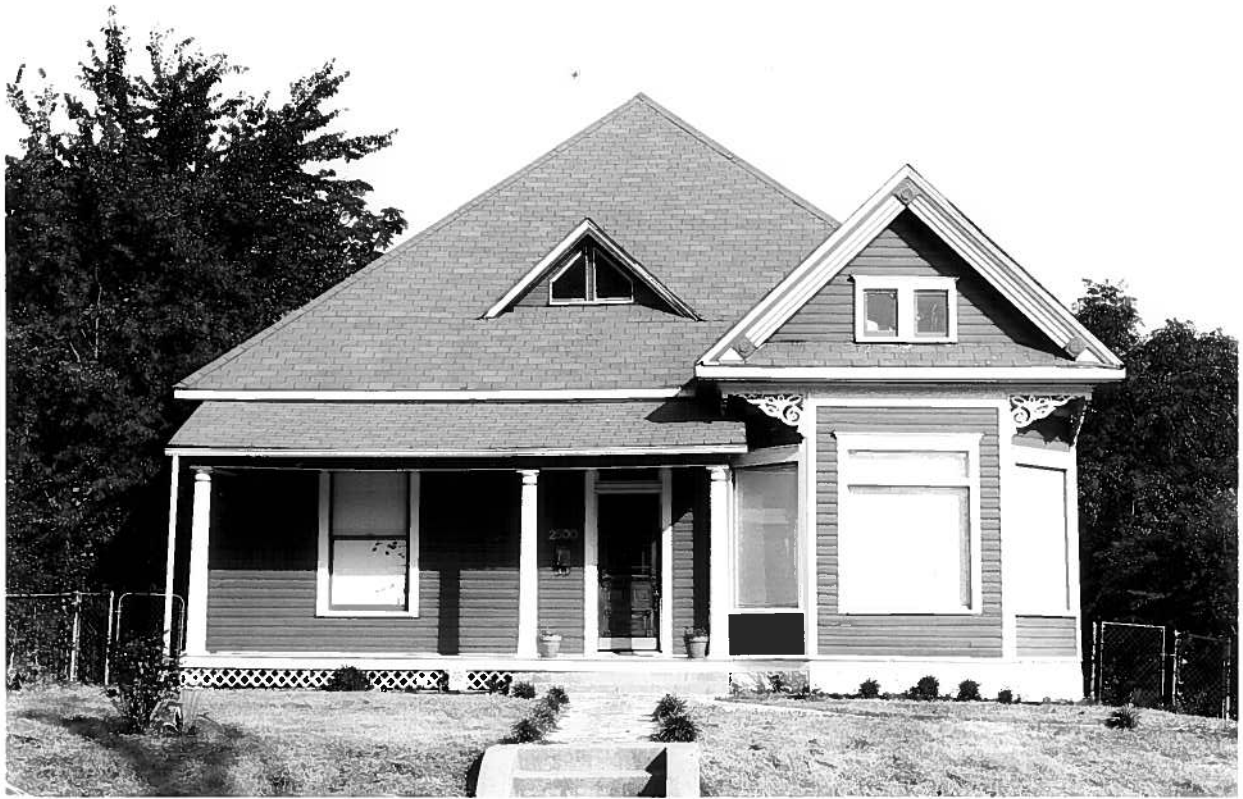
No. 22 - 2500 State

Description: Queen Anne Victorian, steep pyramid roof with intersecting gable, gable dormer, large bay, cornice window heads, 1/1 windows, ornate gable trim, ornate knee braces from bay to gable.

Condition: Excellent - restored.

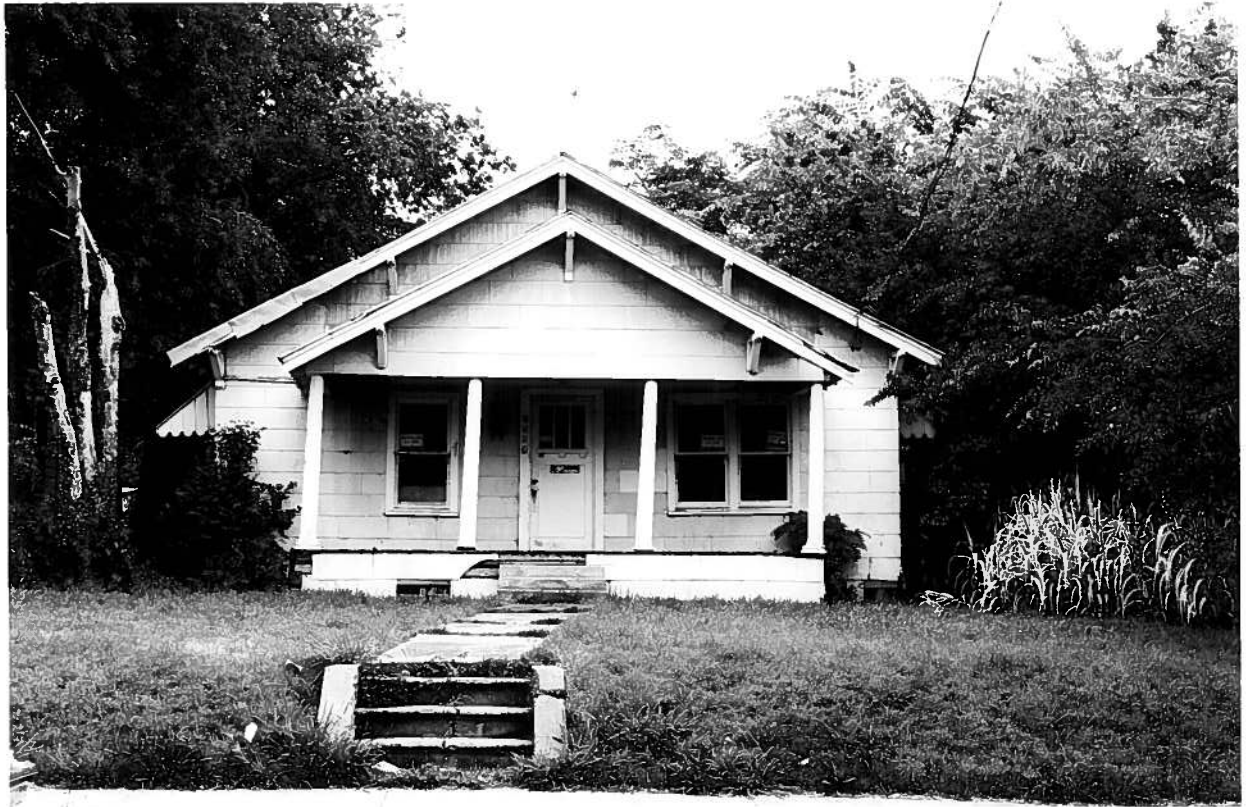
No. 23 - 2504 State

Description: Bungalow, gable roof, smaller gable porch roof, exposed rafter ends, 4 round porch posts, 1/1 windows with wide trim, angle brackets and braces to support projecting eaves, original wood porch.

Condition: Fair - covered.

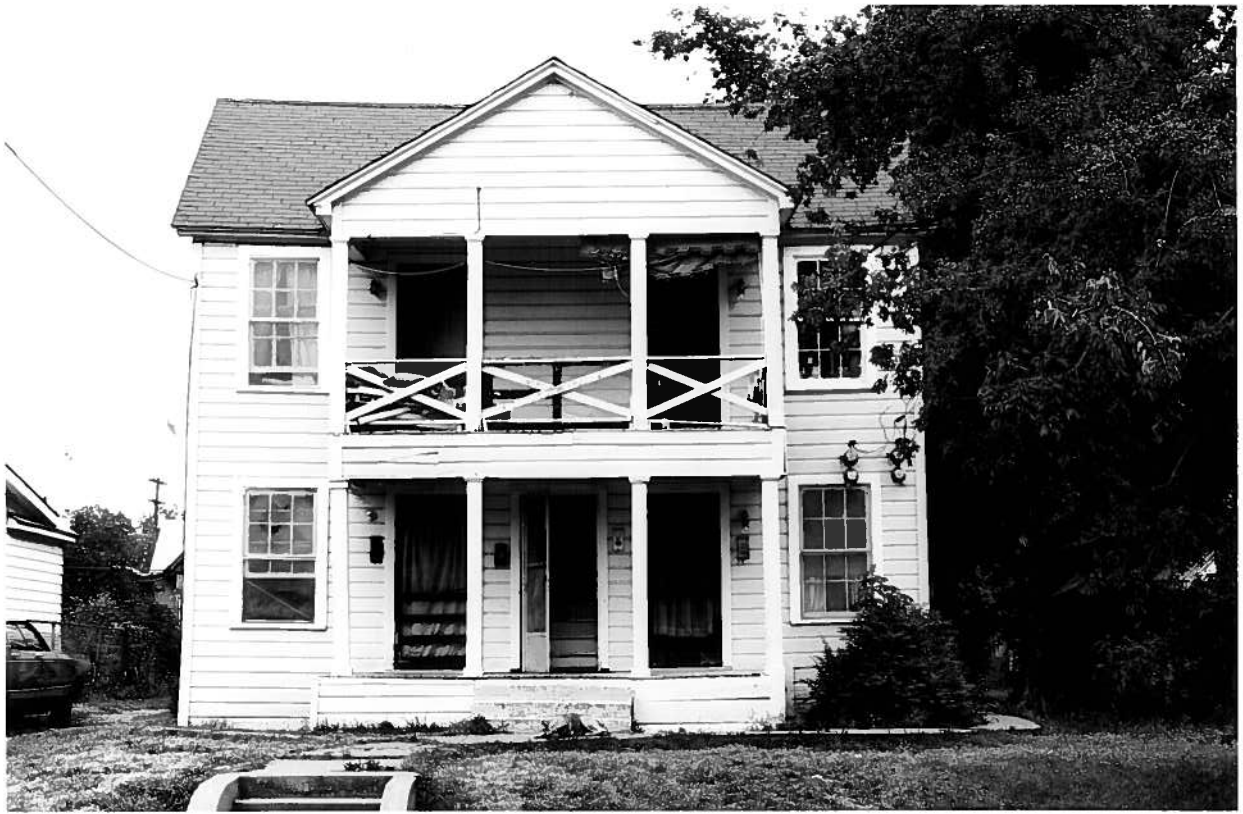
No. 24 - 2508-10 State

Description: Craftsman, 2 story, gable roof with intersecting porch gable, 3 first floor doors, 2 second floor doors to balcony, 6/6 windows with wide trim, square porch posts, wood porch.

Condition: Fair.

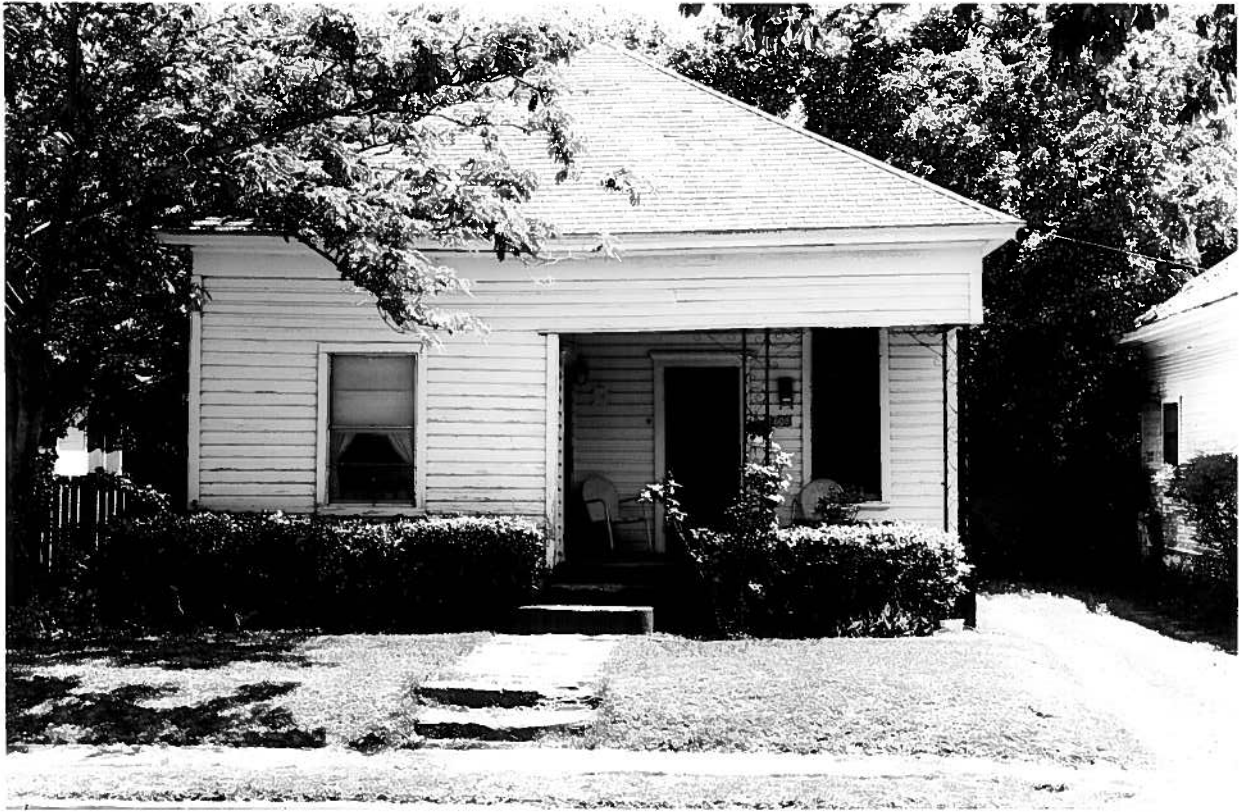
No. 25 - 2512 State

Description: Planbook, pyramid roof inset front porch, deep cornice, 1/1 windows, grill work porch posts, boxed eaves.

Condition: Good

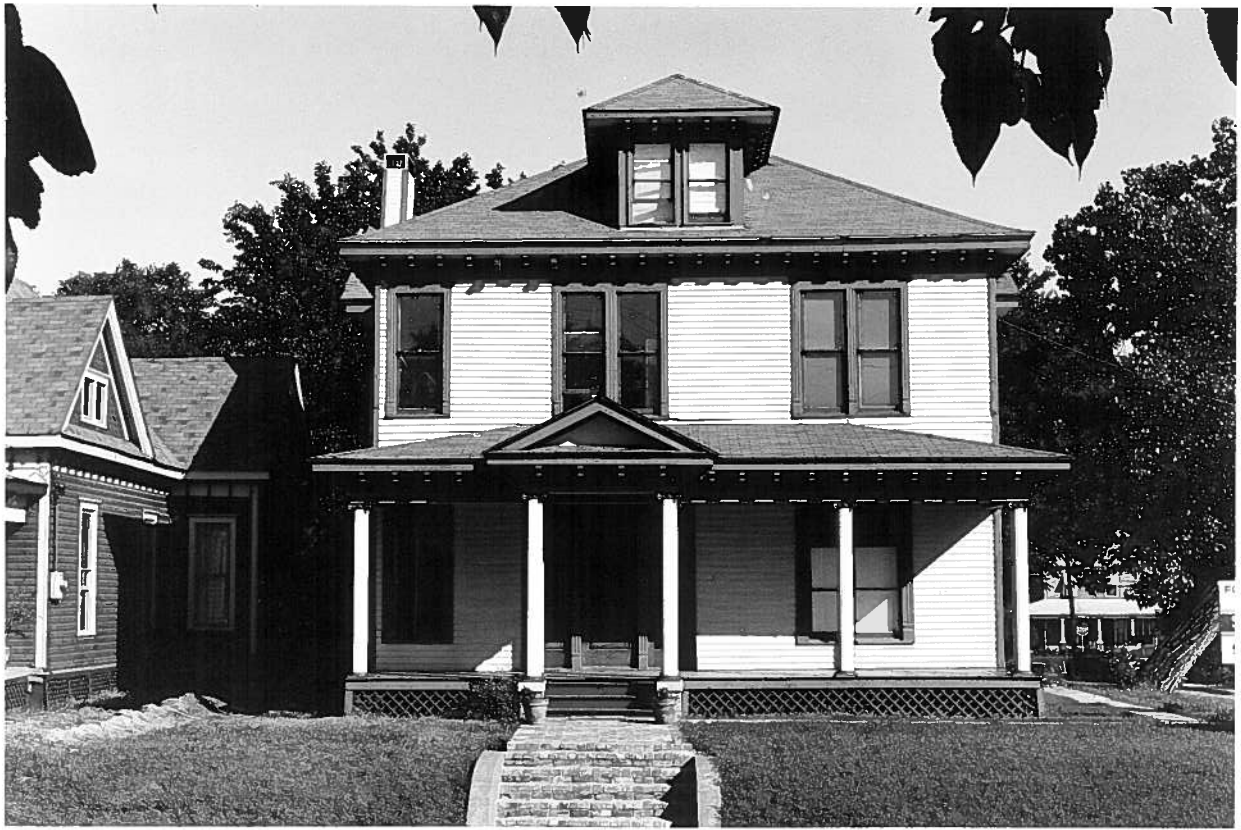
No. 26 - 2600 State

Description: Italianate, 2 story, pyramid roof, large hip dormer, intersecting gable with bay pavilion, extended eaves with brackets every 12", tall 1/1 windows with cornice window heads, ornate knee brackets at gable, transom corner and sidelights.

Condition: Excellent.

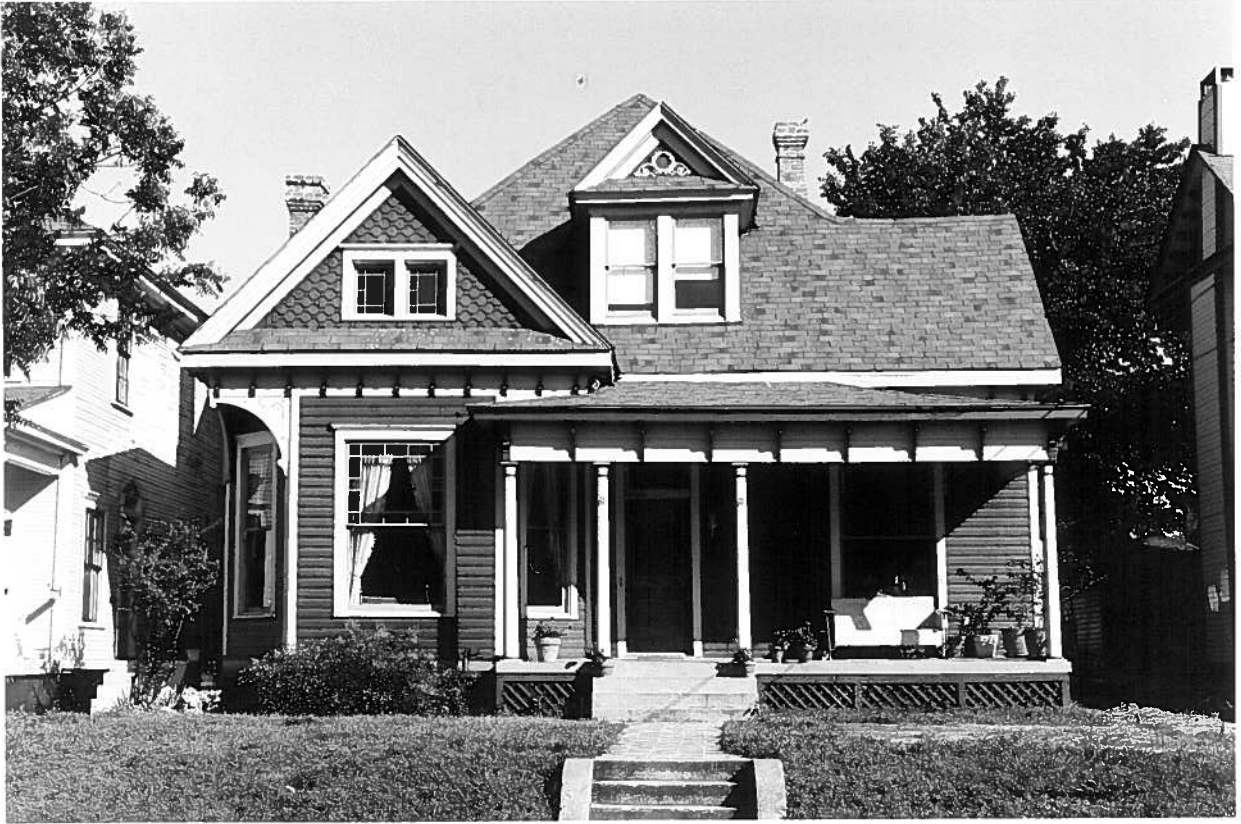
No. 27 - 2606 State

Description: Eastlake, main gable with hiplet, large projecting bay with gable, hip porch roof, large gable dormer, 1/1 windows with cornice window heads, side and back chimneys, stain glass in bay and gable end, transom; Doric porch columns, brackets every 1 to 2 feet, ornate bay knee braces.

Condition: Excellent.

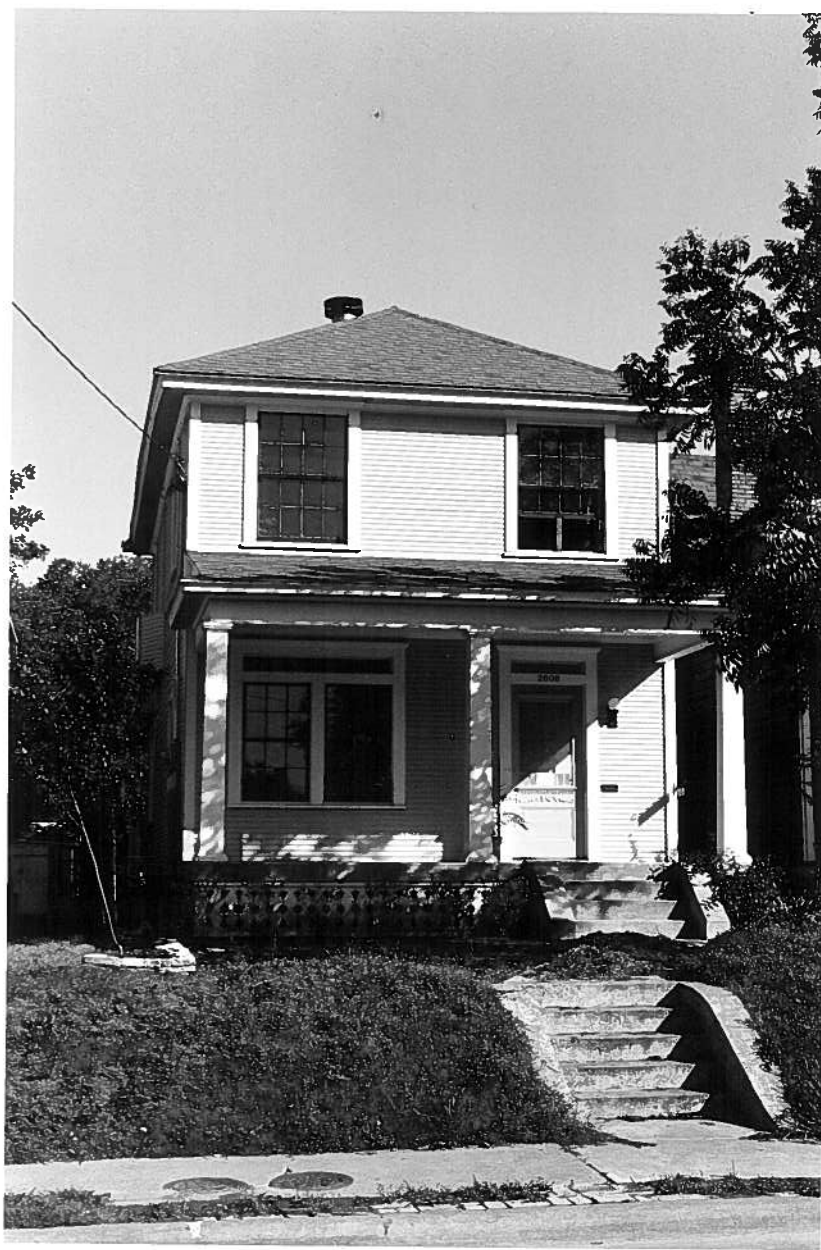
No. 28 - 2608 State

Approx. 1900-10;  
Description: Craftsman, 2 story, hip roof with shed porch roof, deep cornice at porch, heavy square porch columns, 8/8, 1/1 windows, exposed rafter ends, narrow lap siding, wide trim boards.  
Condition: Excellent - restored.

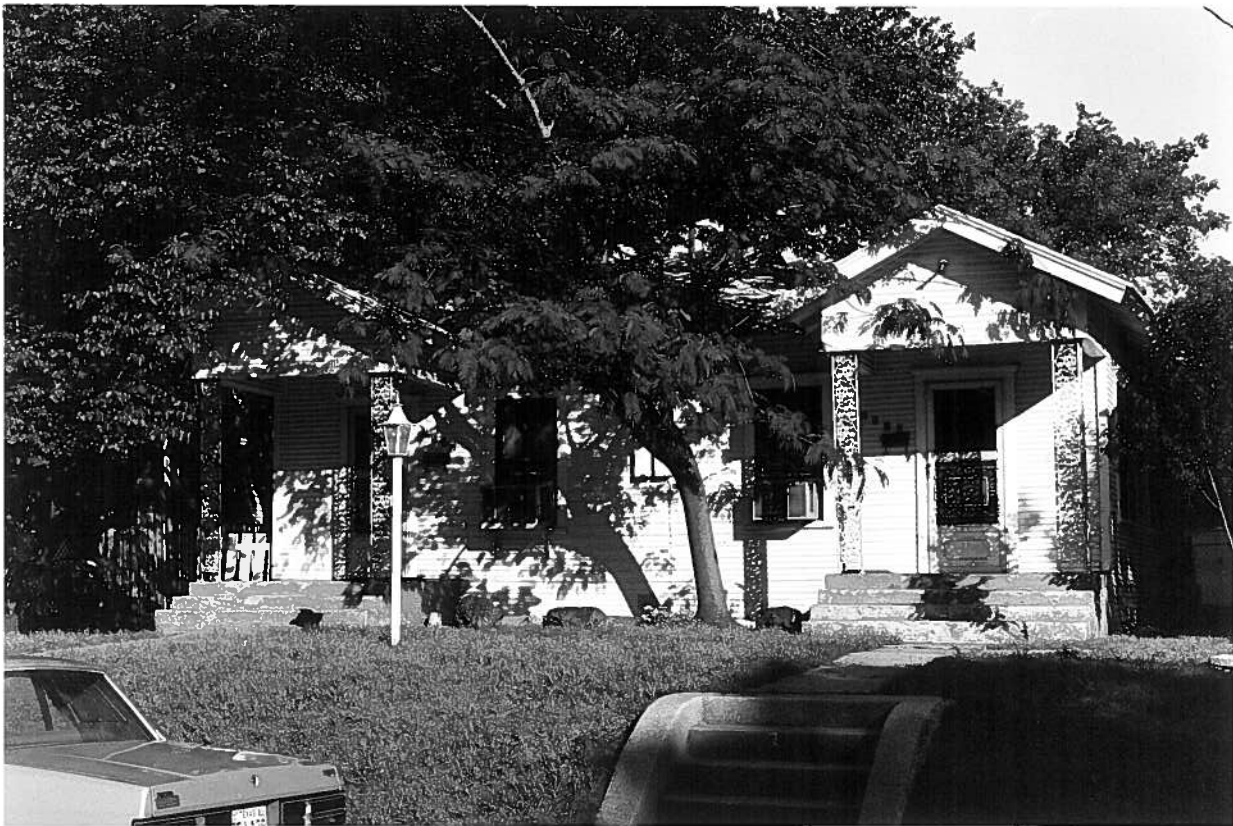
No. 29 - 2612 State

Description: hip roof with 2 gable porch roof projections, extended eaves, exposed rafters, narrow lap siding, 1/1 windows, wide trim boards.

Condition: Good-excellent.

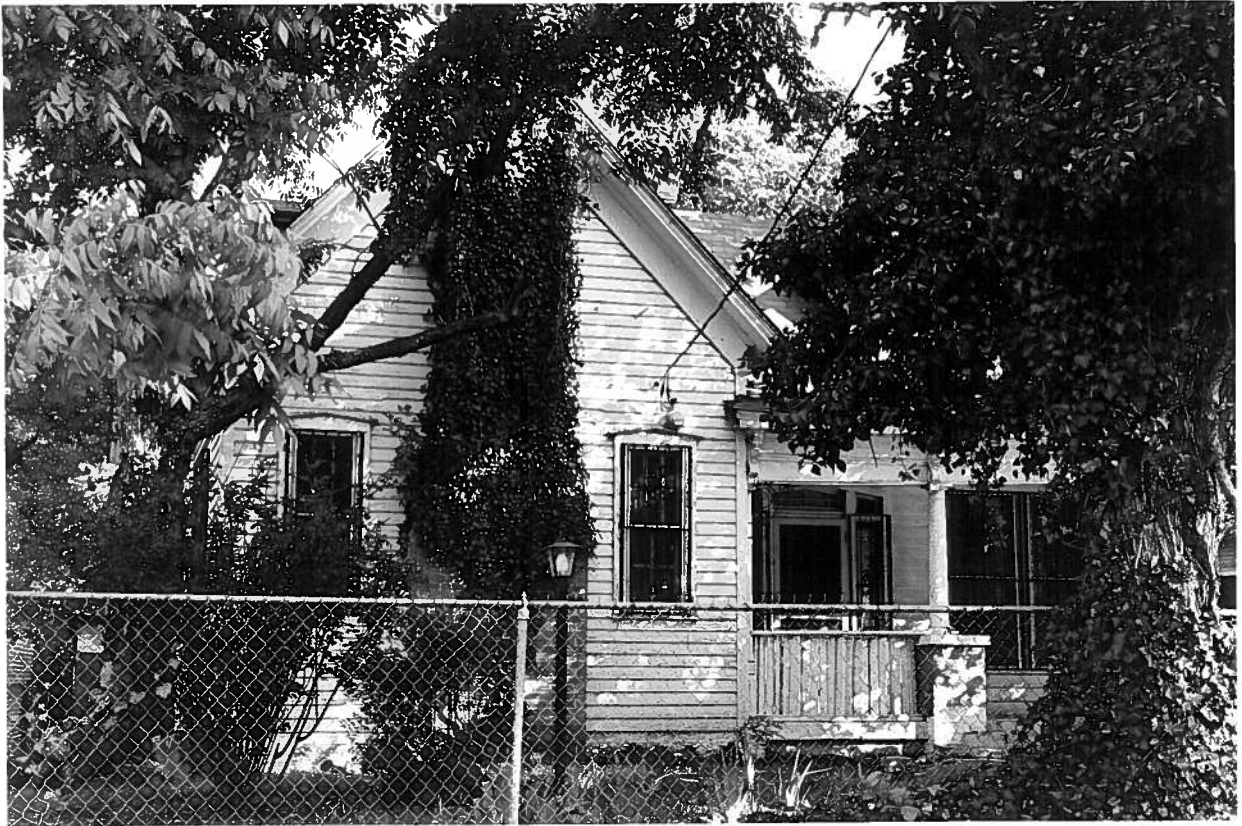
No. 30 - 2616 State

Description: Victorian planbook, intersecting gable roofs, shed porch roof with small pediment, gable dormer, Greek Revival pediment window heads, 1/1 narrow windows, transom, corner and sidelights with pediment, Doric porch columns, on brick piers, lap siding.

Condition: Fair.
