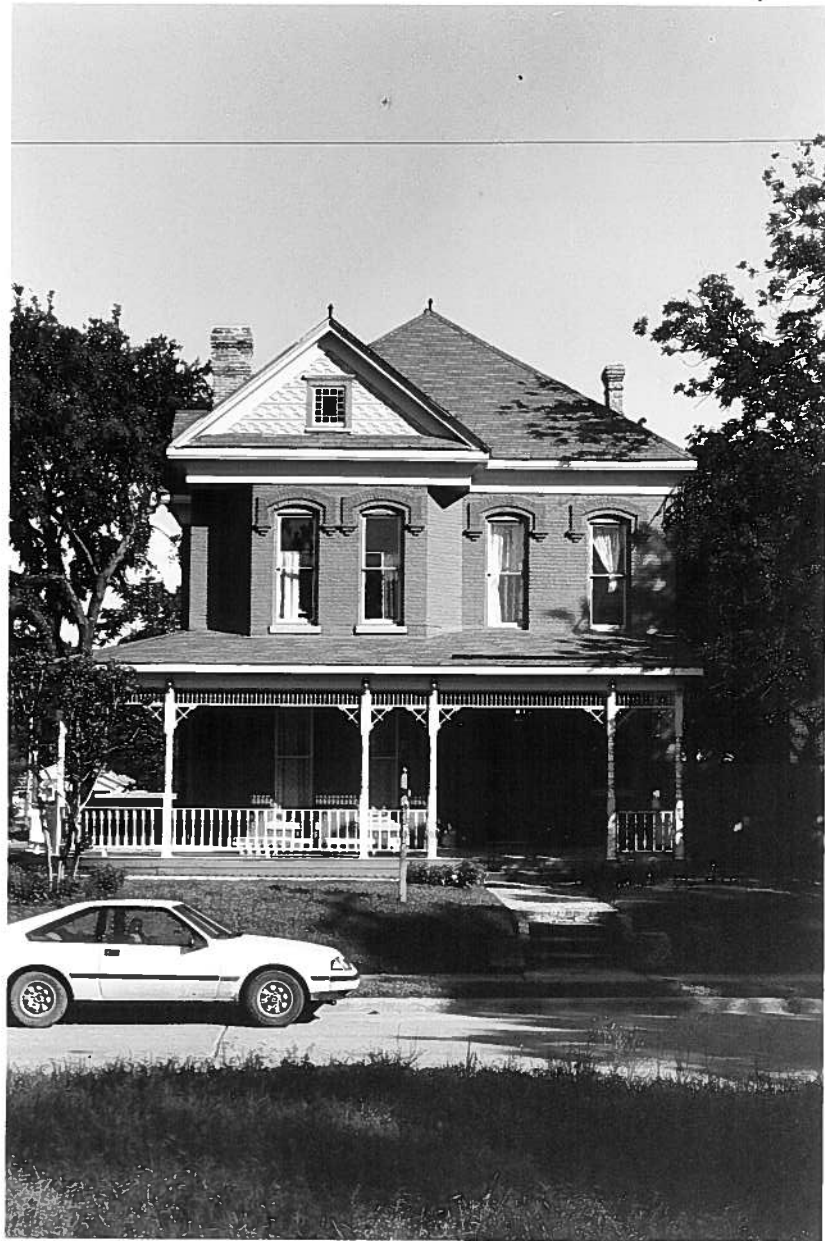
No. 31 - 2620 State

Description: 2 story brick Victorian, steep hip roof with short ridge, gabled front and side bay pavilions, brickwork hood with corbel stops, narrow 1/1 windows, wrap porch, ornate shingle work on gable ends, interior side chimney, brick work string course.

Condition: Excellent - restored. One of 2 brick Victorians in City.

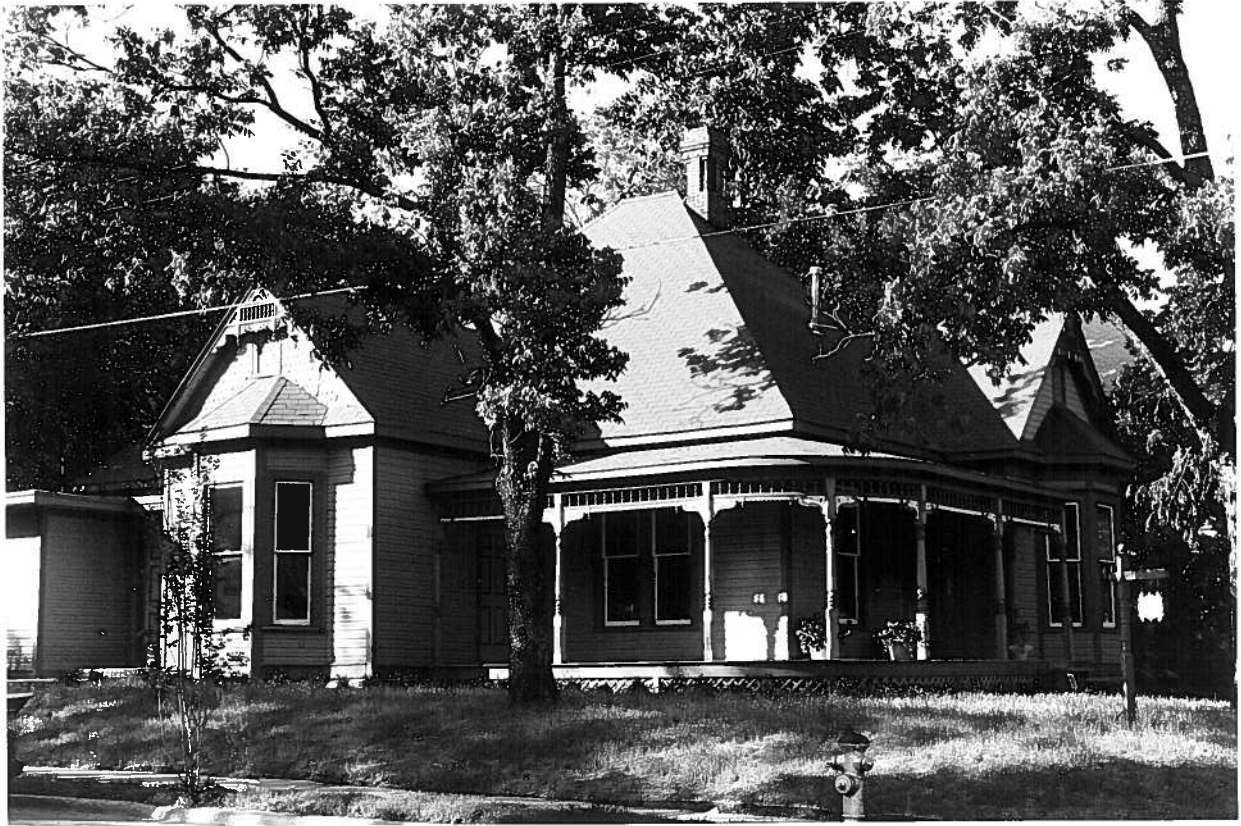
No. 32 - 2701 State

Description: Queen Anne cottage, steep hip roof with intersecting gable over bay room, wrap around porch with spindle porch frieze, brackets and turned porch posts, narrow 1/1 windows, cornice window heads.

Condition: Excellent - restored.

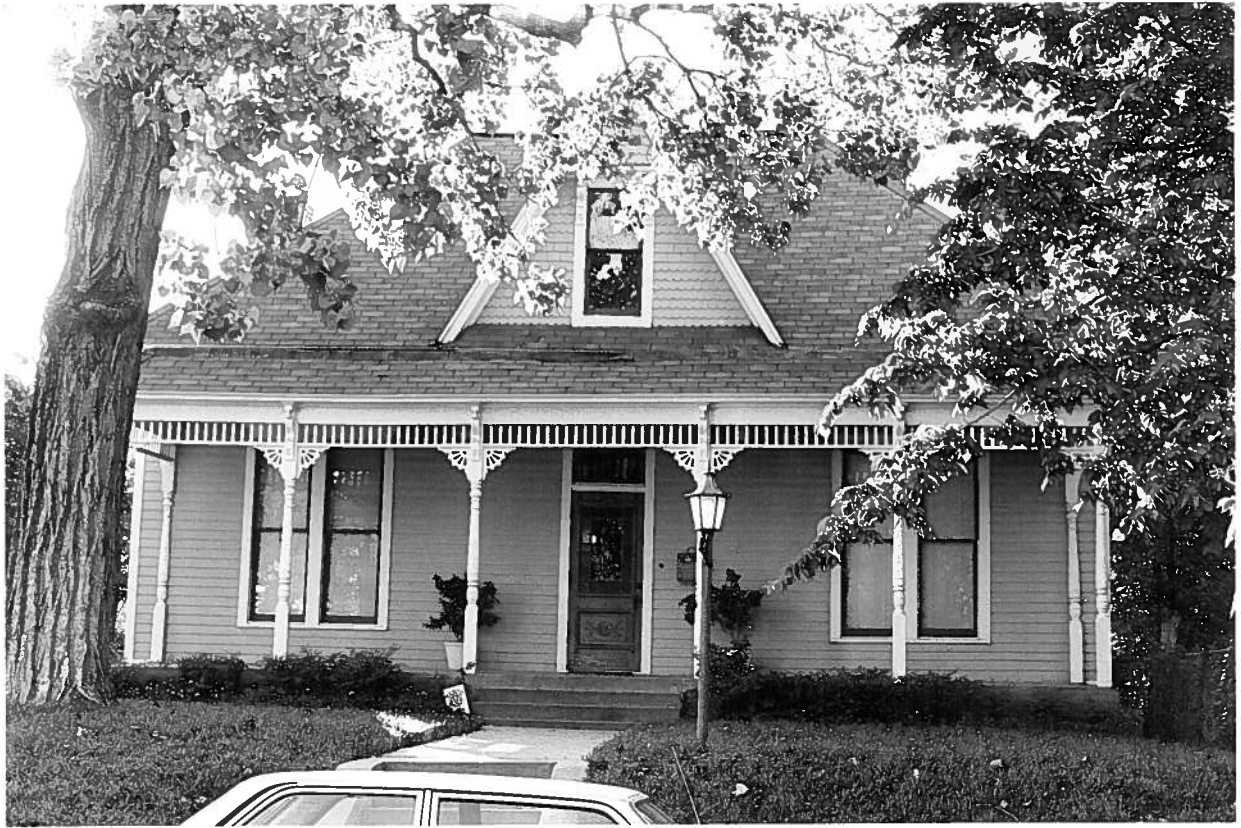
No. 33 - 2615 State

Description: Victorian cottage, Second Empire, steep Mansard main roof, steep gable dormer, one story Mansard roofed porch, tall narrow paired 1/1 windows in front, 2/2 windows side, transom, ornate brackets all around house, turned porch posts, spindle porch frieze, spindle fan brackets.

Condition: Excellent - restored.

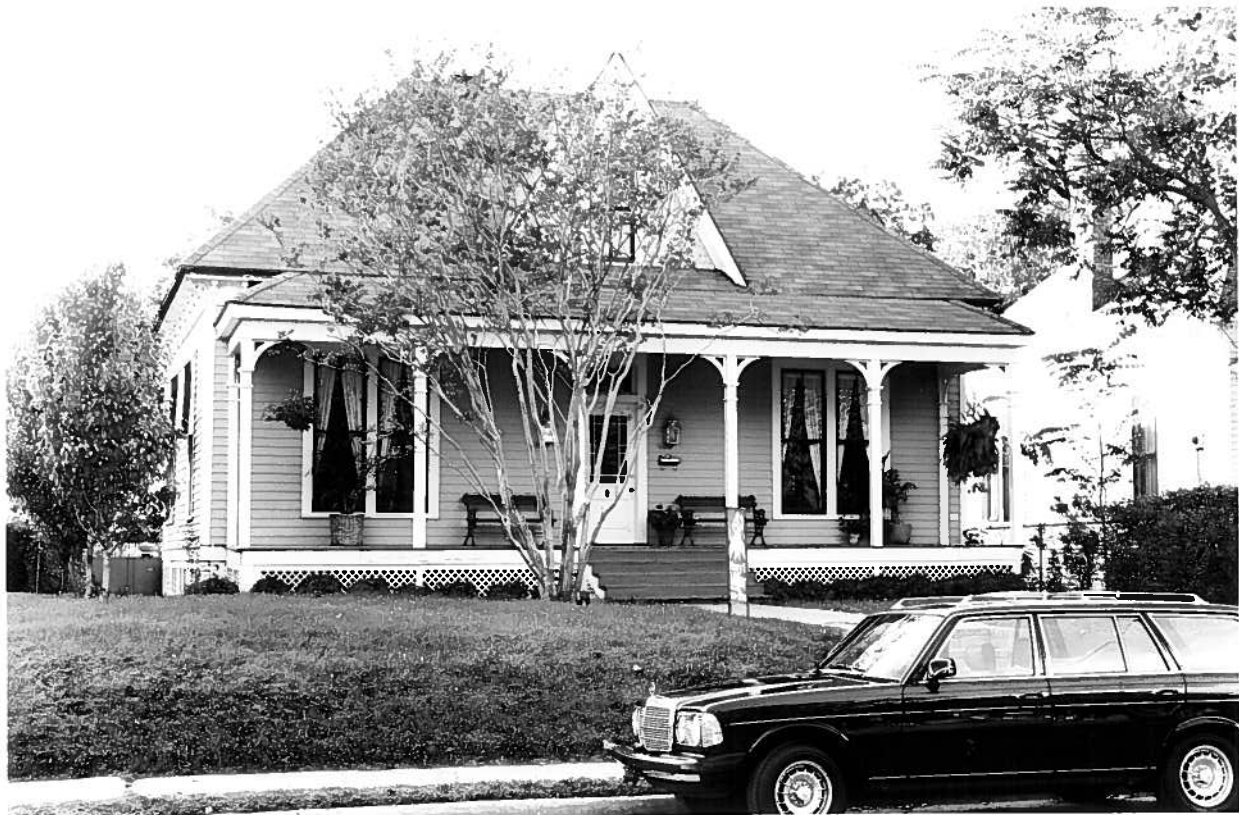
No. 34 - 2611 State

Description: Victorian cottage, twin to 2615 State, steep mansard main roof, steep gable dormer, tall narrow paired 2/2 windows, transom, brackets all around cornice line of house, square porch posts with brackets.

Condition: Excellent - restored.

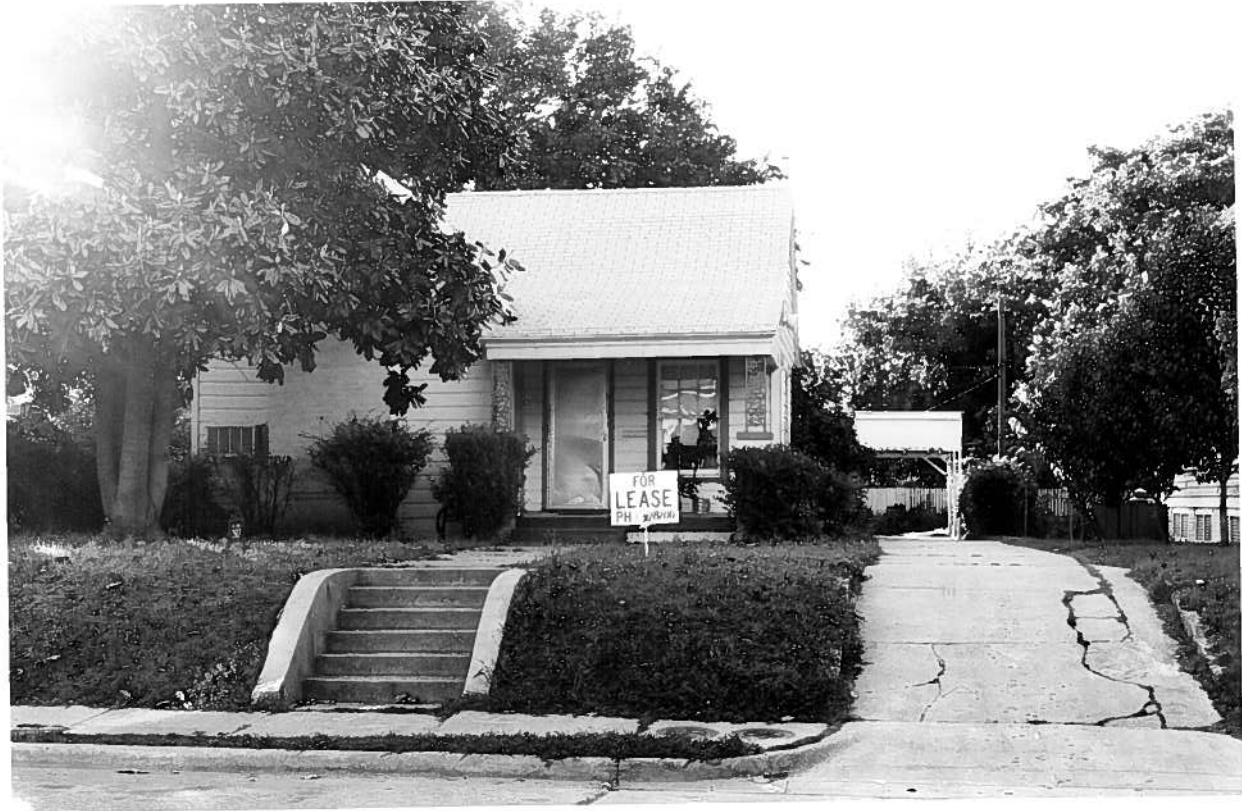
No. 35 - 2607 State

Description: Planbook, intersecting gable roof, large brick front exterior chimney, grill porch posts, boxed eaves, 6/6 windows, shed porch roof extension.

Condition: Good.

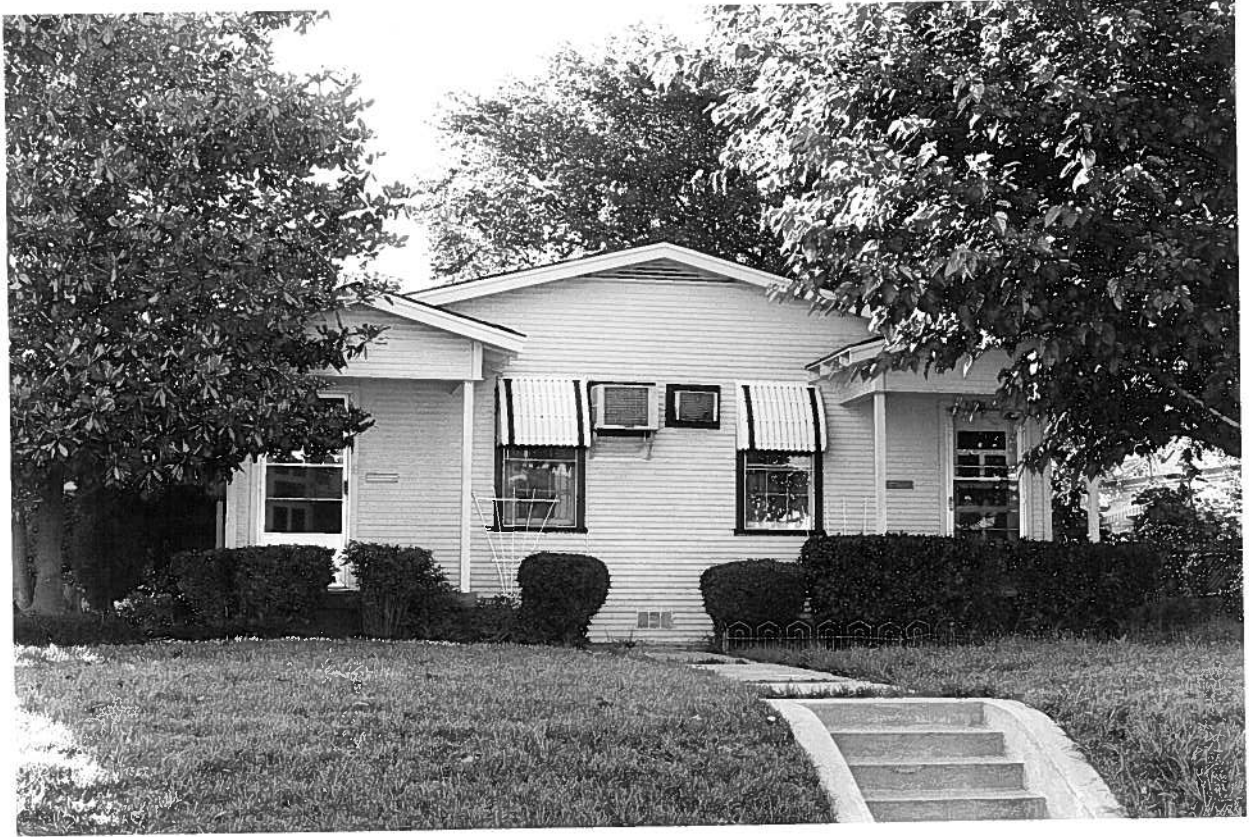
No. 36 - 2601-03 State

Description: Planbook, shallow gable roof, 2 projecting gable porch roofs, small square porch posts, exposed rafter ends, metal awnings on 6/6 windows, narrow lap siding.

Condition: Good.

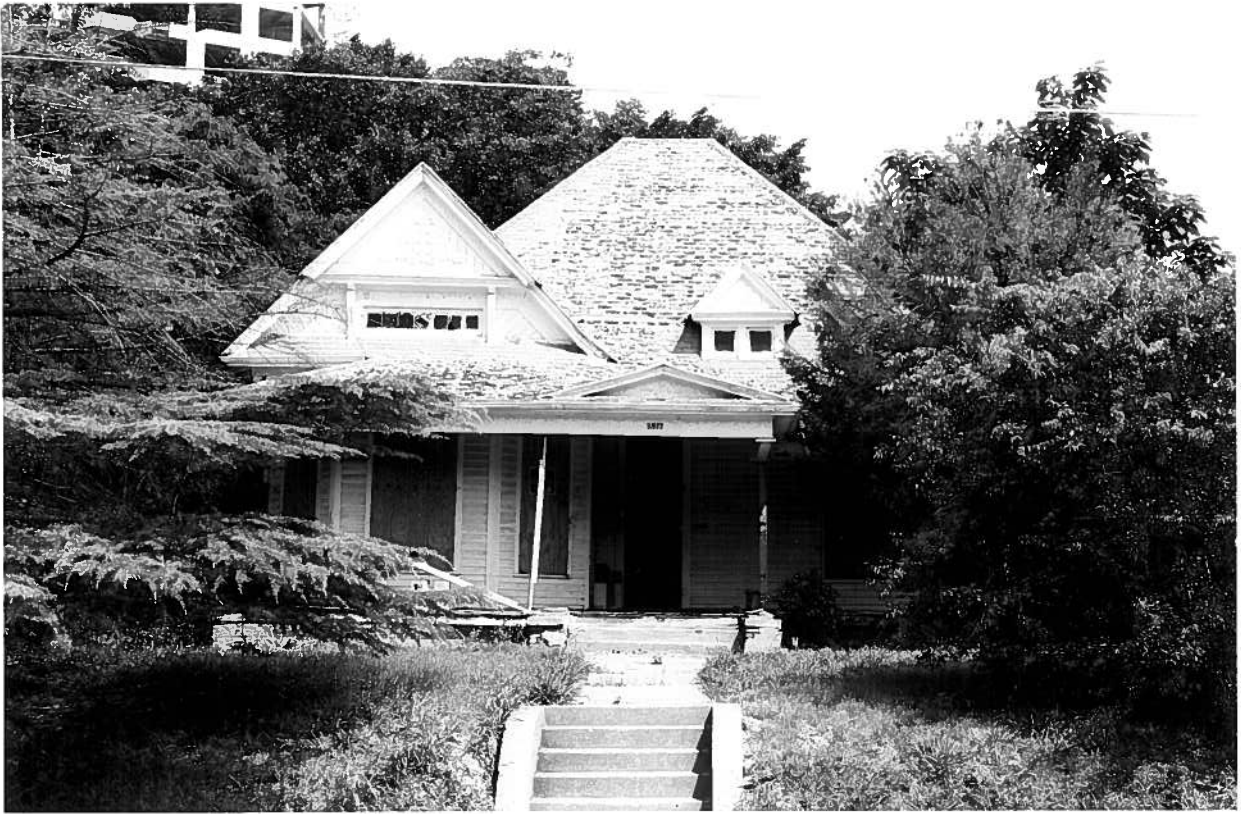
No. 37 - 2517 State

Description: Vernacular Victorian, intersecting gable roof, decorative brackets in gable ends, narrow 1/1 windows, dormer.

Condition: Fair.

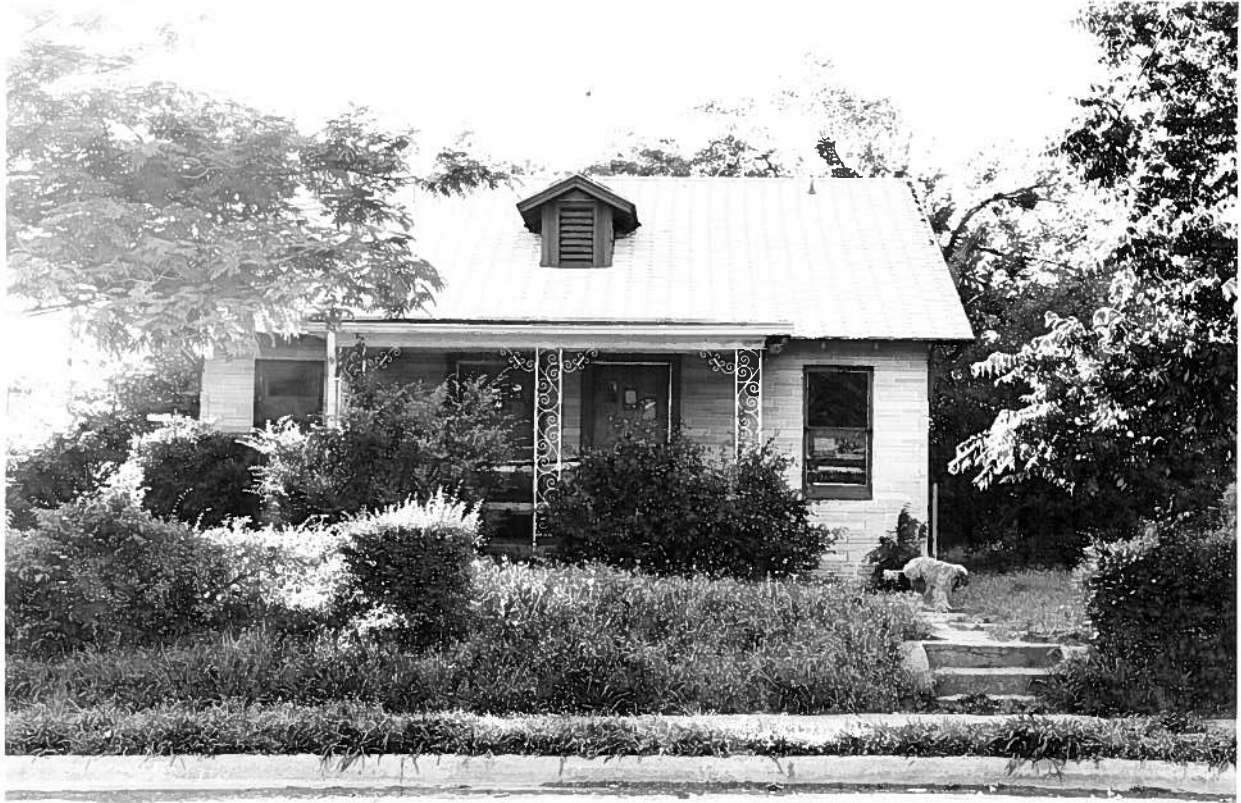
No. 38 - 2501 State

Description: Vernacular, bungalow style, exposed
rafter tails, grillwork porch posts.

Significance: Probably none.

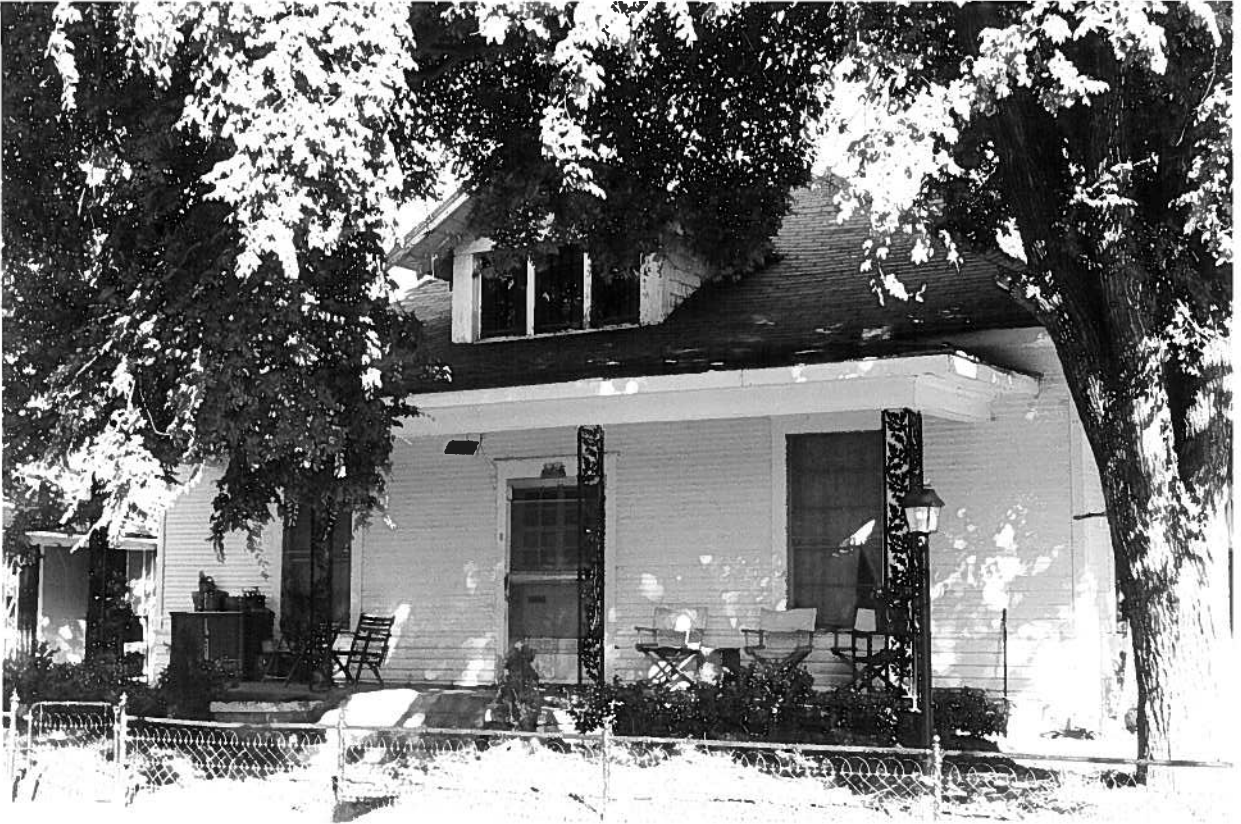
No. 39 - 2600 Hibernia

Description: Pyramid roof, gable dormer with
3 windows, hip porch roof, grillwork porch posts.

Condition: Excellent.

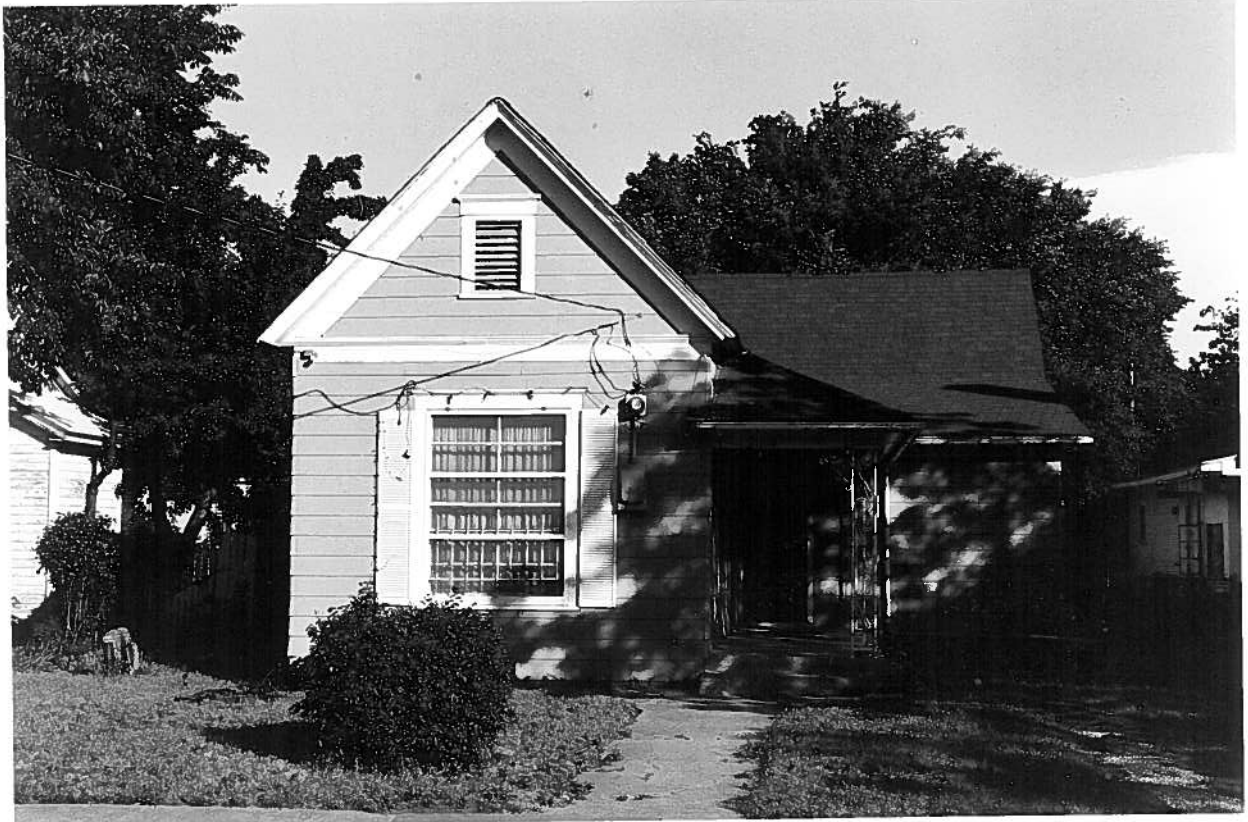
No. 40 - 2604 Hibernia

Description: 'L' plan with intersecting gables,
hip porch roof, new siding, cornice window heads.

Condition: Good - excellent.
