Memorandum

CITY OF DALLAS

SUBJECT **Margaret McDermott Bridge Status Update**

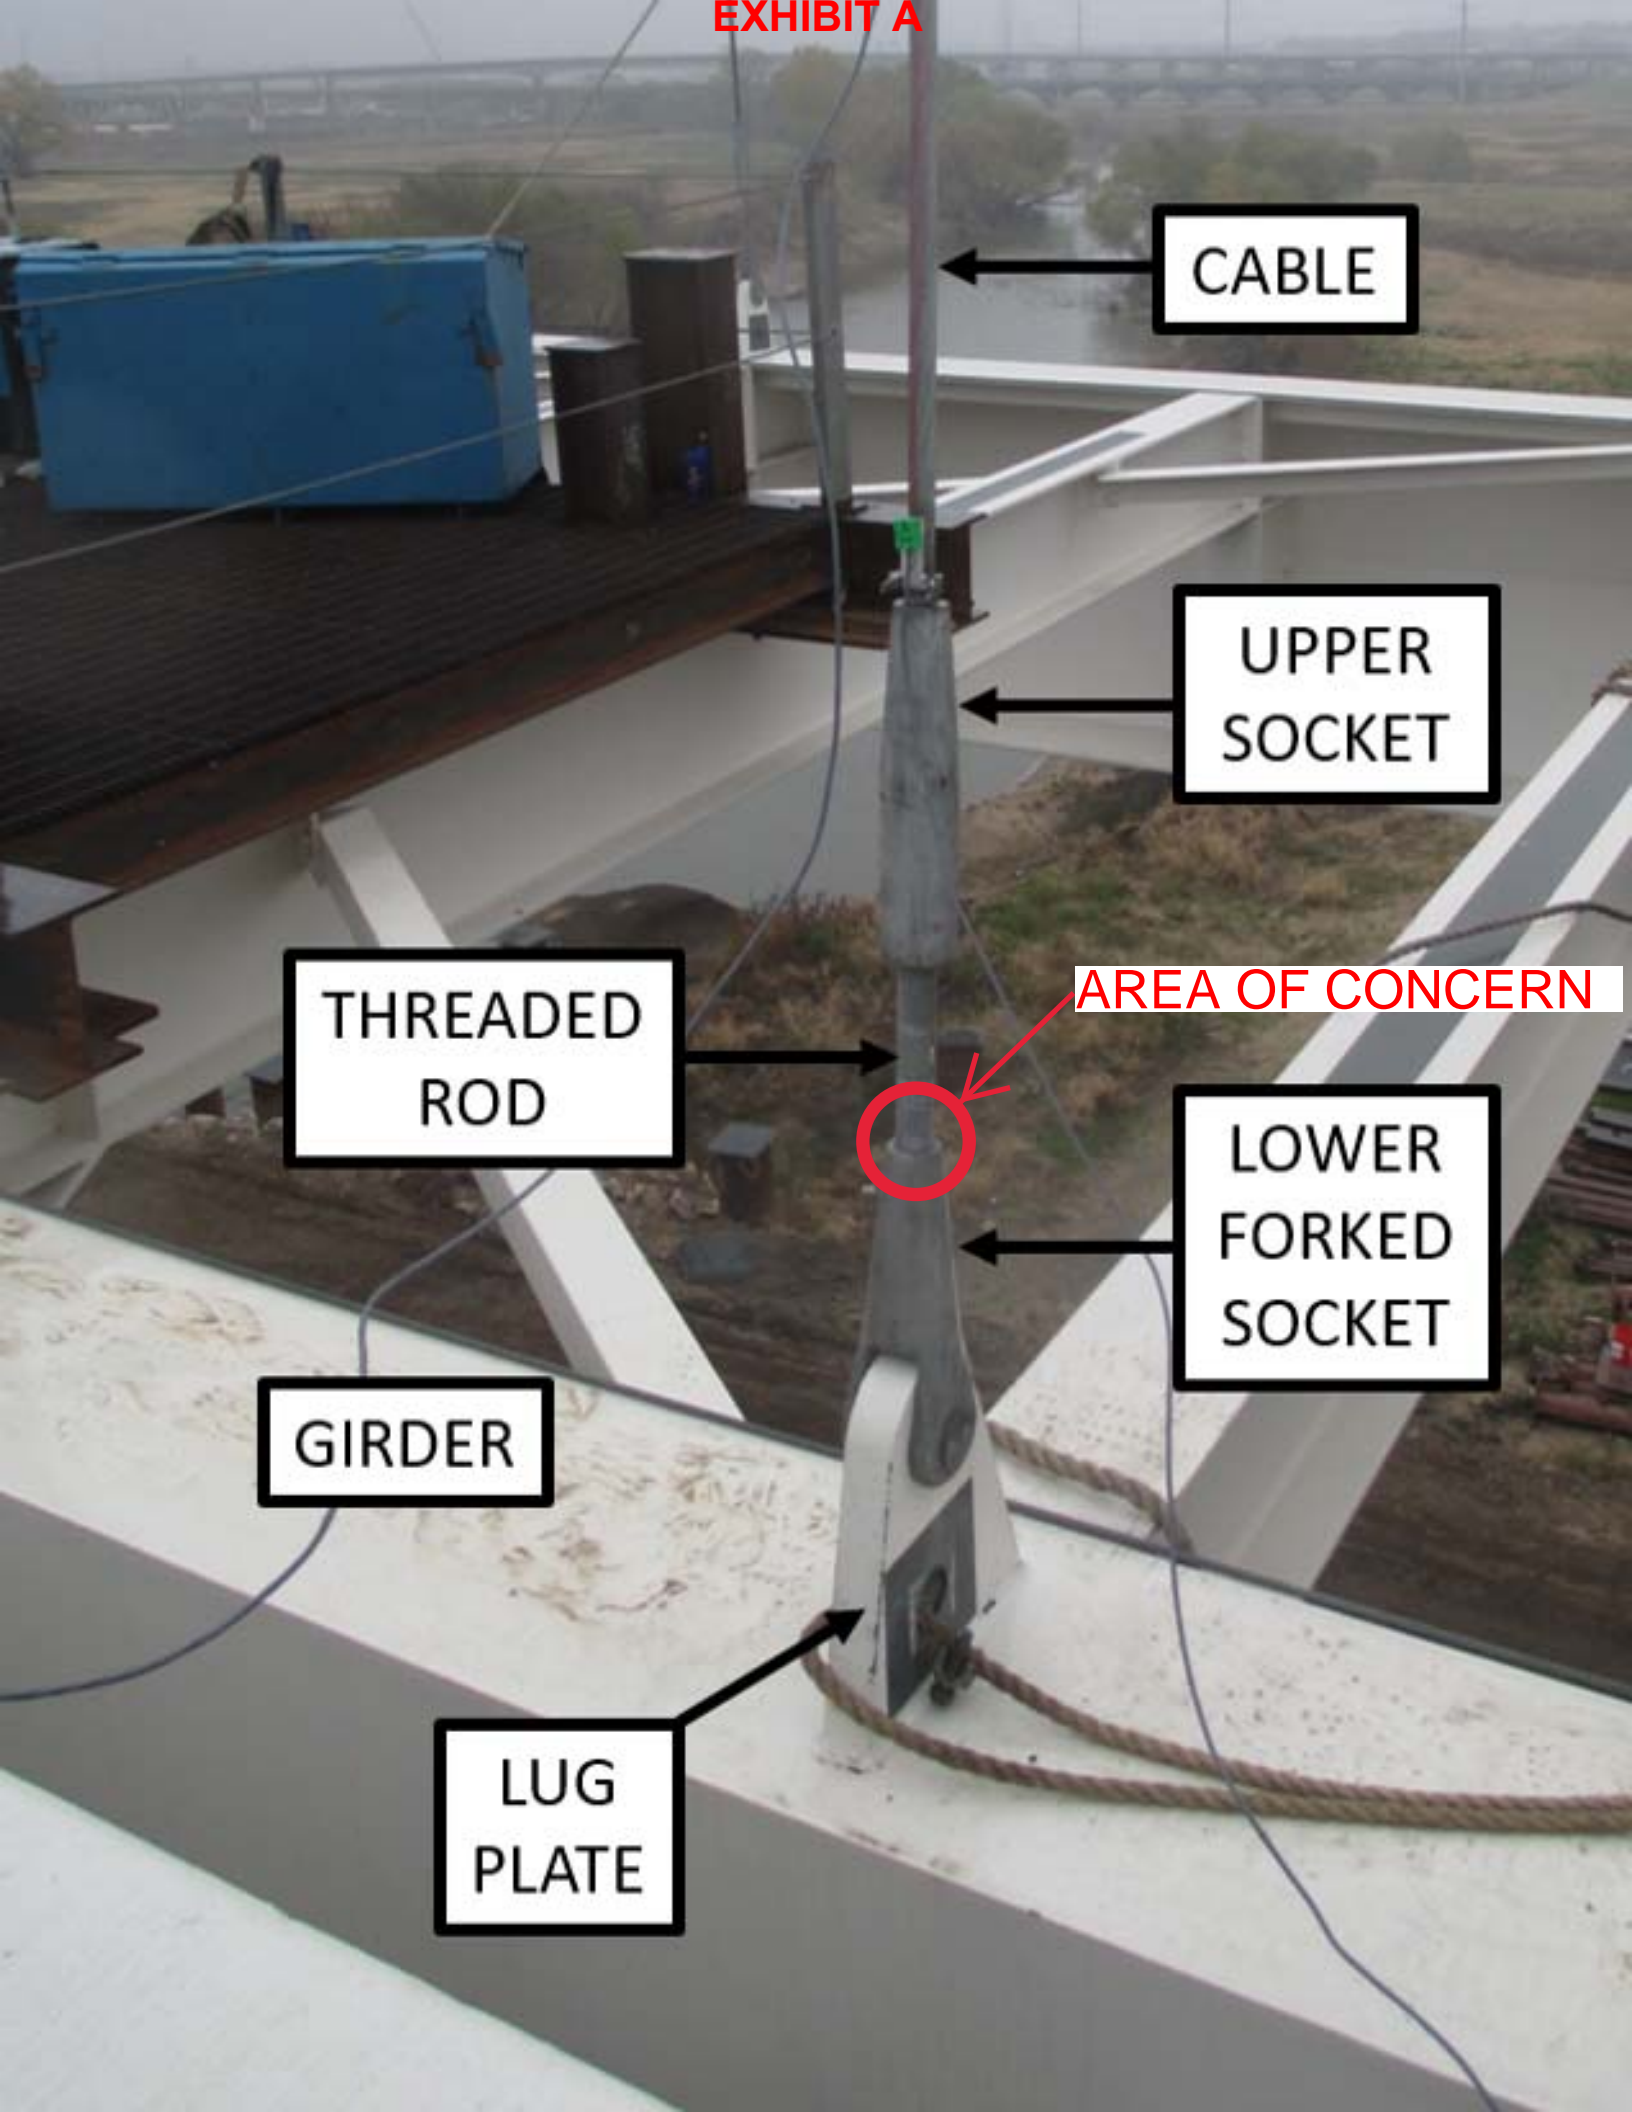
EXHIBIT A

As Staff has been working through the summer to gain greater clarity and a proposed path forward, the information provided by the Engineer of Record indicates that the cable anchorage system has failed to perform as originally designed and intended for long-term maintenance; the remedies to date including additional dampners have failed to address the vibrations, and prior vibrations have subjected some of the elements to premature fatigue. Attached you will find a photo diagram showing the bridge assemblage (Exhibit A), and plan view of the locations of the cable subsystem failures with areas of concern (Exhibit B) as prepared by the Engineer of Record. In the March to April 2016 timeframe, during bridge construction, the anchor rod on the lower cable assemblage assembly fractured on two different cables on the East Bound Bridge.

AREA OF CONCERN

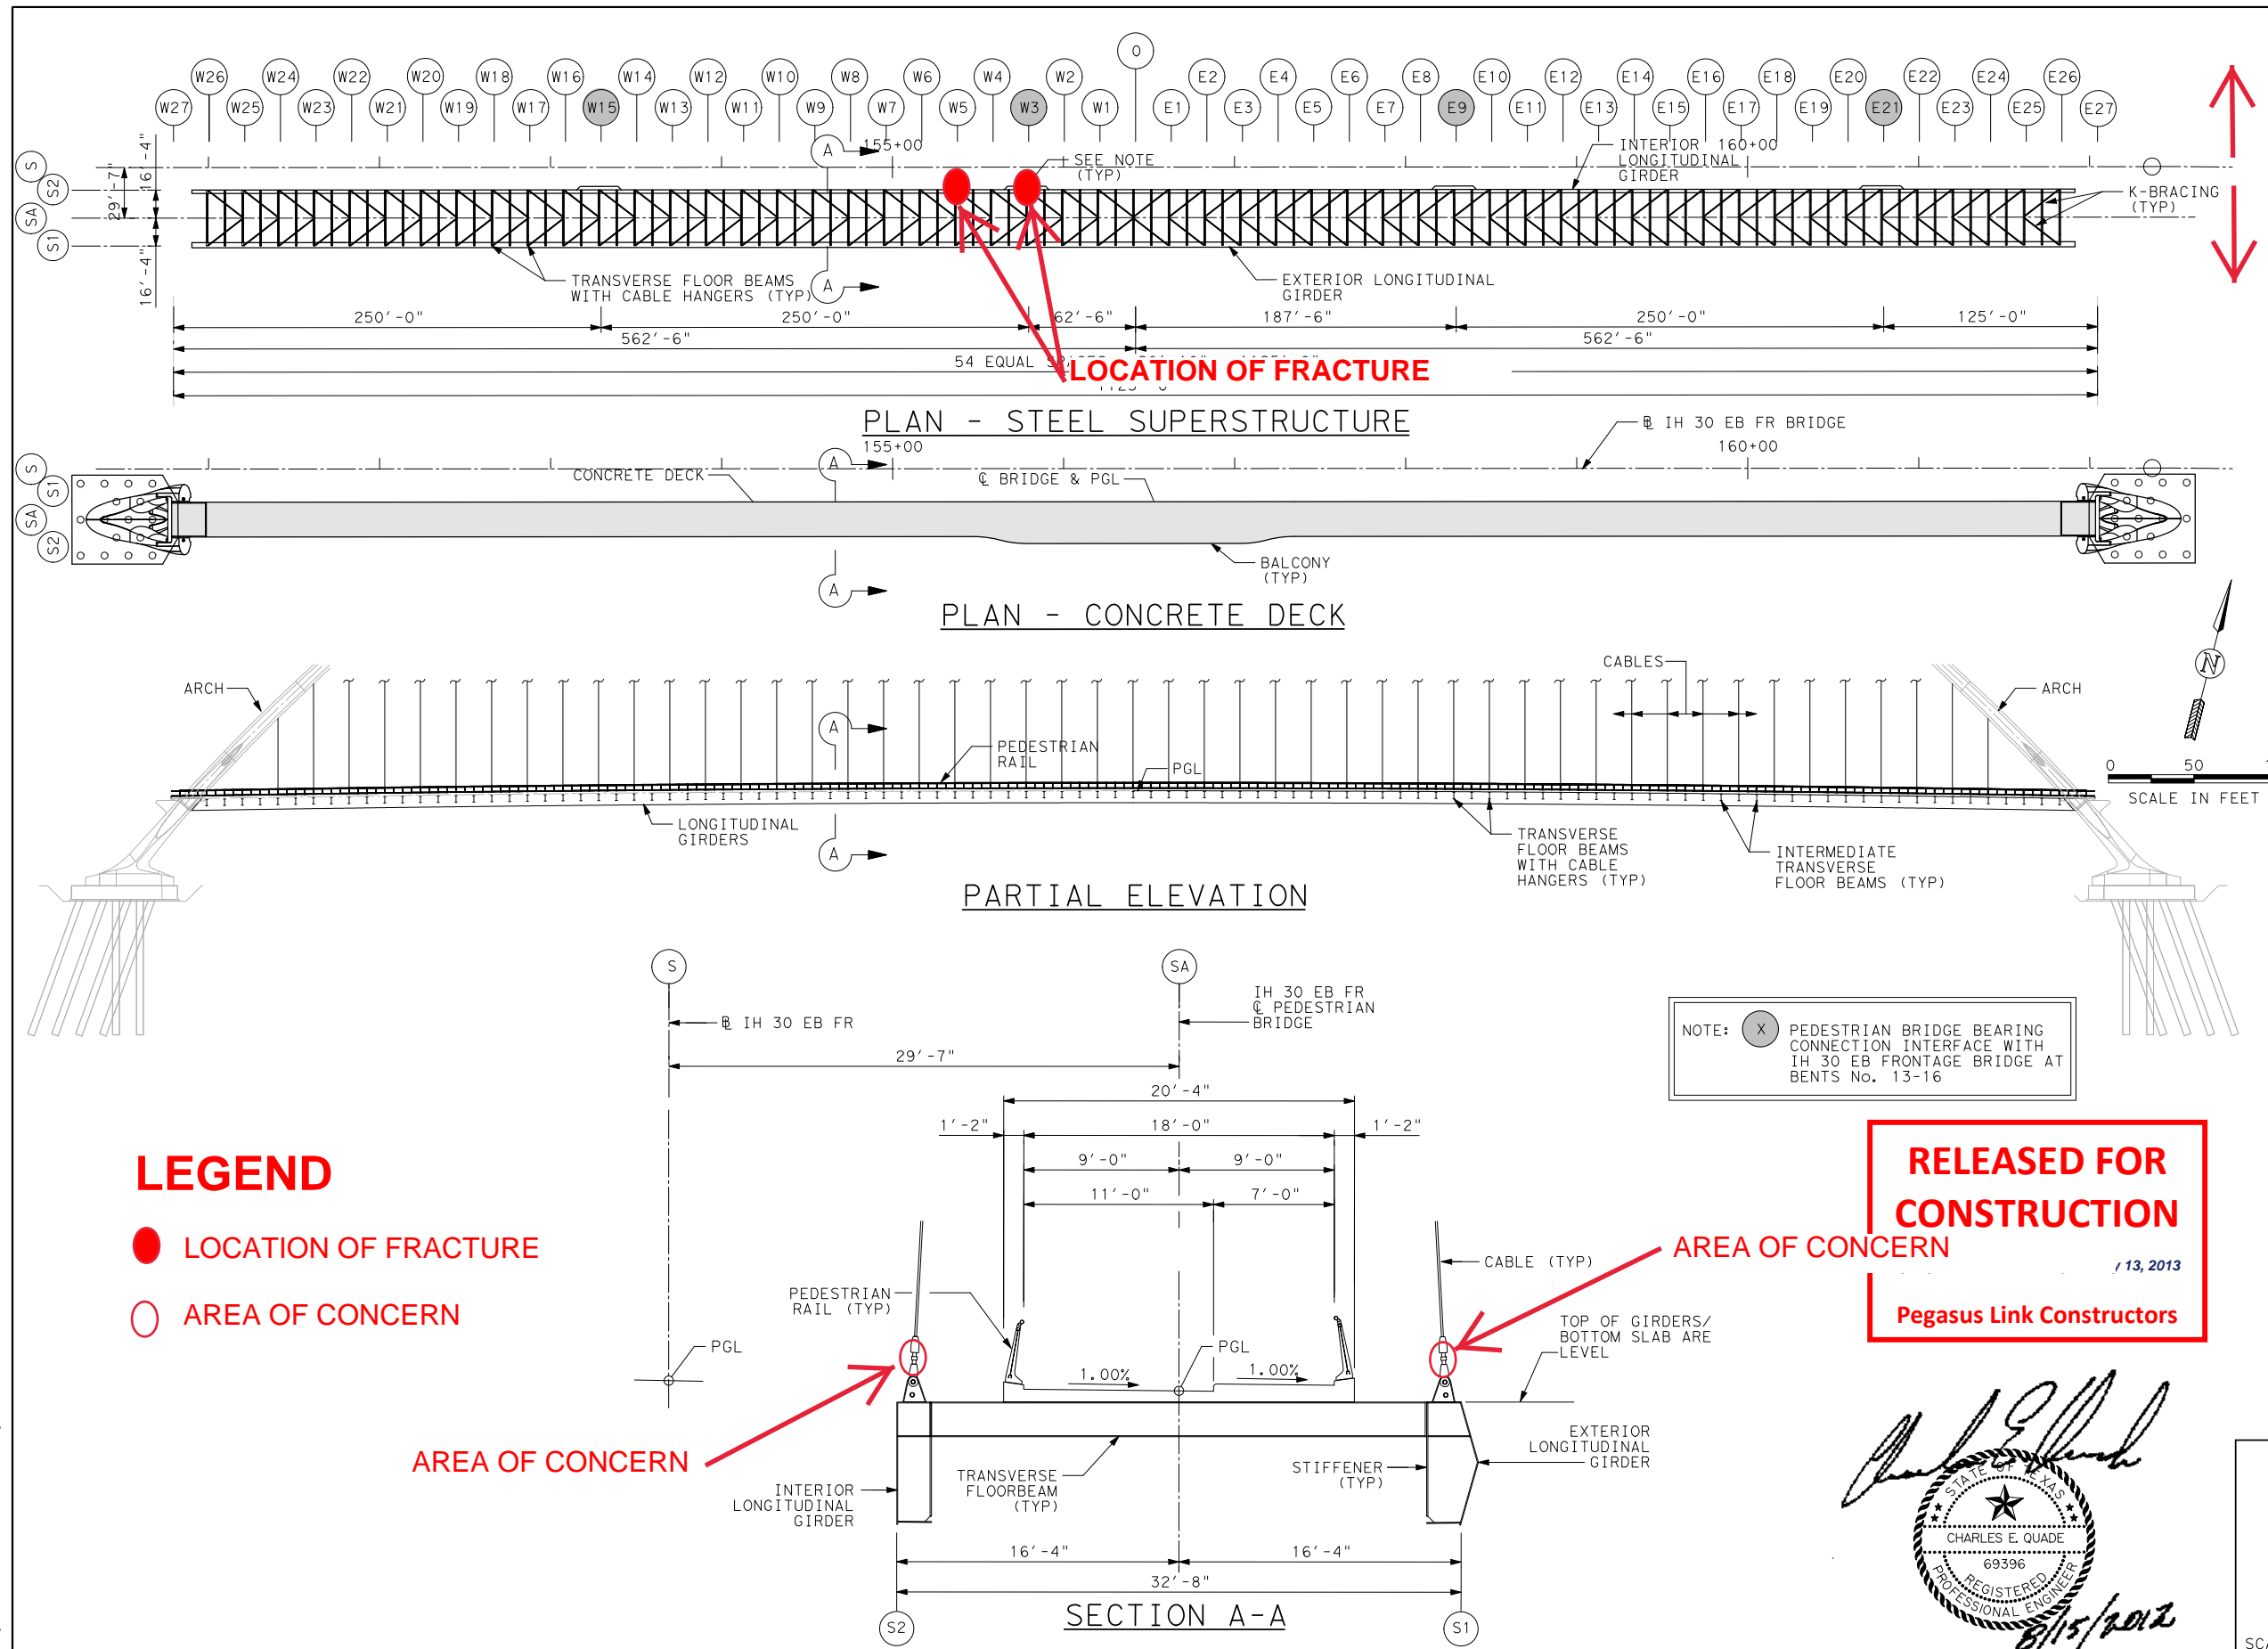
GENERAL BRIDGE GEOMETRY

● LOCATION OF FRACTURE

○ AREA OF CONCERN
