CITY OF DALLAS

SUBJECT **Pipeline Safety Evaluations of Atmos Energy Conducted by the Texas Railroad Commission**

Re: Pipeline Safety Evaluations of Atmos Energy conducted by the Texas Railroad
Commission

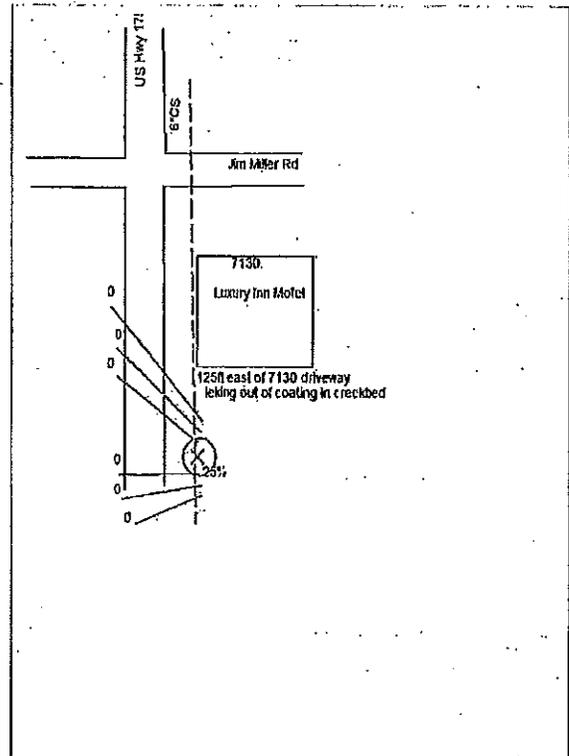
Probable Source: Main
 Gas Detected: Soil
 CGI Test: 25
 Meter #:
 Bar Tested each direction to 0%
 No migration indicated
 Surface Over Leak: Concrete
 Surface Over Main: Concrete
 Probable Pipe Type: Coated Steel
 Temporary Repair Type:
 Temp Repair Date:
 Transaction Date:
 Cross Reference #:
 Line Locate #:

Leak Repaired On: Main Type: Pipe Material: Coated Steel Pipe squeezed: EFC Pipe Size: 6.00 Pressure: Cause of Leak: Corrosion Station Plus:	External Corrosion: External Pits: External Coating: Min Pit Depth: Min Length of Pit: Internal Corrosion: Technician:
---	--

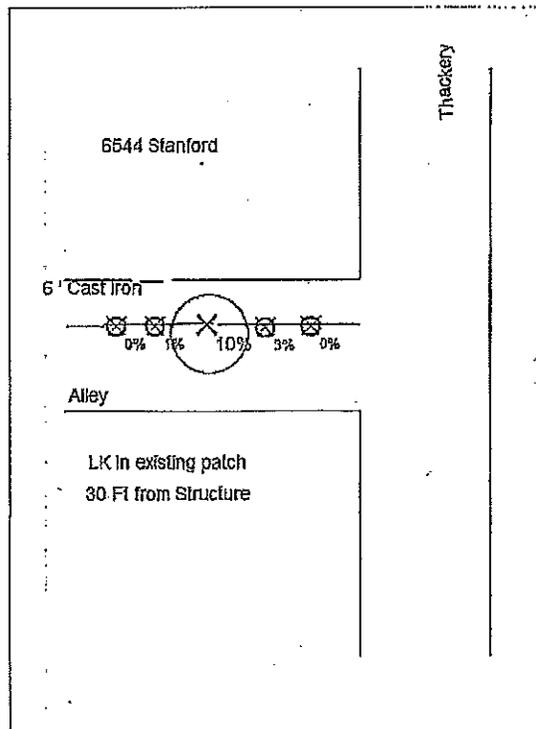
Leak Repaired On: Main
 Type: Joint
 Material: Cast Iron
 Pipe squeezed: EFC
 Pipe Size: 6.00
 Pressure: L.P. oz
 Cause of Leak: Gasket / O-rings
 Station Plus:
