SUBJECT **2017 Dallas City Hall Facility Condition Assessment (FCA) Report**

# Facility Condition Assessments

City of Dallas

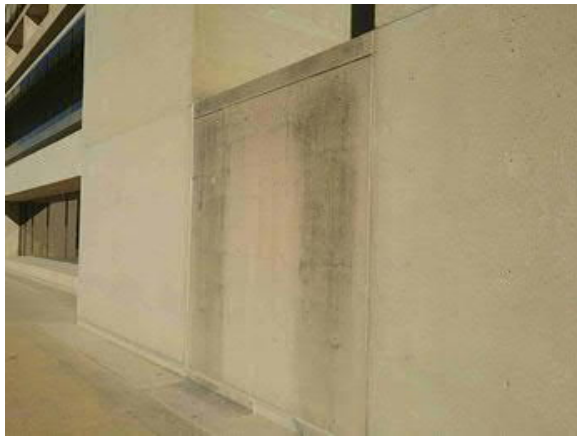
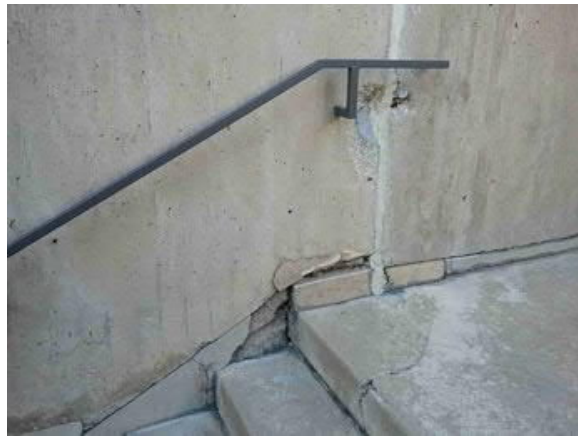
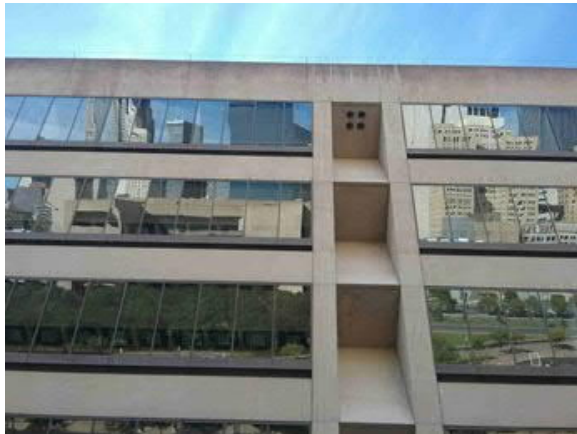
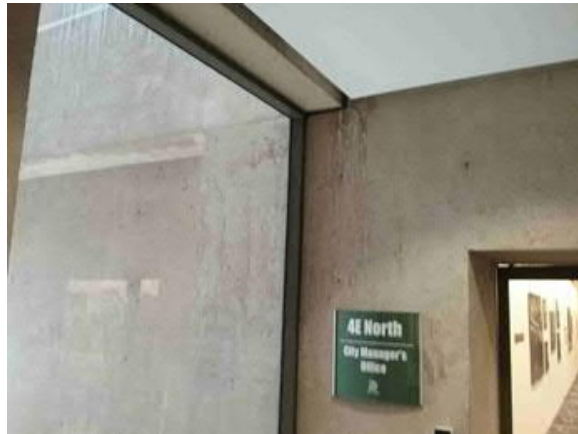
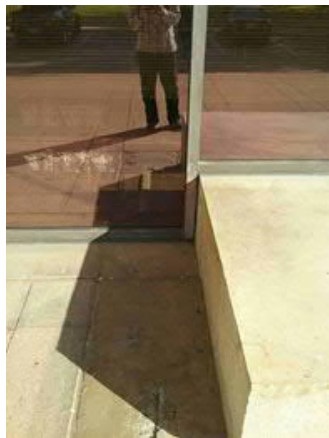
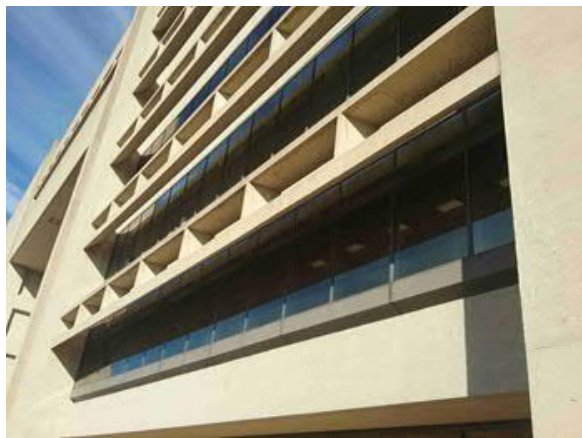
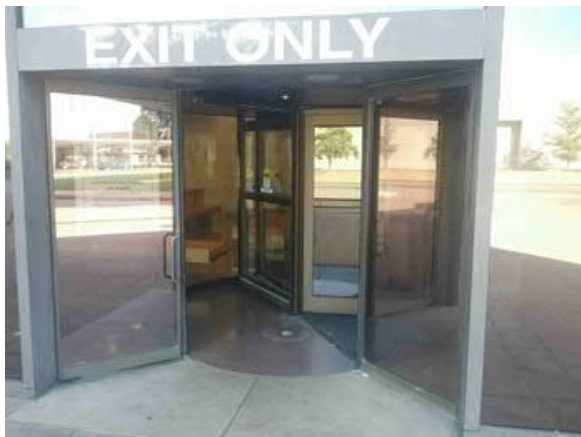
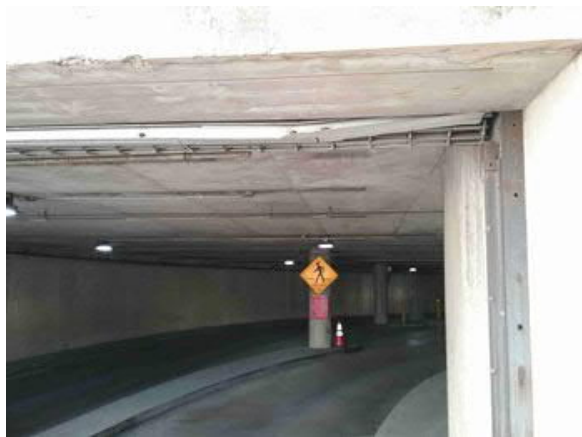
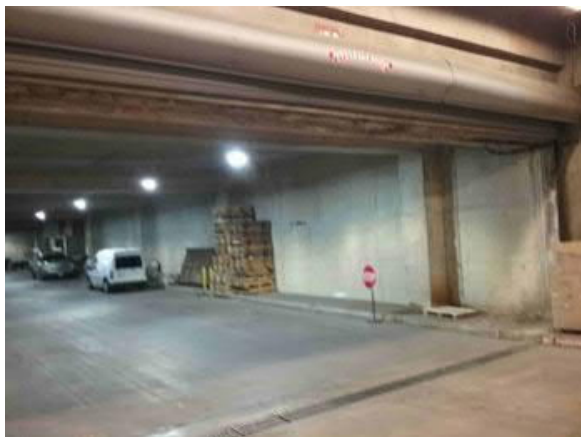
### Exterior Enclosure

| Subsystem | Condition and Deficiency Overview | System Condition Rating |
|---|---|---|
| Exterior Walls | <p>The exterior walls consist of exposed cast-in-place concrete with a sand blasted/acid etched finish. The north façade/wall of the building is battered or angled at 35 degrees as each floor is cantilevered over top of the floor below.</p> <p>Deficiencies noted included weathered, stained and discolored concrete on the south and ground floor facades. The aggregate in the concrete was observed to be more exposed in some locations due to erosion. Part of a concrete wall/beam at 1C-North had large areas of spalling at the bottom corner. The east wall at the top of the seventh floor roof had a sharp, acute, angle and showed signs of water staining and discoloration.</p> | 3 - Average |

1. Clean the water-stained areas of exterior concrete walls on south facade and near ground surface.
2. Patch the spalled areas in the exterior concrete walls.
3. Clean the water-stained areas of the exterior concrete walls at roof edge.
4. Repair window leaks near 4E-North
5. Repair peeling coating (paint) on upper and lower level clerestory exterior windows.
6. Clean and repair the weathered finish of the aluminum windows and storefront frames.
7. Repair broken revolving door at 1F-South.
8. Repair damage to overhead garage door at L1-Northwest
9. Clean and repaint rusted overhead door.

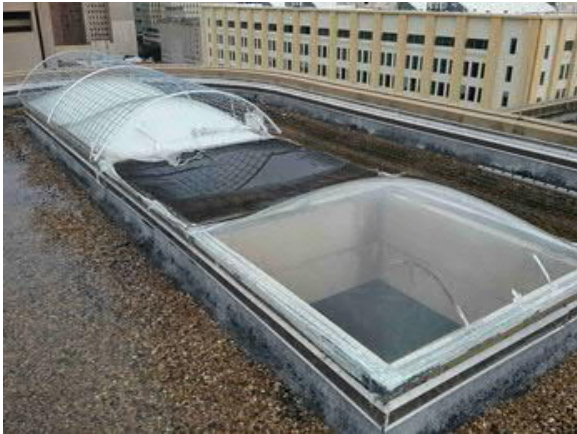
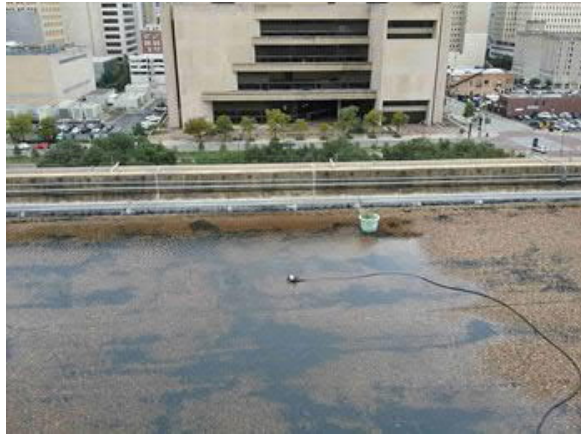
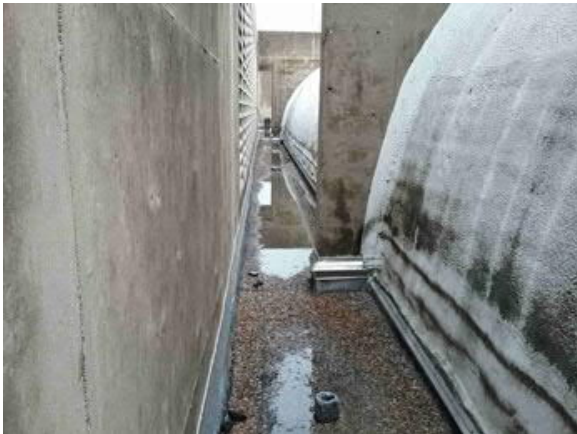
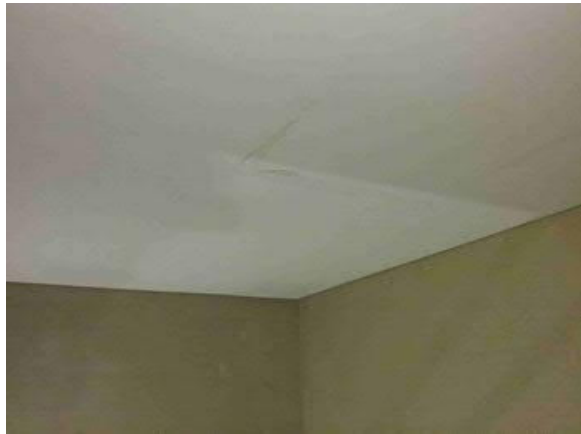
## Roofing

| Subsystem | Condition and Deficiency Overview | System Condition Rating |
|---|---|---|
| Roof | <p>The roof of the building consists of three distinct areas and types of roofing. The majority of the building's roof construction, for both the upper and lower roof areas, is built-up roofing with some small areas of modified bitumen covered with gravel and rock ballast. The barrel vault roofs are covered with a liquid elastomeric membrane. The roof is assumed to have been installed around 1997 based upon facility feedback.</p> <p>Other roofing features include area drains, flashing, equipment and antenna supports, and skylights.</p> <p>Deficiencies noted included leaking skylights over the main emergency egress stair towers on the north side of the building, and one skylight cover was observed to be missing and the opening was covered with plywood, plastic sheeting, and duct tape. Most of the low roof areas were observed to have ponding water and missing/worn ballast/gravel cover. The roof drains appeared to be clogged with roofing material. Significant ponding water was observed on the upper roof areas as well.</p> | 2 - Poor |

1. Replace missing skylight cover and repair seals of leaking skylights at the stair towers.
2. Clean out clogged roof area drains.
3. Replace low roofing.
4. Repair high roofing to allow for proper drainage of water off of the roof surface.

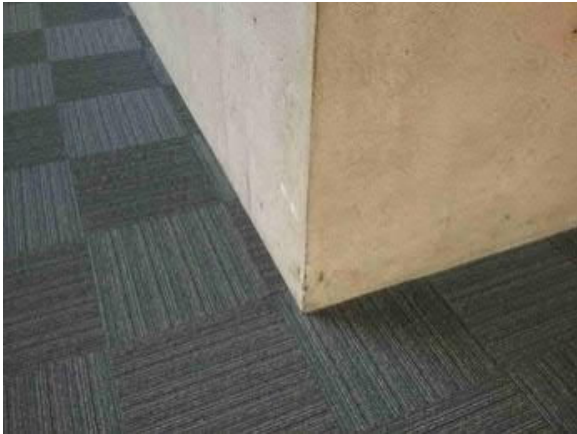
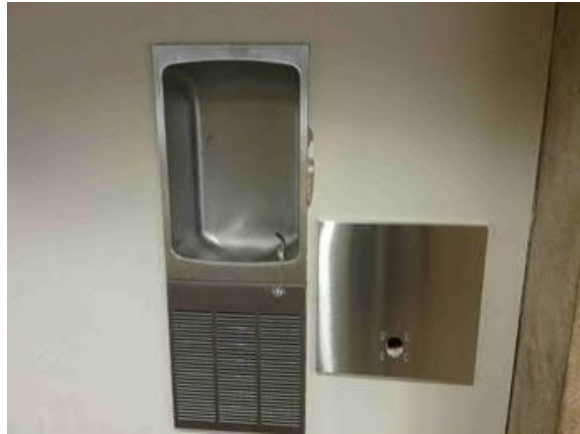
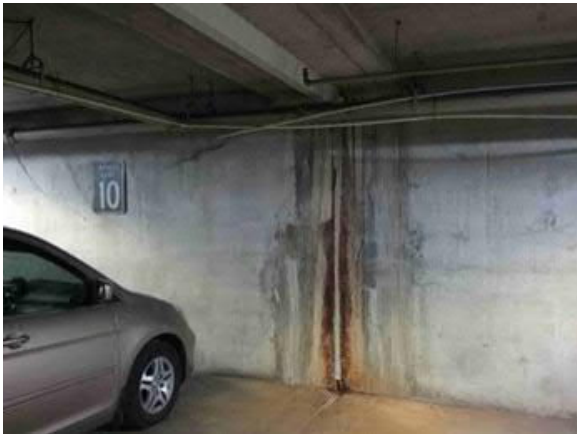
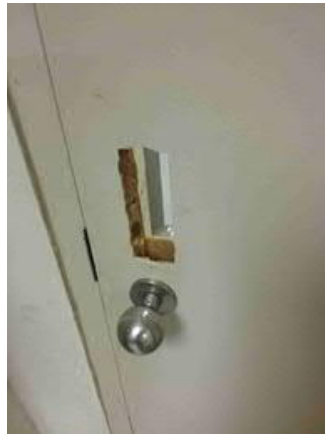
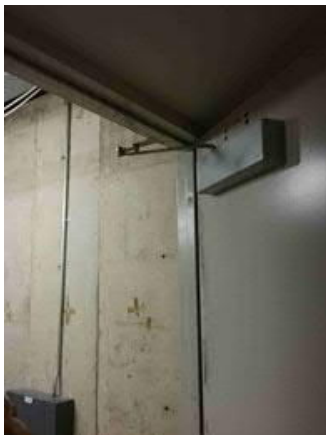
### Interior Construction

| Subsystem | Condition and Deficiency Overview | System Condition Rating |
|---|---|---|
| | <p>room walls are exposed concrete. Typically electrical closets are painted gypsum board over steel stud construction.</p> <p>Deficiencies noted included dirt/stained areas, small non-structural spalling on concrete walls, and wear at outside corners presumably from collisions. The gypsum board near 1B-South and 1C-South at the water fountain was observed to be damaged. Typical gypsum board deficiencies observed included wear and dirt marks, scuffs, and some damage like scratches and small gouges in drywall at narrow hallways between areas such as 6C-North and 6D-North. Exposed concrete walls of the L2 parking garage were observed to have significant water leaks at expansion joints. The concrete walls of the L1 F-North mechanical room were observed to be leaking water and had signs of efflorescence and staining. Interior walls of the plaza pool pump room were observed to be leaking significantly and had severe efflorescence and staining.</p> | |

1. Clean dirty and stained concrete walls.
2. Patch and paint or replace damaged gypsum board.
3. Address water leaks and clean/repair expansion joints.
4. Repair or replace interior doors with damage.
5. Repair or replace broken door hardware.
6. Clean and or replace old, worn, dirty and stained cubicles and partitions.

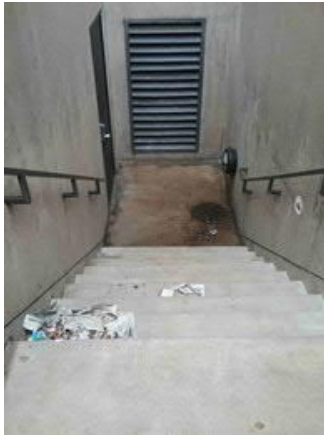
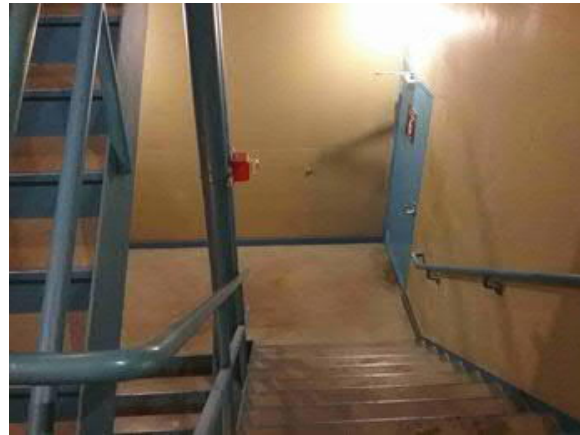
### Stairs

| Subsystem | Condition and Deficiency Overview | System Condition Rating |
|---|---|---|
| Exterior Stairs | <p>The building contains six sets of exterior/egress stairs. The stairs at all six locations are made of concrete-filled steel pan treads supported by steel channel stringers. Each of these egress stairs services every level of the building. The lower level L1 parking garage has three exterior stairs from the plaza on the north side of the building.</p> <p>Deficiencies noted included stained and dirty concrete on the stairs. The exterior stair near 5D-North to L1 parking was observed to have standing water at its lower level.</p> | 3 - Average |

1. Service drains and clean exterior stairs from plaza to L1 parking garage.
2. Clean exterior egress stairs.

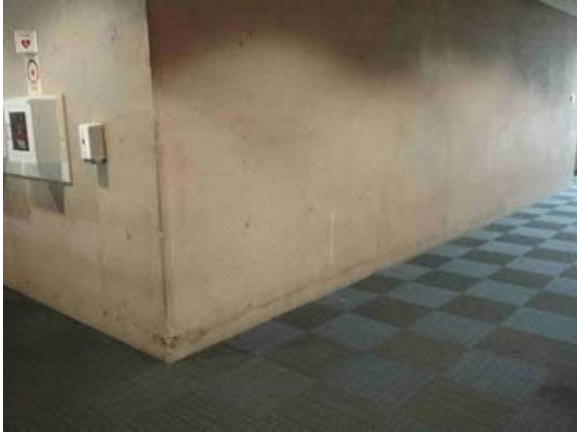
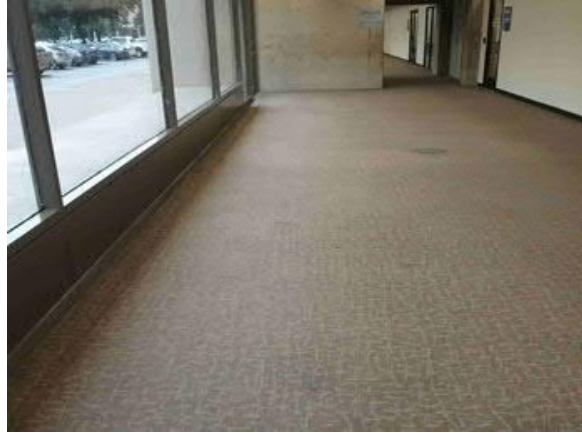
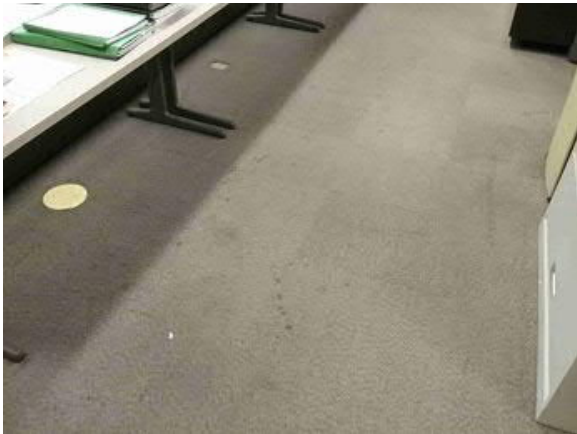
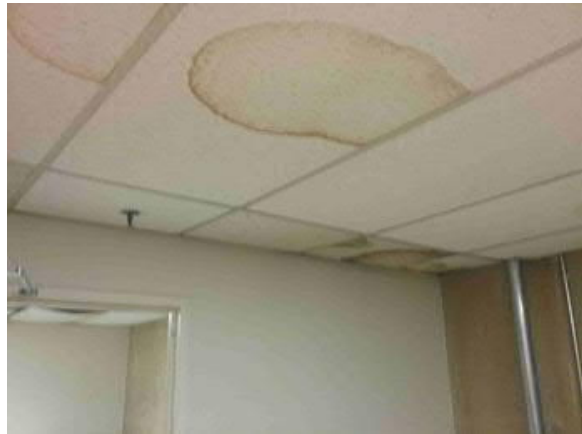
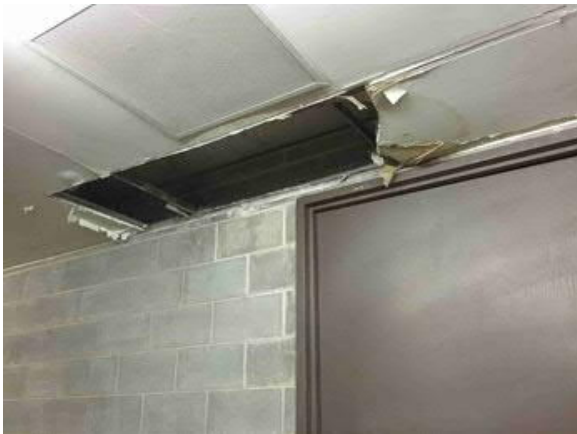
### Interior Finishes

| Subsystem | Condition and Deficiency Overview | System Condition Rating |
|---|---|---|
| Interior Wall Finishes | <p>The interior walls of the building consist primarily of exposed concrete. Offices typically consist of three types of wall construction: exposed concrete, painted gypsum board, and fabric/laminate covered partitions. Room 3D-South has full height interior glass partition walls. Most of the offices are next to the interior atrium and have partial height glass window walls. The interior walls of the L2 parking garage are exposed concrete. Typically electrical closets are painted gypsum board.</p> <p>Deficiencies noted included dirt/stained areas, small non-structural spalling on concrete walls, and wear at outside corners presumably from collisions. Typical gypsum board finish deficiencies observed included wear and dirt marks, scuffs, and some damage like scratches and small gouges in drywall at narrow hallways between areas such as 6C-North and 6D-North.</p> | 3 - Average |
| Interior Ceiling Finishes | <p>The building's most common ceiling finish is the exposed concrete waffle slab of the building's structure. Some areas have suspended acoustical tile while other areas have painted gypsum board. The office at L1 B-South has perforated painted metal panels.</p> <p>Deficiencies noted included missing and damaged acoustical ceiling tiles and dirty and stained gypsum board.</p> | 3 - Average |

1. Clean and repair interior wall finishes.
2. Clean carpet flooring throughout the building.
3. Replace stained and torn carpet.
4. Replace missing and damaged acoustical ceiling tiles.
5. Patch and repair damaged gypsum board ceiling finish.

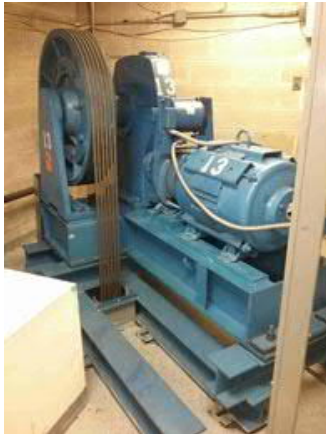
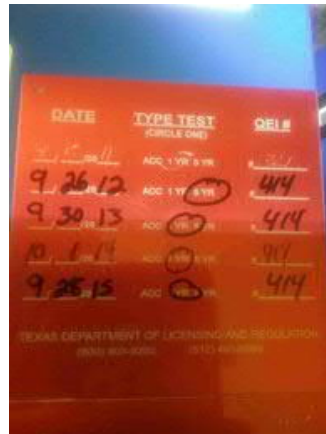
### Conveying

| Subsystem | Condition and Deficiency Overview | System Condition Rating |
|---|---|---|
| Elevators, Lifts, and Escalators | <p>The building has a total of thirteen elevators; twelve of which are passenger elevators and one freight elevator. All of the elevators were observed with an inspection tag on the control equipment dated August of 2016 which meets annual requirements except where noted below in the deficiencies portion where some elevator inspection tags were last dated September of 2015. All of the elevator controls were on the 8<sup>th</sup> floor mechanical space.</p> | 3 – Average |

1. Repair the elevators and/or its controls, along with making any other necessary updates, to more permanently address the continuous maintenance issues.
2. Confirm that the annual inspections are completed on the three passenger elevators that were expiring the week of the assessment.

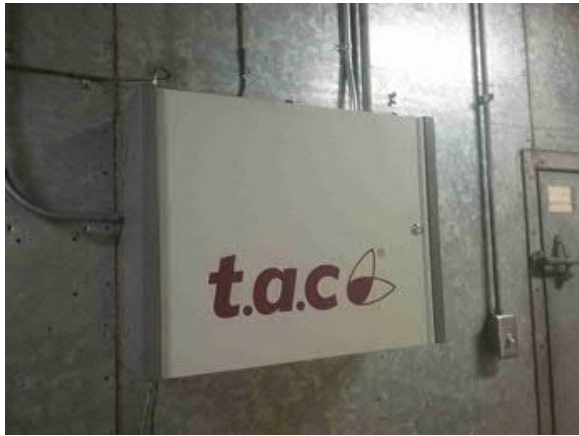
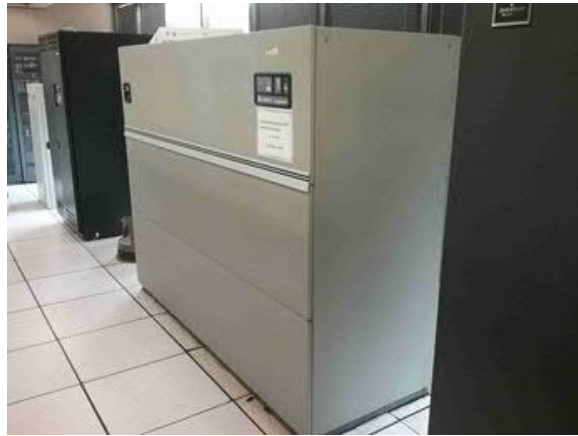
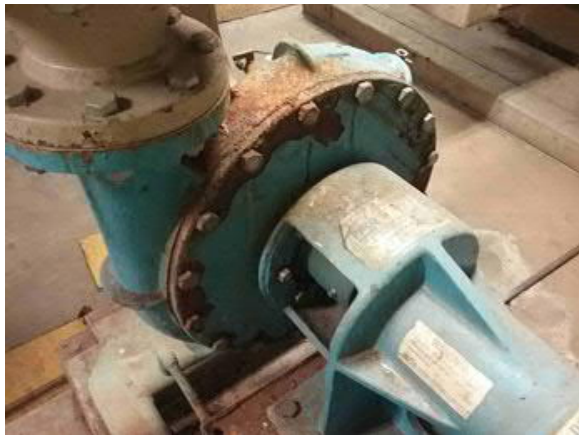
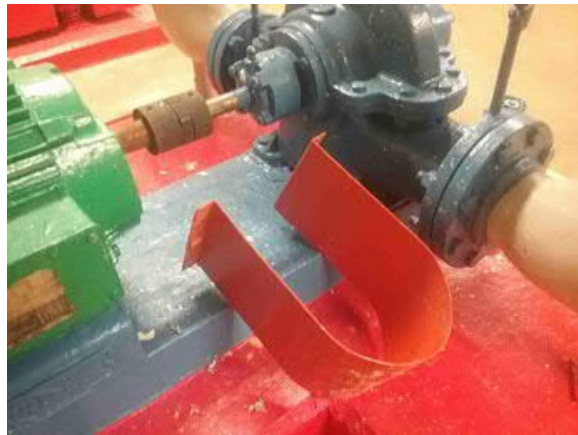
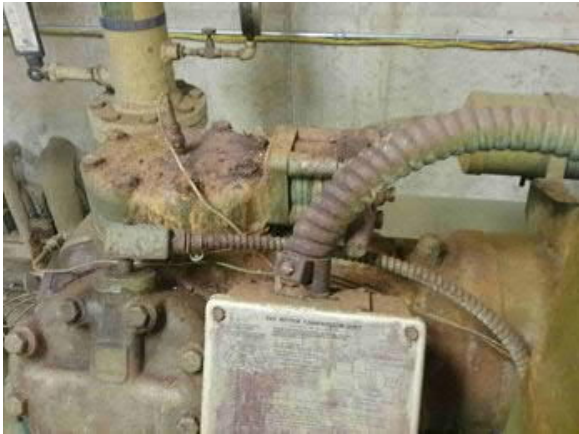
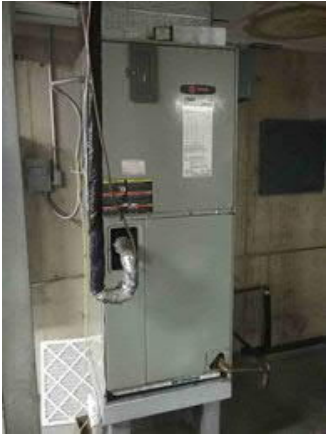
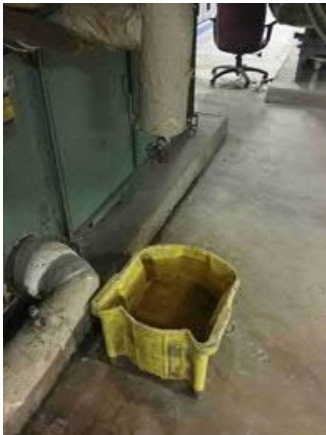
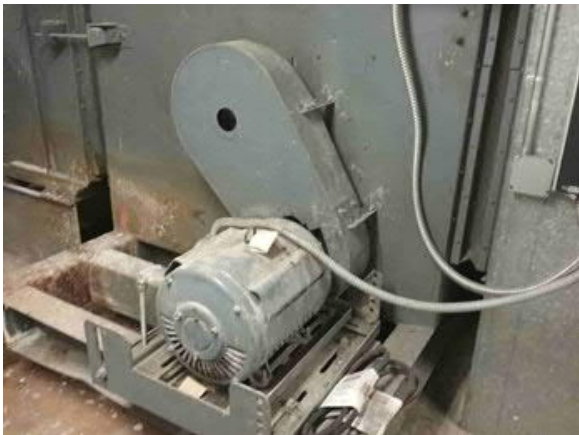
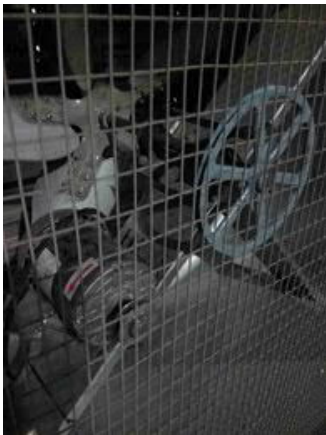
### Mechanical/HVAC

| Subsystem | Condition and Deficiency Overview | System Condition Rating |
|---|---|---|
| Mechanical / HVAC | <p>The major mechanical equipment consists of boilers, chillers, cooling towers, condensing units, air handling units (AHUs) to service all of the heating, ventilating, and air conditioning (HVAC) system.</p> <p>The first type of major mechanical equipment includes seven chillers located throughout the facility in various mechanical spaces. The first area containing chillers is the seventh floor mechanical space, which holds three 570-Ton chillers. Two of these chillers are act as the primary source of chilled water to cool the facility, while a third is considered a backup. A fourth and fifth units are 120-Ton reciprocating units located in the L1 South mechanical space below grade, and serves as a backup system to cool the 311, 911, and fire dispatch call centers. The sixth and seventh reciprocating chilled water units are 60-Ton units, located in the L1 West mechanical space which is an antiquated system no longer in use. The second type of major mechanical equipment includes two approximately 300-Ton cooling towers located on the roof. The facility contains eight direct expansion units serving split systems throughout the facility. These condensing units range in size from 4-Ton to 42.5-Ton units and are located in L2A south mechanical room or the uninterruptable power</p> | 3 - Average |

1. Adjust HVAC controls to better balance the system, or if needed install VAV boxes to better regulate the temperature in spaces of high temperature fluctuations.
2. Insulate the floor of the data center to reduce heat transfer and water condensation caused by CRAC units.
3. Mitigate corrosion issues found on the chilled water pumps.
4. Permanently mount shaft covers on distribution pumps.
5. Repair the corroded chiller in the basement mechanical space.
6. Repair the non-functioning air handling unit in the central elevator mechanical room.
7. Repair leaking AHU piping.
8. Repair excessive vibration on AHU fan motor.
9. Repair industrial garage exhaust fans.

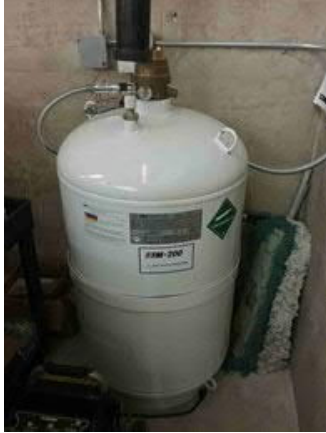
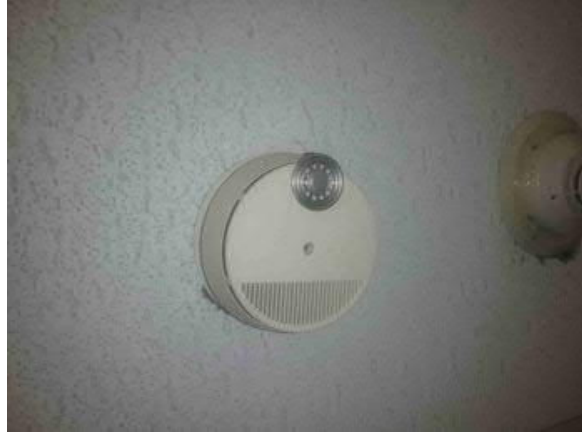
### Fire Protection

| Subsystem | Condition and Deficiency Overview | System Condition Rating |
|---|---|---|
| Fire Alarm | <p>The building has a fire alarm system that consists of alarm and signaling devices such as annunciators, strobes, horn/strobe combinations, pull stations, detectors, etc. including devices for the halon system and standard devices in the parking garage.</p> <p>The fire alarm system control equipment includes a fire alarm control panel (FACP) along with other equipment such as transponder and relay panels.</p> <p>Deficiencies noted included some fire alarm devices were observed to be nearing the end of their typical design service life.</p> | 4 - Good |

| Subsystem | Condition and Deficiency Overview | System Condition Rating |
|---|---|---|
| | <p>The building also has supplemental, portable fire extinguishers for fire suppression which has inspection tags dated within the last year as required.</p> <p>Deficiencies noted include the lack of fire suppression coverage in the radio room. A FM-200 clean agent fire suppression system was observed to be in place, but not yet hooked up.</p> | |

1. Hook up fire suppression system in the radio room on floor L2 serving the dispatch call centers.
2. Monitor the aged fire alarm devices that are nearing the end of their typical design service life for replacement in the future as needed.
