Re: 338 S Fleming Ave, Dallas, TX 75203 (Tenth Street Historic District)

## **BRIEF IN OPPOSITION TO THE LANDMARK COMMISSION'S DECISION**

Project Name: Visual Foundation Evaluation Report

**General Structural Initial Foundation Inspection**

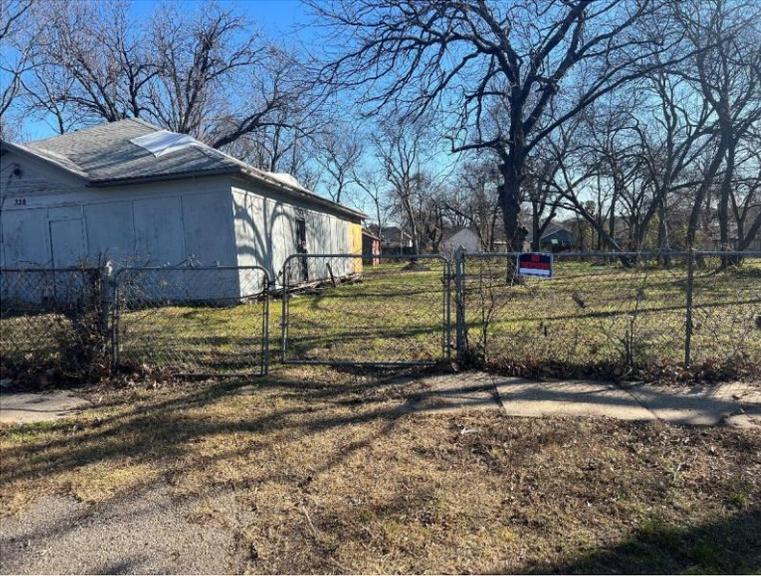
6593

The house is a "1-story" wood siding structure converted into residence with perimeter and interior piers and wood beam type foundation (see pic 6593). The structure appears to have collapsed. Most of the structure is sitting directly on the ground (see pics 6596, 6610 and 6612). Crawl space was not accessible, and any visible members of the foundation were rotten (see pics 6598, 6599 and 6602). None of foundation members are salvageable. The siding, walls and ceiling are in deteriorating condition and contain visible cracks. The walls are made/covered by siding, plywood, and sheet metal (see pics 6603, 6607 and 6608). The walls have large openings to the outside (see pic 6609). Most of the house structural lumber is damaged and not salvageable. Any attempt to lift this structure to repair the foundation might result in total collapse of the building. Our findings are similar to structural report obtained by the owner.

1. A total reconstruction of the foundation will be needed if this building can be raised.
2. There is limited amount of material that could be salvaged.

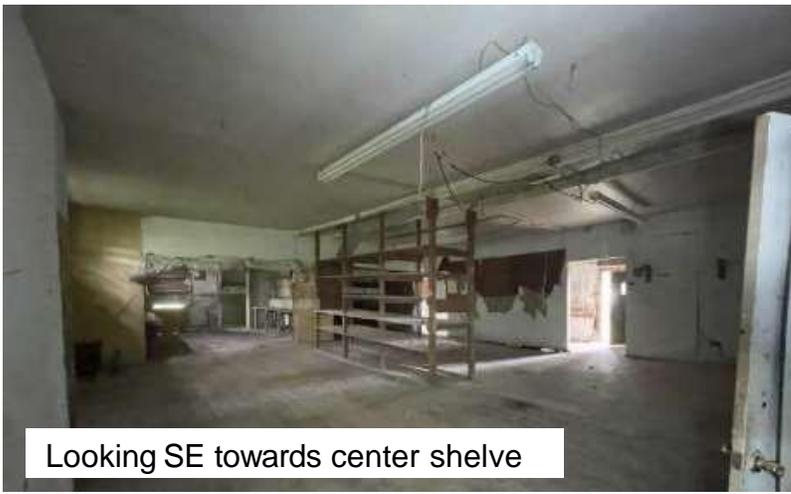
Looking SE towards center shelves

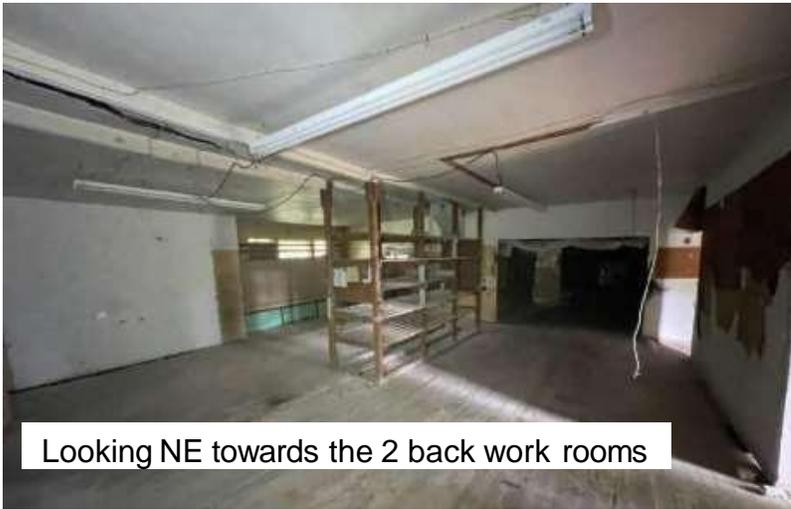
Looking NE towards the 2 back work rooms

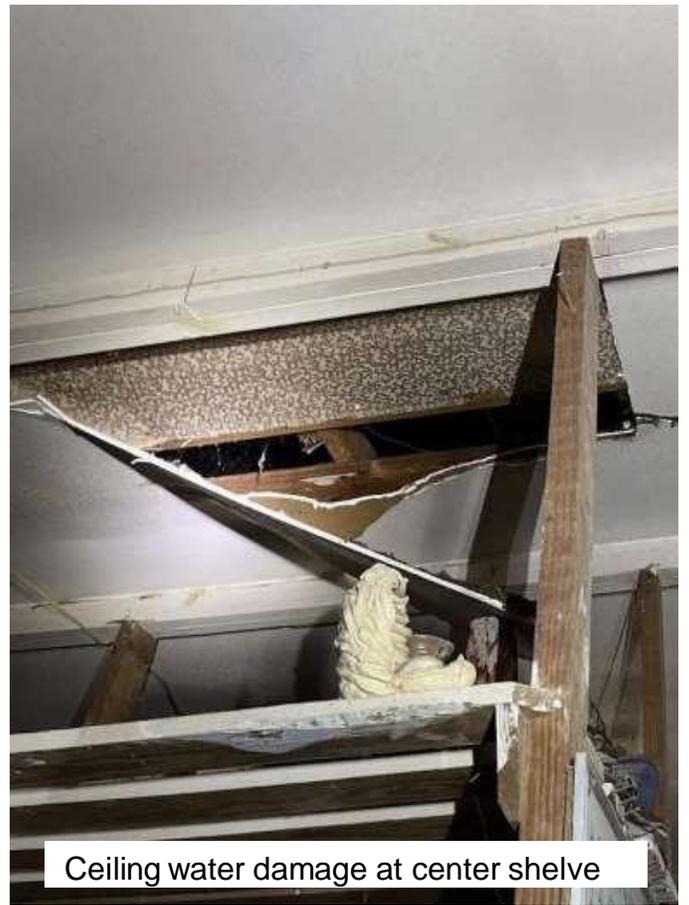
Ceiling water damage at center shelves
