# Masters Drive Transportation Safety Study

Limits: US 175 to Military Parkway

Public Meeting  
April 22, 2025

City of Dallas Department of Transportation  
and Public Works

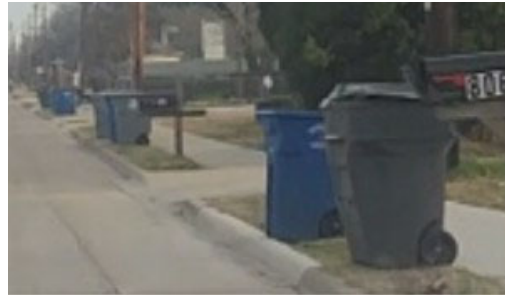
Sidewalks obstructed by utility poles,  
mailboxes, and trash cans

Consolidate mailboxes which are abutting into sidewalks.

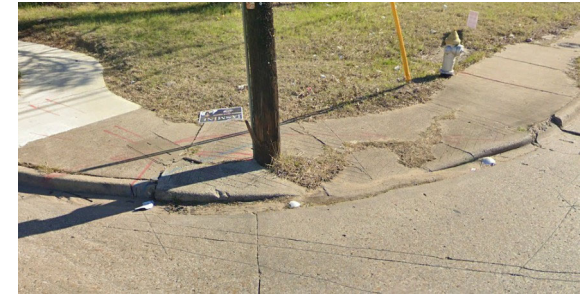
Ramps not ADA compliant

Install or upgrade curb ramps to meet ADA standards.

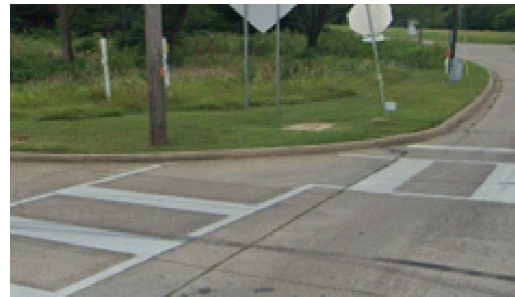
Curb ramps missing at Sam  
Houston Road

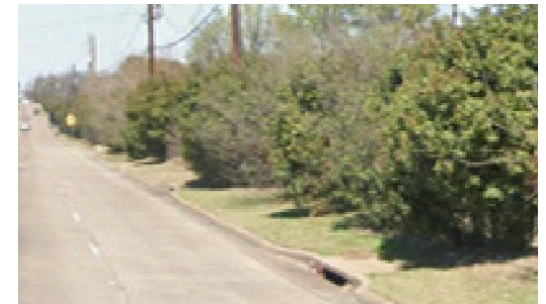
No sidewalks and road signs  
obscured by overhanging trees

Cut back overgrown trees and bushes that block signs.

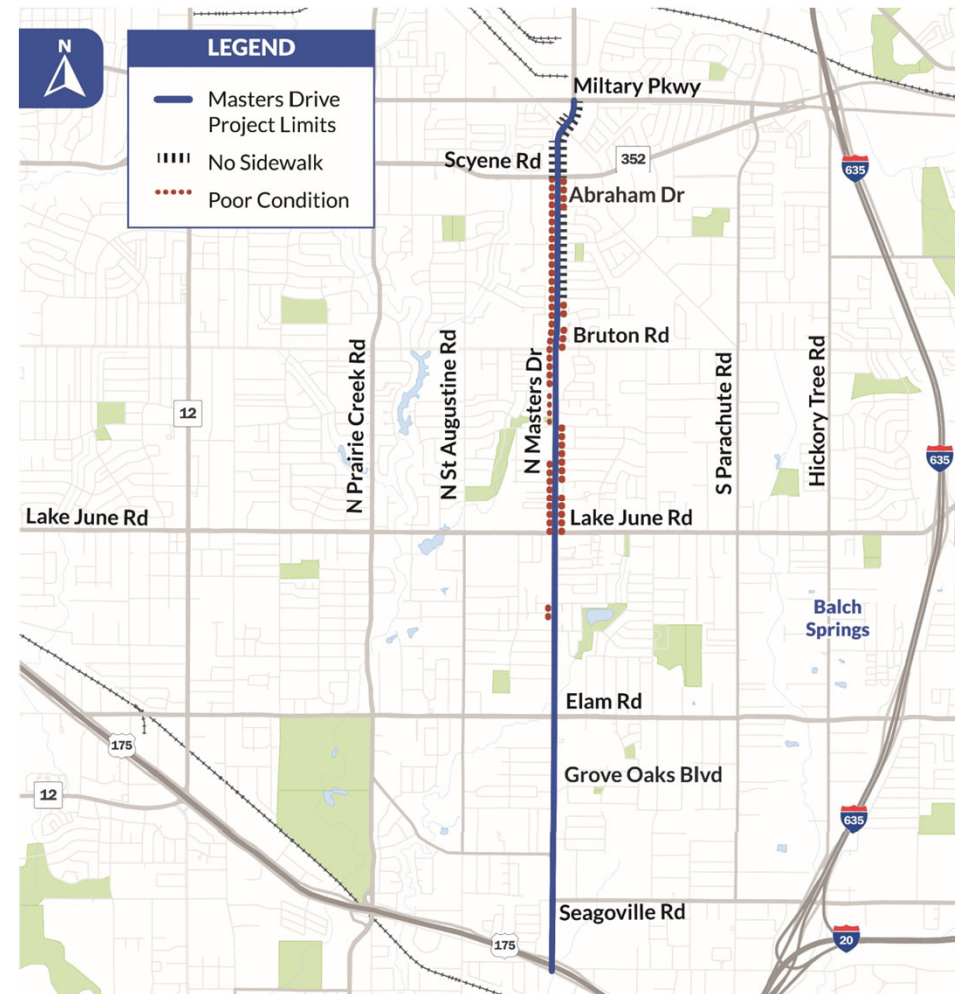
- No sidewalks on east side between Carolina Oaks Drive and Abraham Drive (Top priority project in Dallas Sidewalk Master Plan, 2021)
- Discontinuous sidewalks on both sides between Scyene Road and Military Parkway
- Approximately 40% of corridor length missing sidewalk or in poor condition

Repair existing sidewalks and widen/repave deficient sidewalks to enhance walkability along the corridor.
