HRS DOCUMENTATION RECORD COVER SHEET

Name of Site: LANE PLATING WORKS, INC.

HRS DOCUMENTATION RECORD

Date Prepared: January 2018

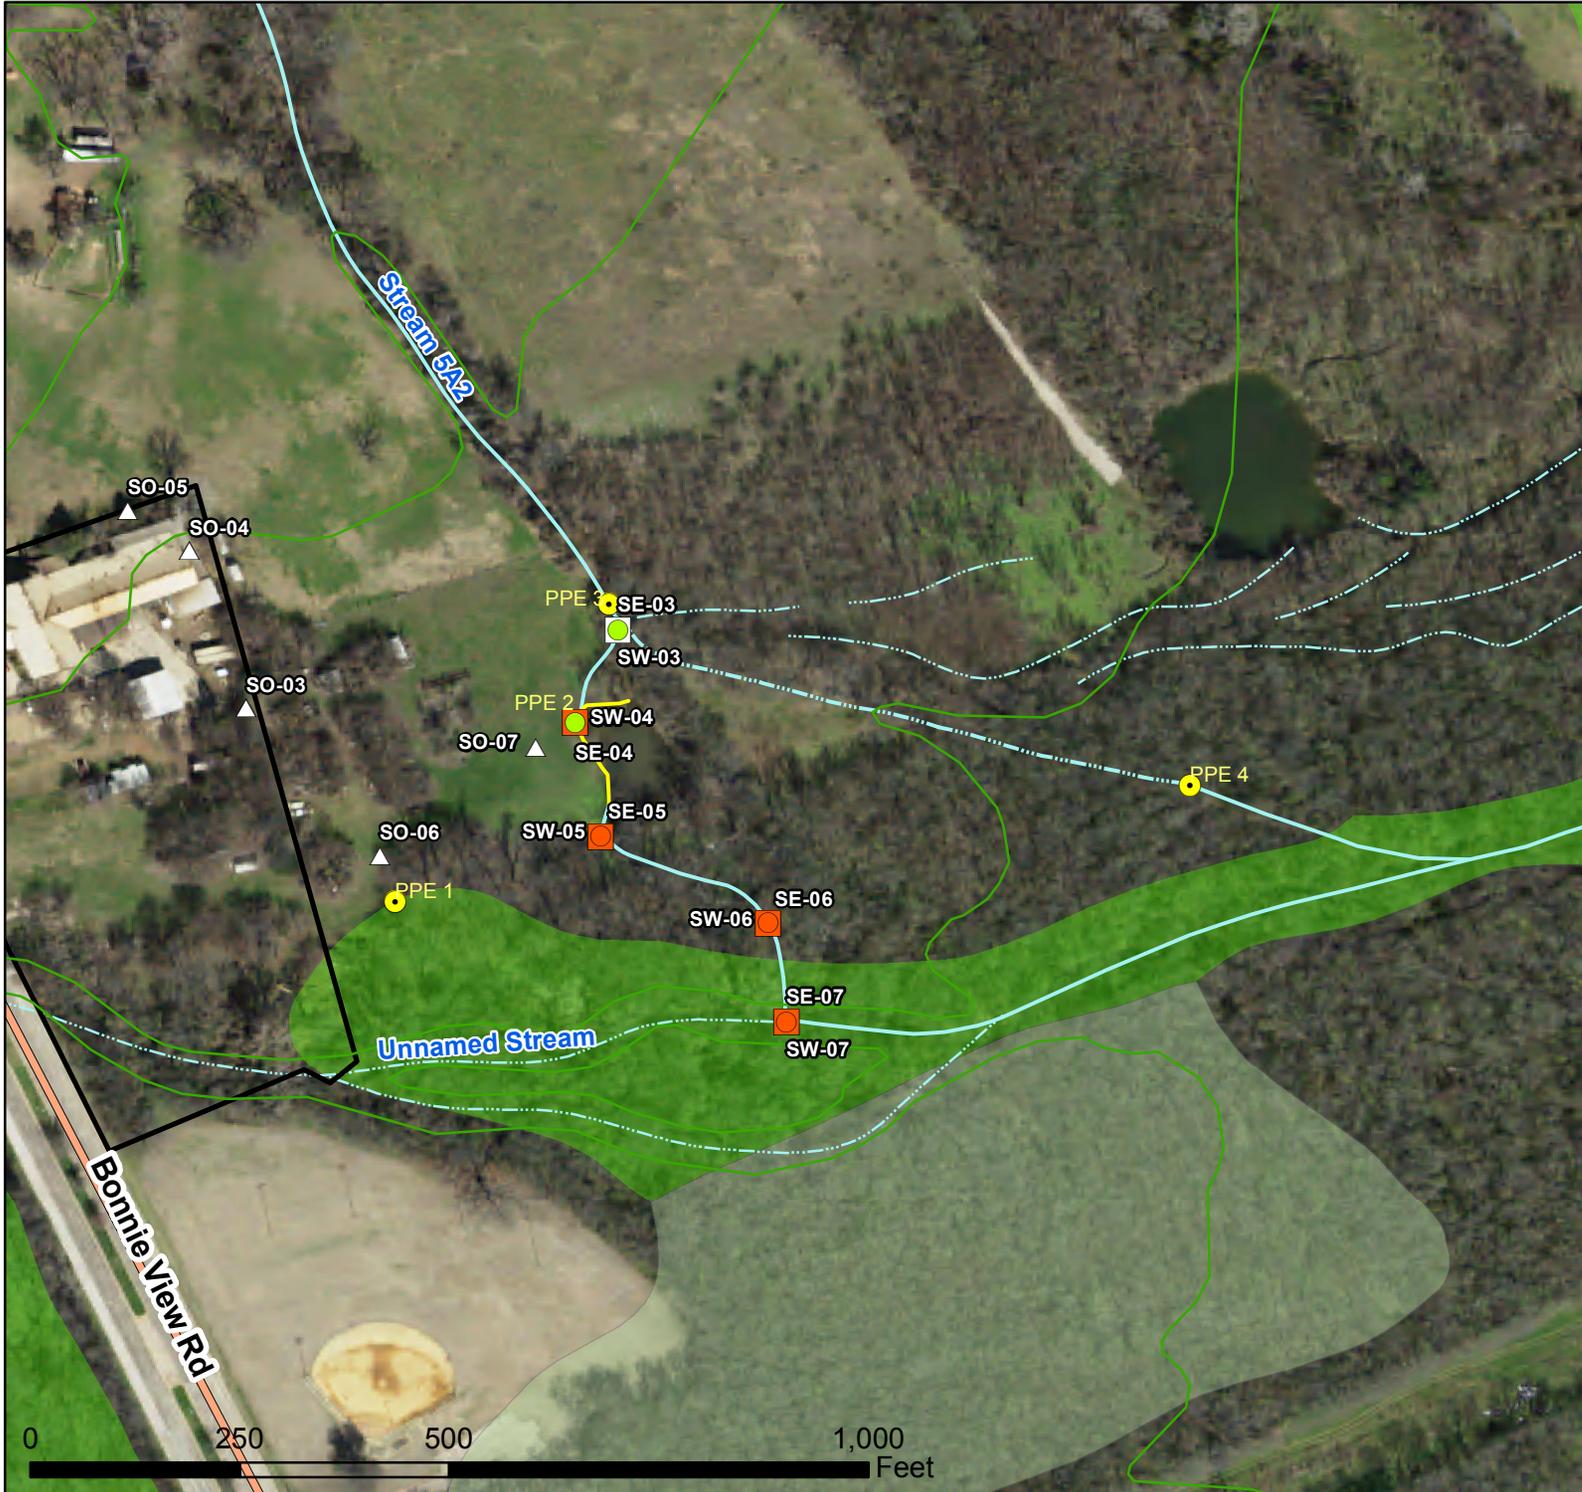
FIGURE 2: SOURCE LOCATIONS MAP

- Streams and Rivers
- Roads
- Main Facility Property Boundary
- PPE
- PPE
- Media**
 - Soil
 - Surface Water
 - Sediment
 - Surface Water Level I
 - Surface Water Level II
 - Sediment Level II
- Wetlands**
 - Freshwater Emergent Wetland
 - Freshwater Forested/Shrub Wetland
- Elevation**
 - Contours- 10 foot intervals
 - Index Contour
 - Intermediate Contour

*Map annotated by TCEQ in June 2017 to depict the facility property boundary, soil, sediment, and surface water sample locations and observed releases, relevant wetland types, and hydrology field observations (Ref. 4, pp. 7-8, 30-33, 35, 44, 49-52, 61-62, 74; Ref. 6, pp. 1-6; Ref. 13, pp. 1, 3-4, 7, 8, 9; Ref. 14, pp. 1-2, 6-7, 9-11, 14; Ref. 27, pp. 4-8; Ref. 28, pp. 8-19; Ref. 47, pp. 2-4; Section 4.1.2.1.1).

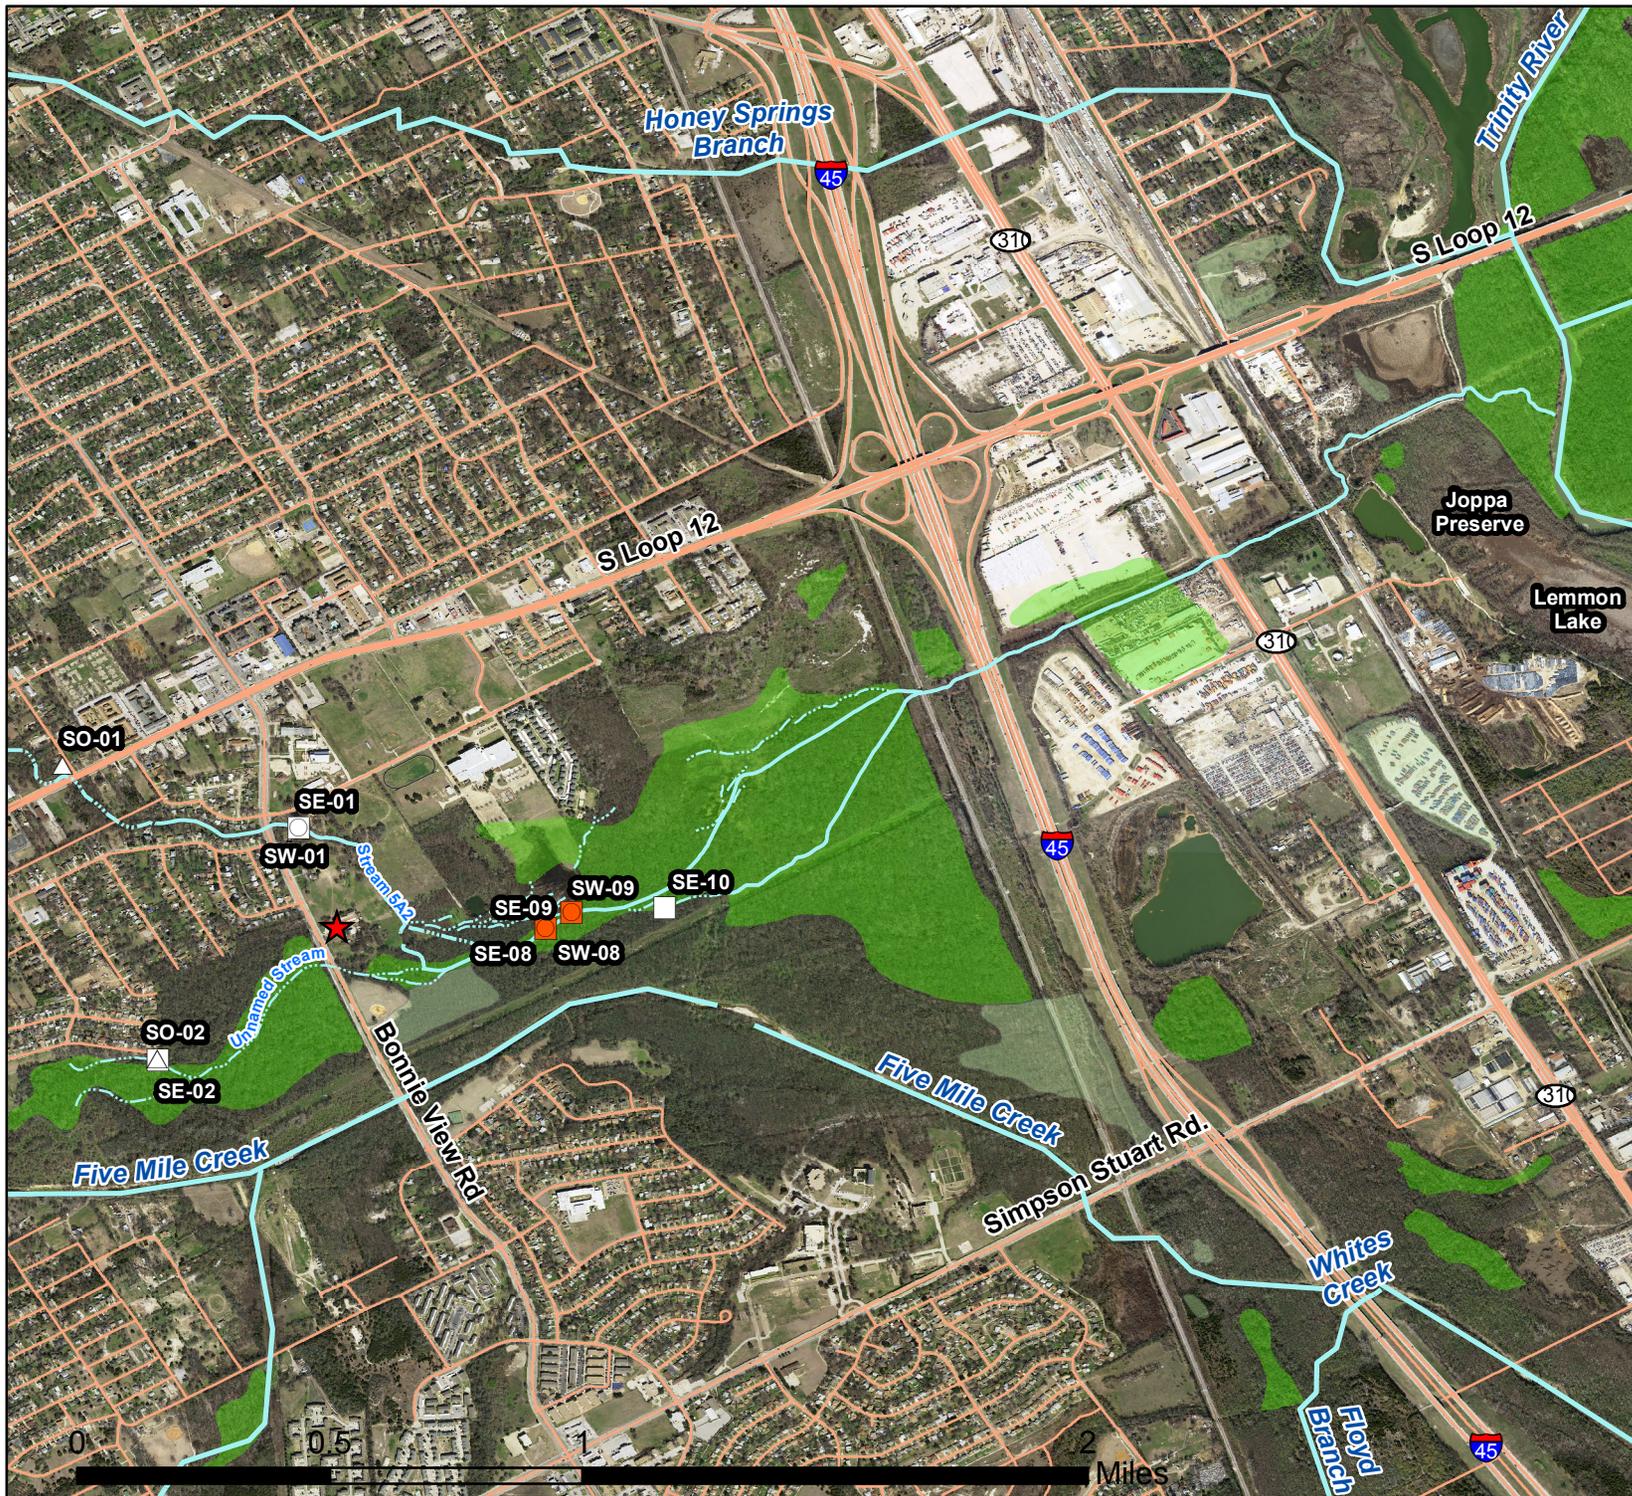
FIGURE 4: SURFACE WATER PATHWAY SAMPLE LOCATIONS MAP

1. The location for SE-10 is approximated by digital map interpolation due to GPS instrument failure in the field.
