B. The Historic Preservation Program and Staff Recommendations

PRESERVATION BRIEFS

3 Improving Energy Efficiency in Historic Buildings

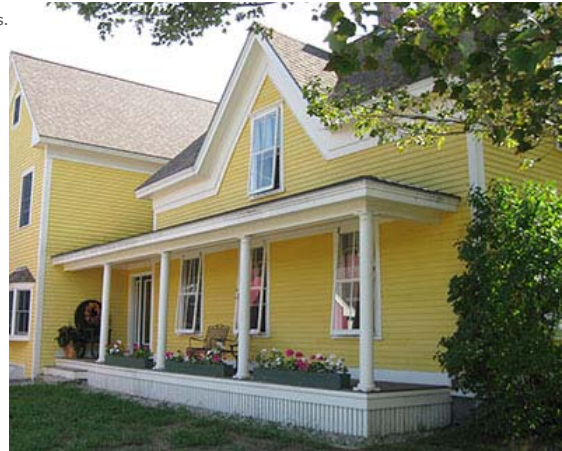
Farmhouse with energy efficient storm windows.

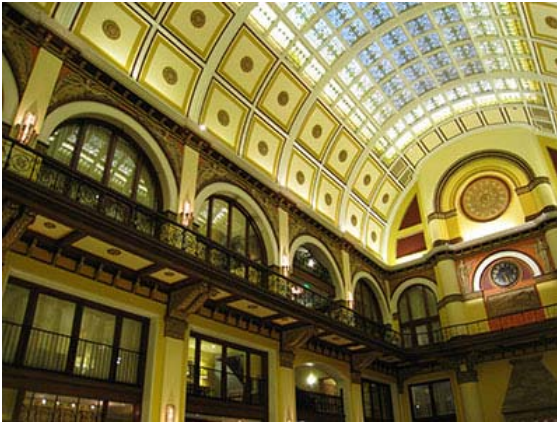
Figure 1. A decorative, stained glass skylight allows natural daylight into the interior.

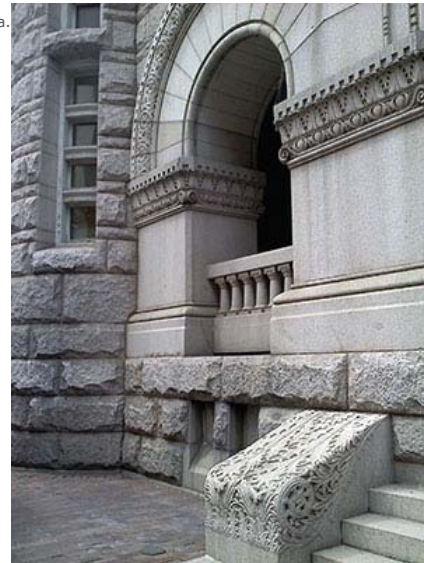
Figure 3. Stone walls with substantial mass have high thermal inertia.

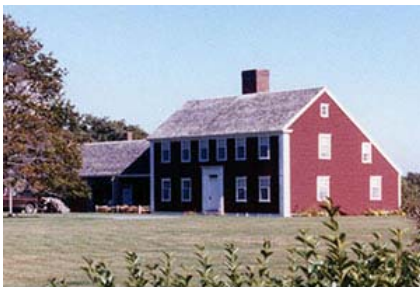
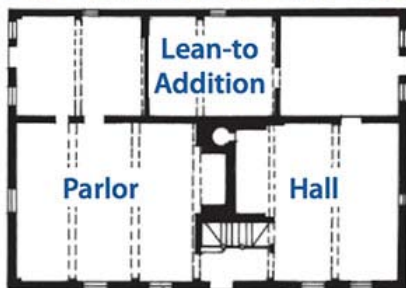
Figure 4. A typical New England saltbox features a steeply sloping roof to shed snow and a floor plan organized around a central chimney to conserve heat.

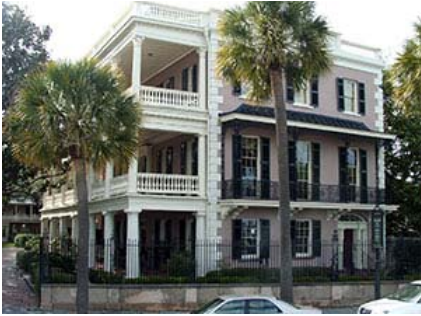
Figure 5. The side porches of this house in Charleston, SC, shade the large windows and provide outdoor living spaces that take advantage of sea breezes.

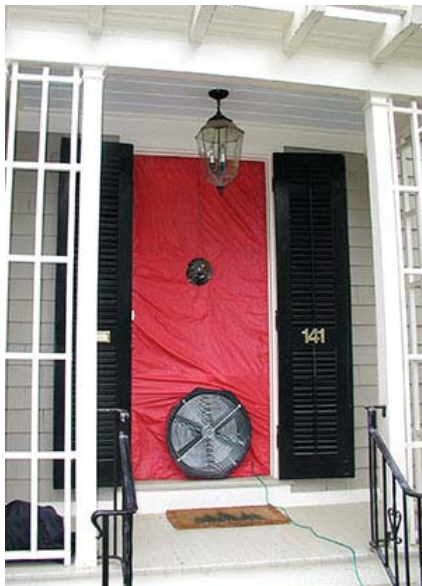
Figure 6. A blower door is used to depressurize a building by exhausting air at a rate that allows pressure gages and tracer smoke to measure the amount and location of air leakage. Photo: Robert Cagnetta, Heritage Restoration, Inc.

Tools such as a blower door test or infrared thermography are useful to identify specific areas of infiltration, lack of insulation and thermal bridging. Mechanical depressurization along with infrared thermography is extremely useful in identifying locations of air leakage and heat loss followed by the use of tracer smoke to isolate specific air leaks. These tests are often challenging to perform on buildings and must be undertaken by experienced professionals to avoid misleading or inaccurate results. There are professional standards for audits, those of the Building Performance Institute (BPI) being the most widely used.

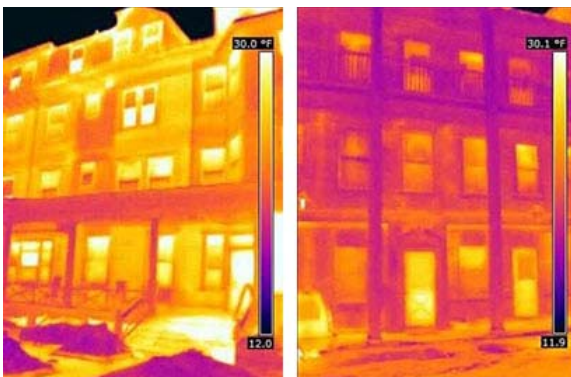
Figure 7. The left thermal image shows the walls of this building before insulating. After insulation was added, the cooler and, thus darker exterior walls evidence how much the heat loss has been reduced. Photos: EYP Architecture & Engineering.

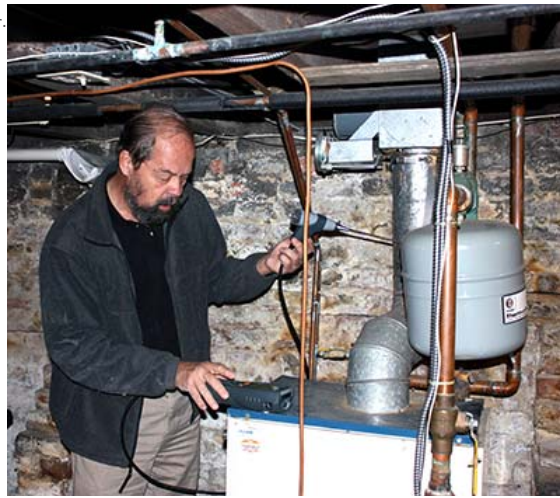
Figure 9. An energy auditor tests the efficiency of a boiler.

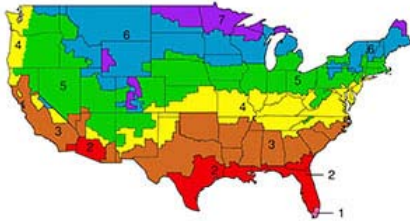
Figure 12. DOE Climate Zone Map Recommended energy improvements vary widely based on climate. The information contained in this document is based primarily on the available data for the Northeast and Mid-Atlantic regions.

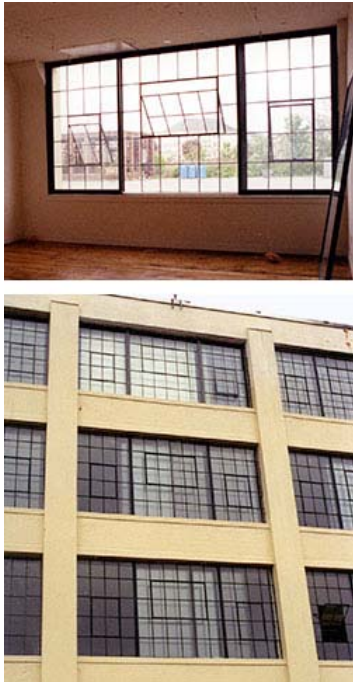
Figure 15. Original steel windows were retained and made operable during the rehabilitation of this historic mill complex. Insulated sliding windows were added on the interior to improve energy efficiency.

For large, steel industrial windows, the addition of interior, insulated sliding glass windows that align with the primary vertical mullions has proven to be a successful treatment that allows the primary window to remain operable.

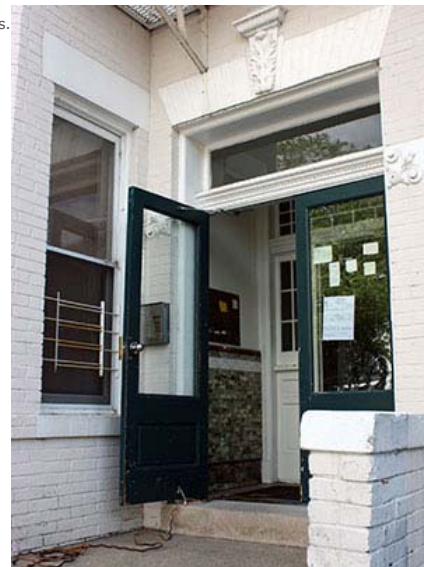
Figure 16. Historic vestibules retain conditioned air in the living spaces.

Vestibules that create a secondary air space or “air lock” are effective in reducing air infiltration when the exterior door is open. Exterior and interior vestibules are common architectural features of many historic buildings and should be retained wherever they exist. Adding an interior vestibule may also be appropriate in some historic buildings. For example, new glazed

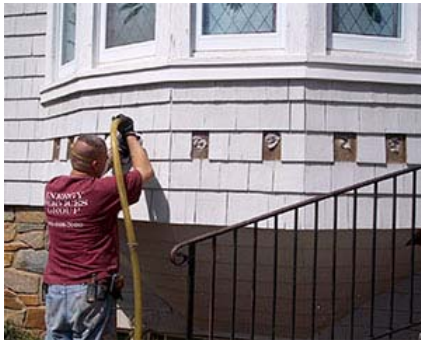
Figure 18. Dense-packed cellulose insulation is being blown in through holes drilled in the sheathing. Once the operation has been completed, the shingles will be reinstalled. Photo: Edward Minch.

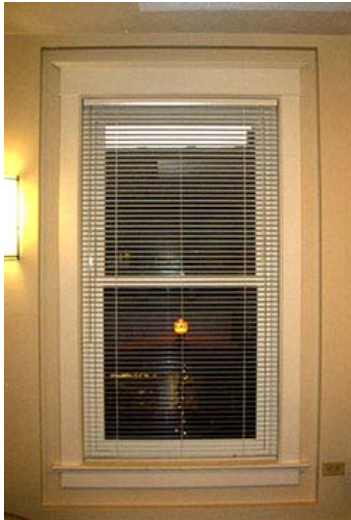
Figure 20. The walls have been furred out inappropriately around the historic window trim creating an appearance the interior never had historically.

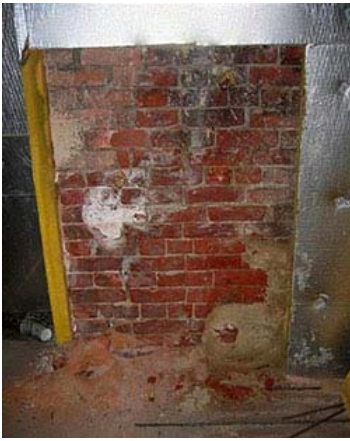
Figure 21. The interior face of a brick masonry wall shows damage that resulted from the installation of a vapor retardant (foil facing) and thermal insulation. Photo: Simpson Gumpertz & Heger.

Depending on the type of masonry, exterior masonry walls can absorb a significant amount of water when it rains. Masonry walls dry both toward the exterior and the interior. When insulation is added to the interior side of a masonry wall, the insulation material reduces the drying rate of the wall toward the interior, causing the wall to stay wet for longer periods of time. Depending on the local climate, this could result in damage to the historic masonry, damage to interior finishes, and deterioration of wood or steel structural components imbedded in the wall. Masonry walls of buildings that are heated during the winter benefit from the transfer of heat from the inside to the outside face of the walls. This thermal transfer protects the exterior face of the wall by reducing the possibility of water freezing in the outer layers of the wall, particularly in cold and wet climates. The addition of insulation on the interior of the wall not only prolongs the drying rate of the exterior masonry wall, but keeps it colder as well, thereby increasing the potential for damage due to freeze-thaw cycles.⁶

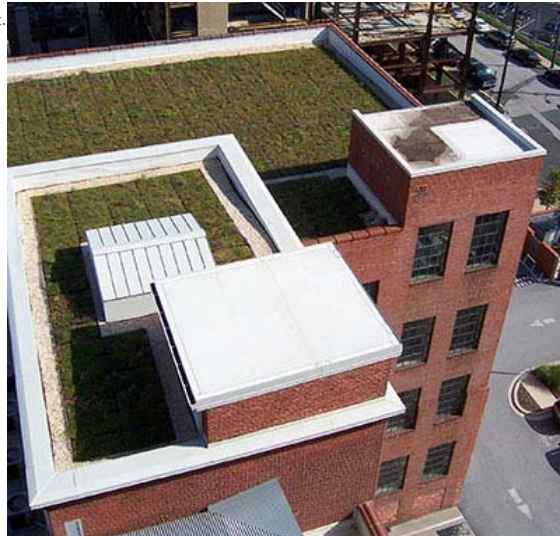
Figure 22. Installation of both cool and green roofs in an urban environment.

Install cool roofs and green roofs: Cool roofs and vegetated “green roofs” help to reduce the heat gain from the roof, thereby cooling the building and its environment. Cool roofs include reflective metal roofs, light-colored or white roofs, and fiberglass shingles that have a coating of reflective crystals. All of these roofing materials reflect the sun’s radiation away from the building, which lessens heat gain, resulting in a reduction of the cooling load. Cool roofs are generally not practical in northern climates where buildings benefit from the added heat gain of a dark-colored roof during colder months. Cool and green roofs are appropriate for use on historic buildings only when they are compatible with their architectural character, such as flat roofs with no visibility. A white-colored roof that is readily visible is not appropriate for historic metal roofs that were traditionally painted a dark color, such as green or iron oxide red. A white reflective roof is most suitable on flat roofed historic buildings. If a historic building has a slate roof, for example, removing the slate to install a metal roof is not a compatible treatment. It is never appropriate to remove a historic roof if the material is in good or repairable condition to install a cool roof. However, if the roof has previously been changed to an asphalt shingle roof, fiberglass shingles with special reflective granules may be an appropriate replacement.

A green roof consists of a thin layer of vegetation planted over a waterproofing system or in trays installed on top of an existing flat or slightly sloped roof. Green roofs are primarily beneficial in urban contexts to reduce the heat island effect in cities and to control storm water run-off. A green roof also reduces the cooling load of the building and helps cool the surrounding urban environment, filters air, collects and filters storm water, and can provide urban amenities, including vegetable gardens, for building occupants. The impact of increased structural loads, added moisture, and potential for leaks must be considered before installing a green roof. A green roof is compatible on a historic building only if the plantings are not visible above the roofline as seen from below.

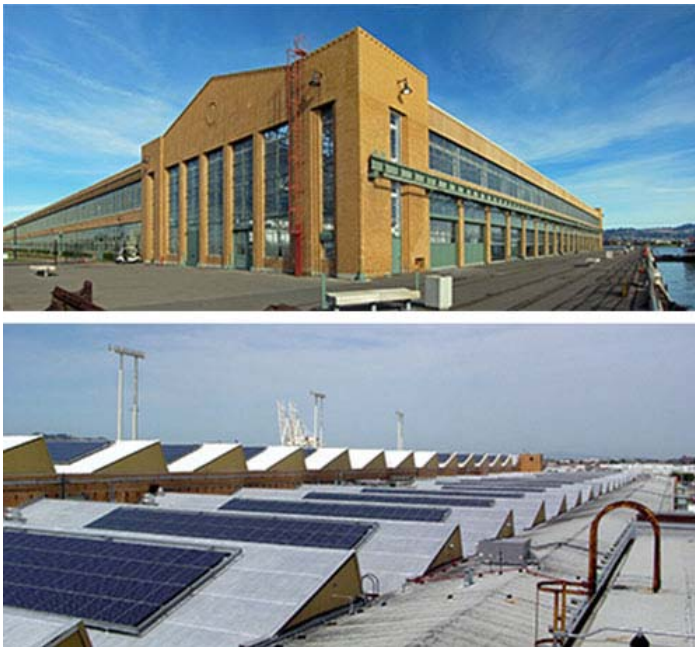
Figure 23. Solar collectors installed in a compatible manner on low sloping sawtooth monitors. Top Photo: Neil Mishalov, Berkeley, CA.

Solar Energy: Man has sought to harness the power of solar energy to heat, cool, and illuminate buildings throughout history. Construction techniques and design strategies that utilize building materials and components to collect, store, and release heat from the sun are described as “passive solar design.” As previously discussed, many historic buildings include passive solar features that should be retained and may be enhanced. Compatible additions to historic buildings also offer opportunities to incorporate passive solar features. Active solar devices, such as solar heat collectors and photovoltaic systems, can be added to historic buildings to decrease reliance on grid-source fossil-fuel powered electricity. Incorporating active solar devices in existing buildings is becoming more common as solar collector technology advances. Adding this technology to historic buildings, however, must be done in a manner that has a minimal impact on historic roofing materials and preserves their character by placing them in locations with limited or no visibility, i.e., on flat roofs at a low angle or on a secondary roof slope.
