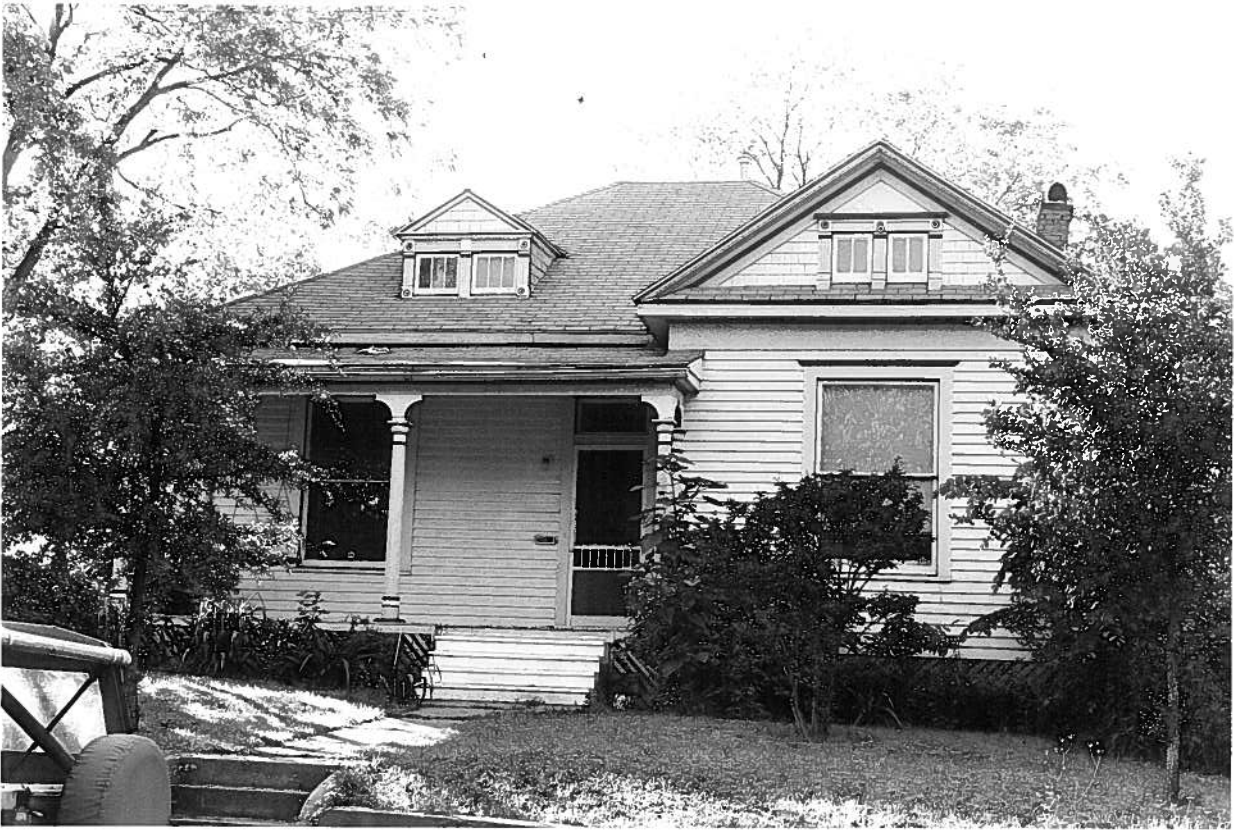
No. 51 - 2715 Hibernia

Approx. 1890-1900;

Description: Late Victorian planbook, steep hip roof with projecting gable for front room, single pane windows, gable dormer, bullseye trim on gable windows, turned porch posts with simple brackets, transom over front door, simple wide board trim, cornice window heads.

Condition: Excellent - recently restored.

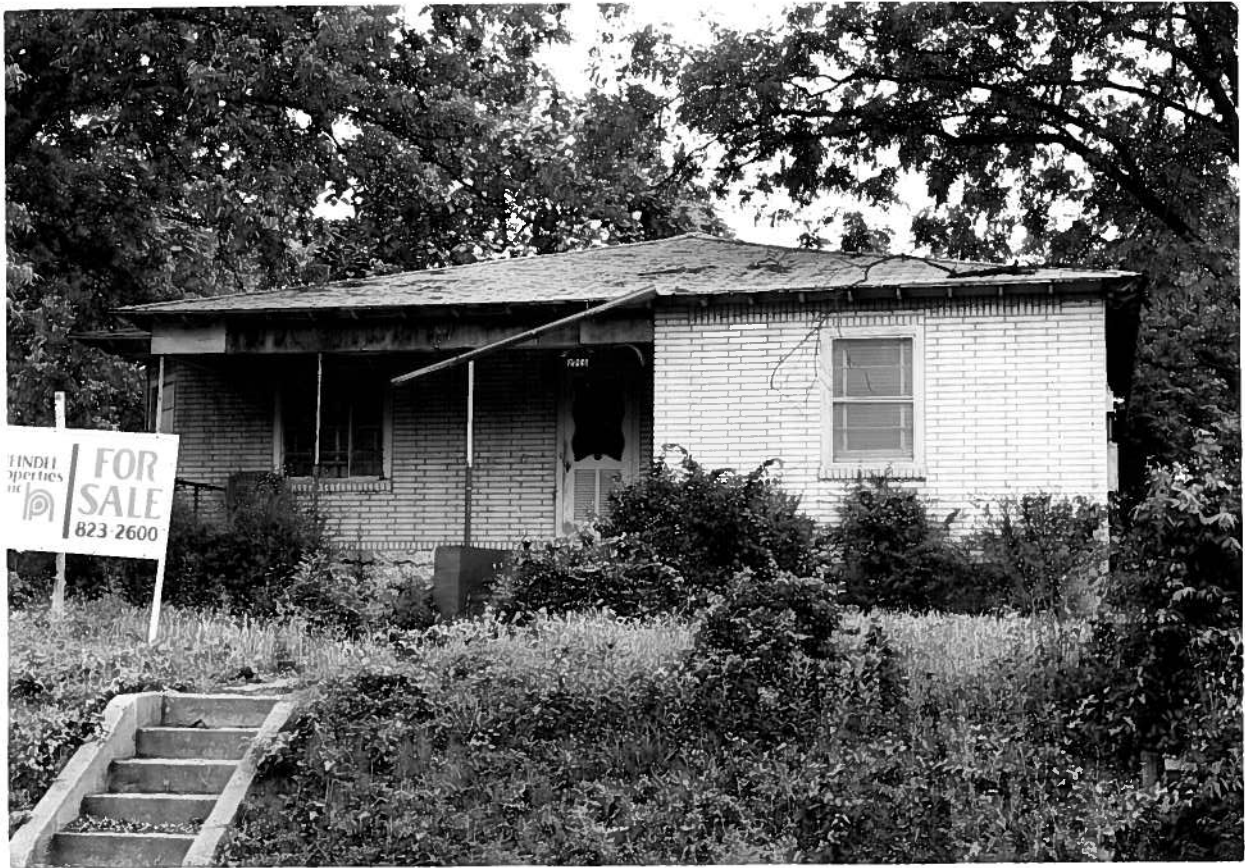
No. 52 - 2711 Hibernia

Approx. 1930 or 1940;

Description: out size bricks, pyramid roof, possibly older house with newer brick, inset porch pipe posts, concrete porch, new windows, exposed rafter ends, deep porch cornice.

Condition: Poor - fair.

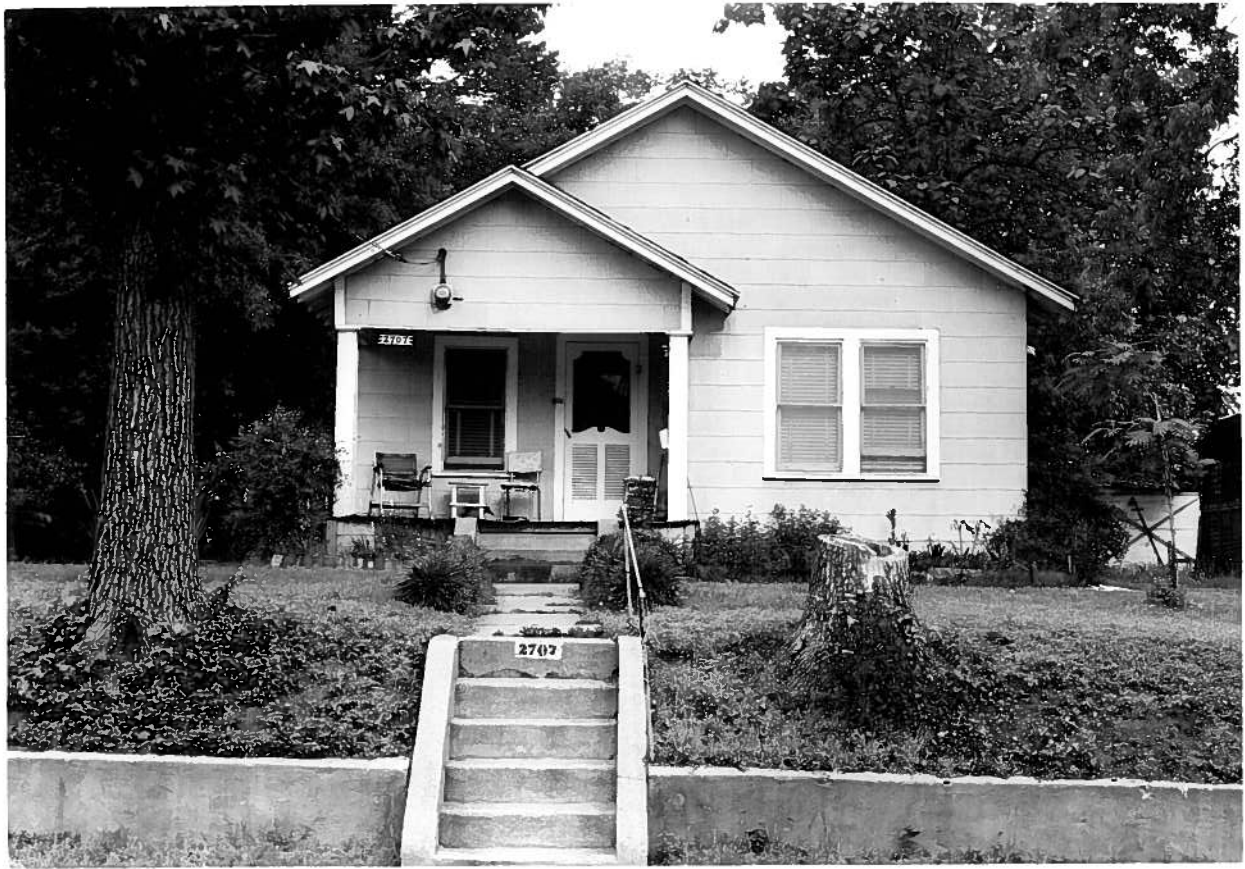
No. 53 - 2707 Hibernia

Approx. 1915-25;

Description: Planbook, gable roof, smaller gable porch roof extending from main roof, exposed rafter ends, 1/1 windows, paired front windows, heavy square porch posts, original wood porch.

Condition: Good - new siding.

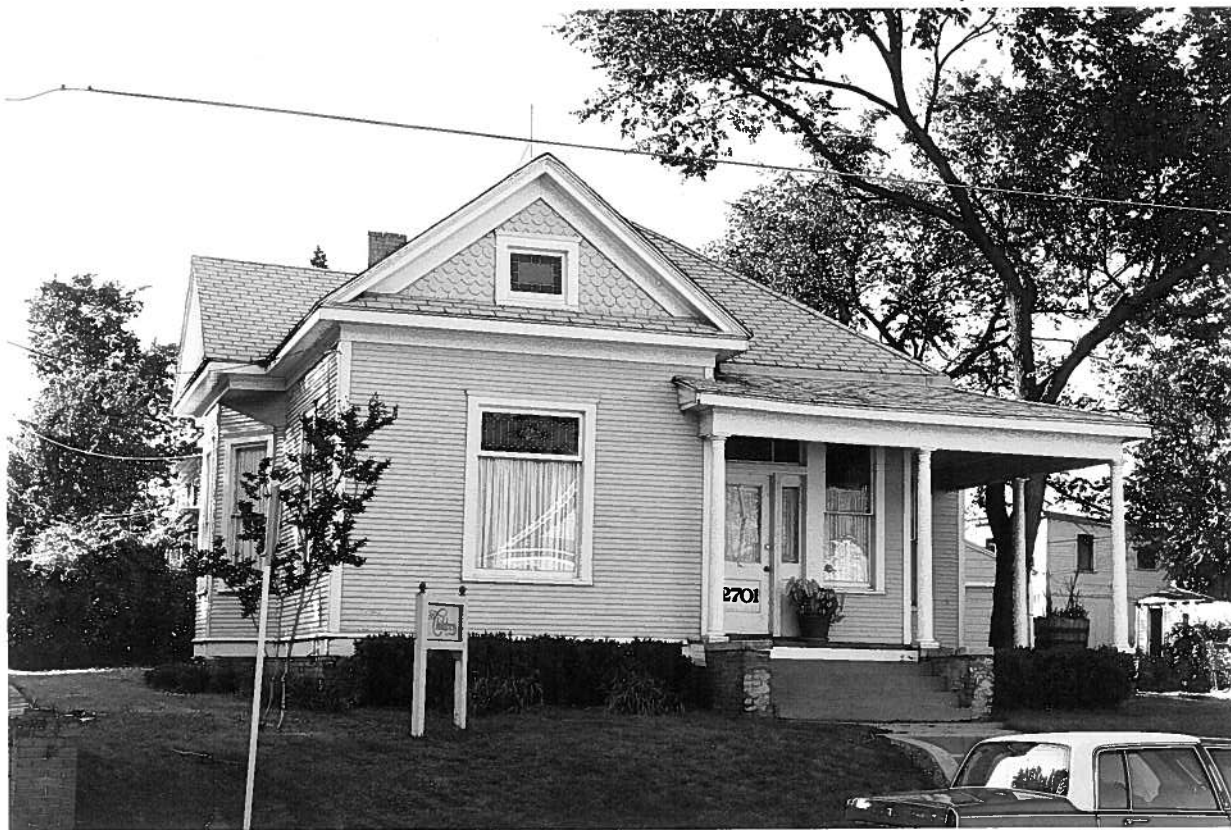
No. 54 - 2701 Hibernia

Approx. 1890-1900

Description: Late Victorian planbook, combination hip and gable roof, inset 'L' shape porch, Doric porch columns, transom, side and corner lights, cornice window heads, boxed eaves, diamond shingles in gable end.

Condition: Excellent - restored.

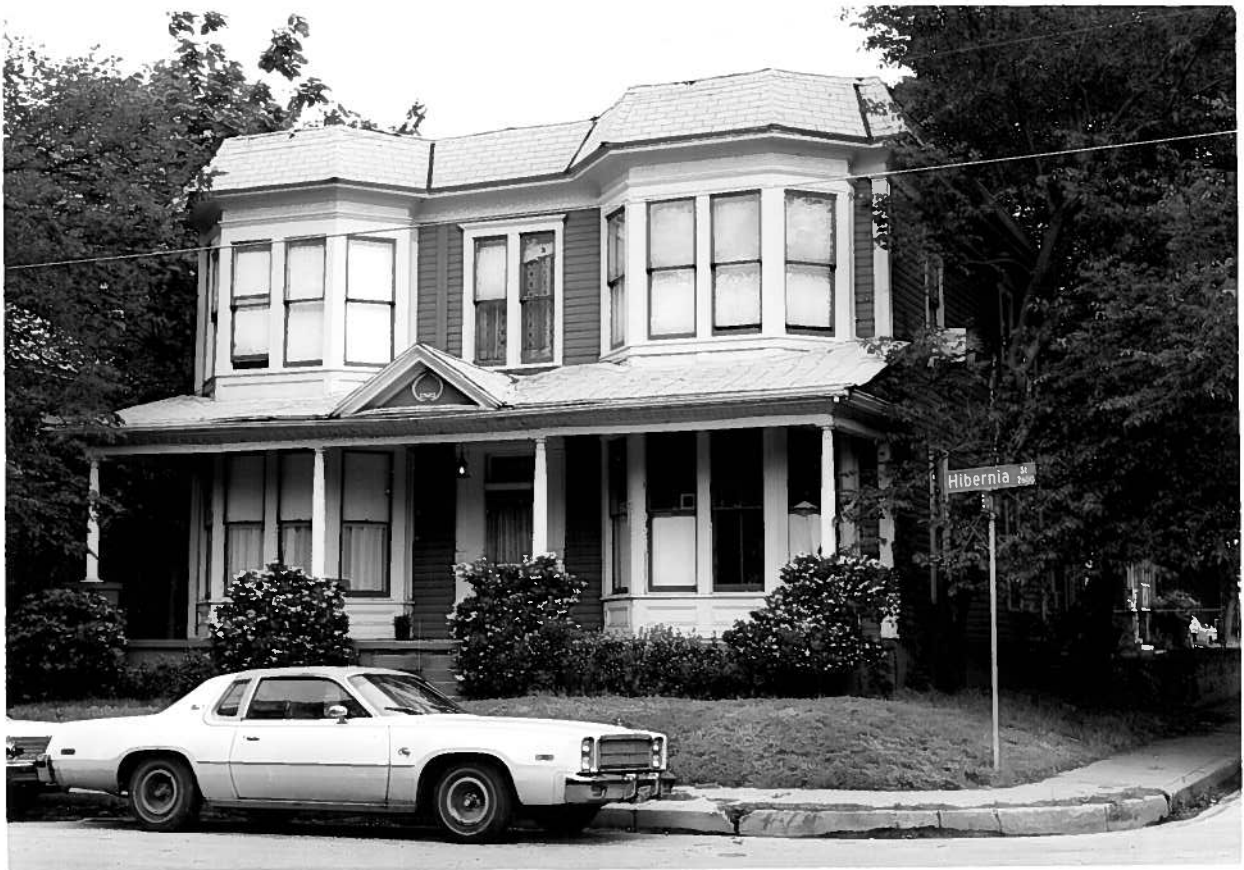
No. 55 - 2619 Hibernia

Approx. 1885-90;

Description: Second Empire, 2 story, twin pavilions, central door with transom, mansard roof, shed porch roof with small pediment on center, paired windows on 2nd floor, 1/1 windows, Doric columns, deep cornice, brick piers under columns, lap siding.

Condition: Excellent. Only one in area.

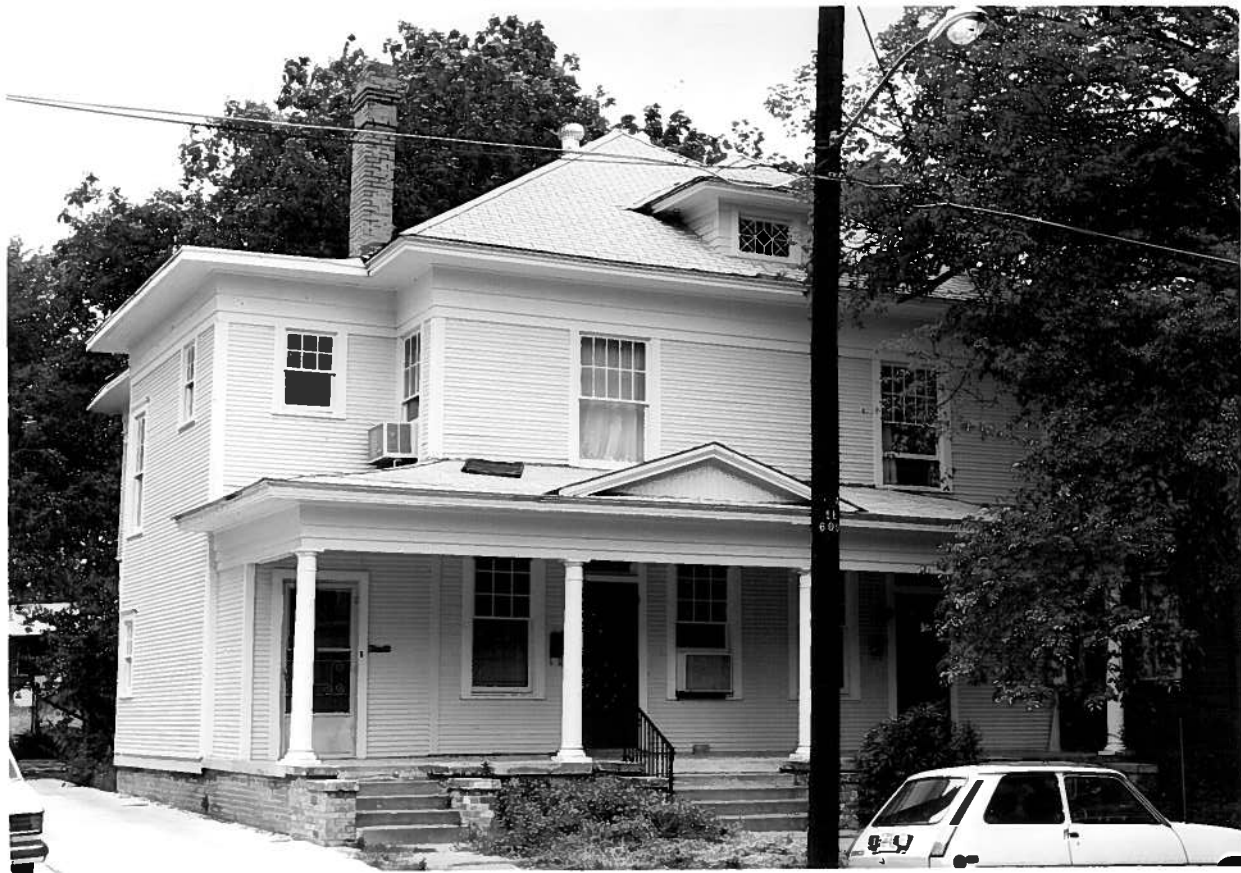
No. 56 - 2615 Hibernia

Approx. 1910-15;

Description: Craftsman - 1 of 3 in row on street, 2 story, central hip roof, hip dormer, hip porch roof with pediment on center, 6/1, 10/1, 9/1 windows, 3 front doors - 2 with transoms, interior chimney, Doric columns, deep layered cornices, wide door and window trim, brick foundation.

Condition: Excellent.

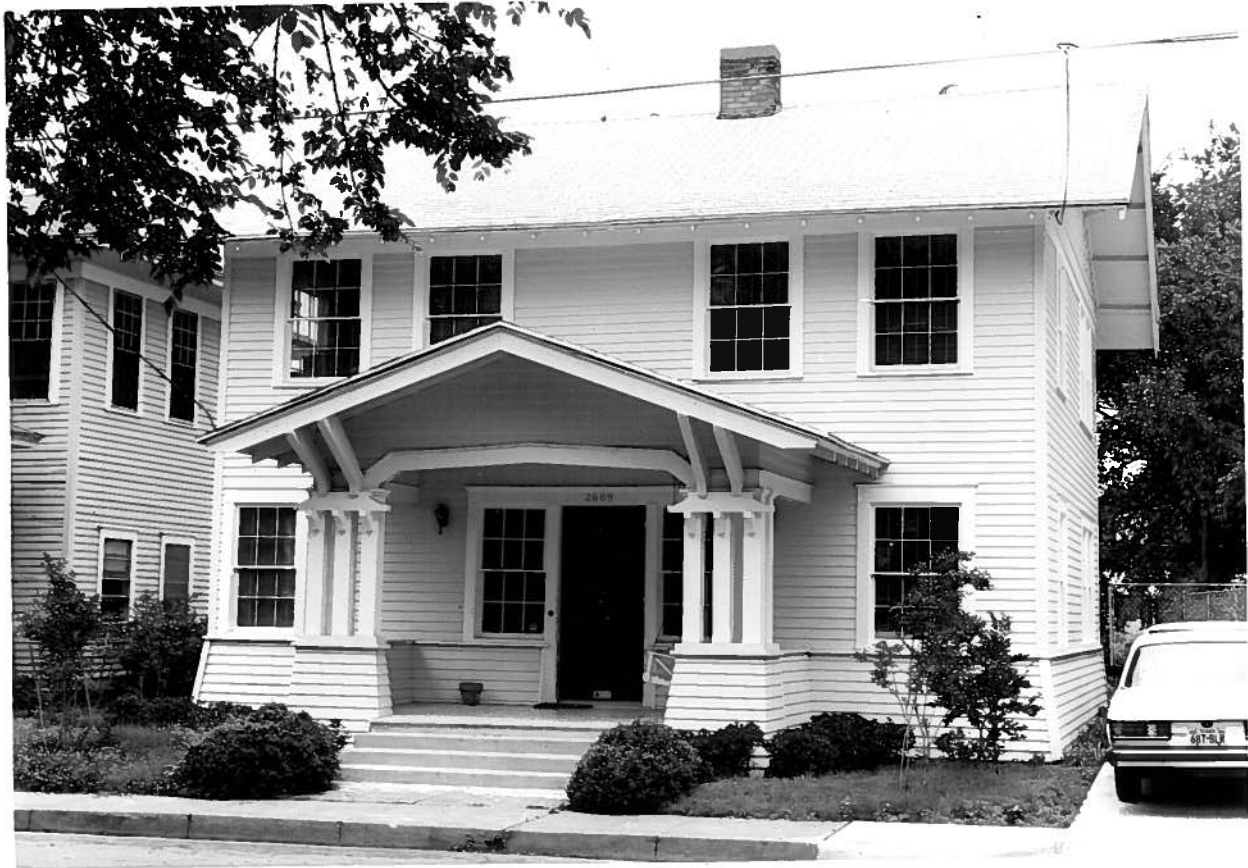
No. 57 - 2609 Hibernia

Approx. 1910-1915;

Description: Craftsman style, gable roof, interior chimney - just off center, flared base, battered porch pier wall, 2 story, wide door and window trim, 6/6 windows, heavy square porch posts and brackets, gable porch roof with trimmed soffit, projecting eaves.

Condition: Excellent - restored.

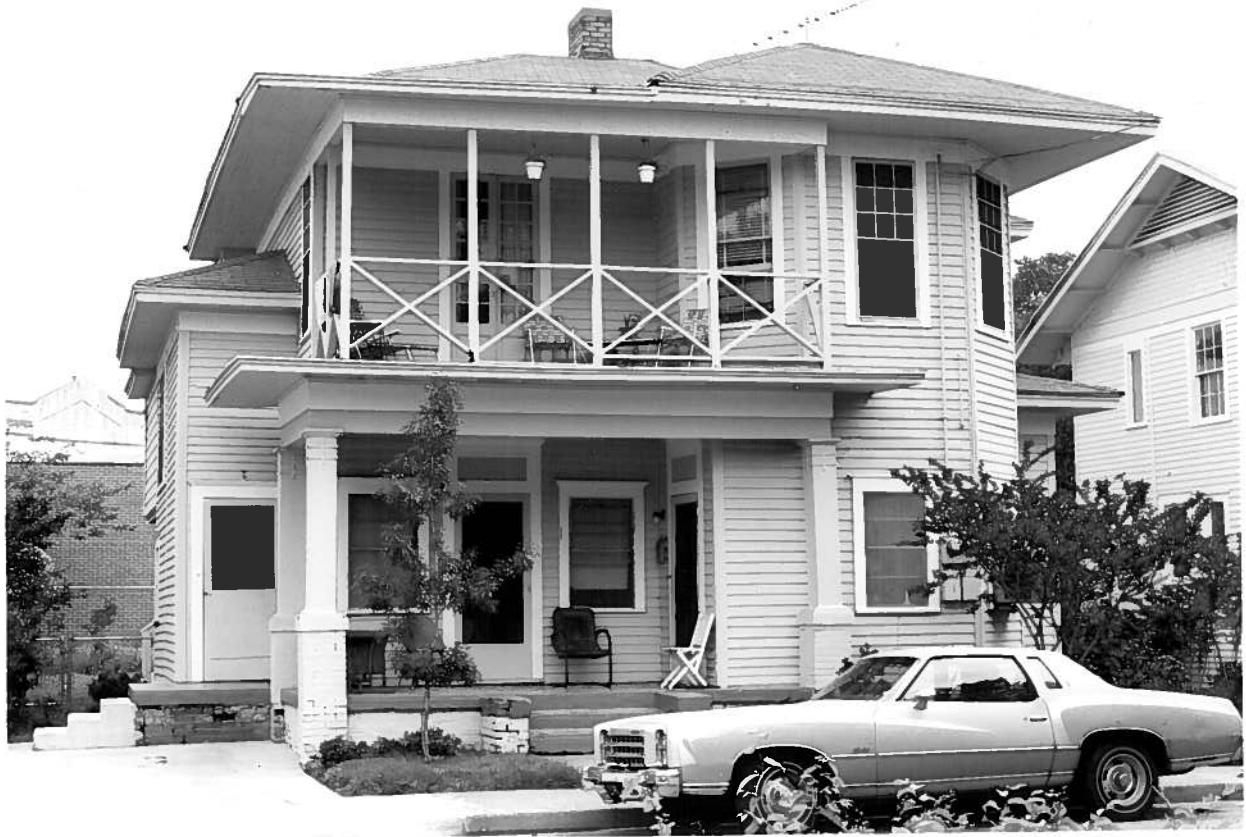
No. 58 - 2605 Hibernia

Approx. 1900-1910;

Description: Main hip roof, bay pavilion central chimney brick, half porch columns with heavy square porch posts, 2 front doors with transoms, 6/6, 9/1 and 1/1 windows, boxed and extended eaves.

Condition: Excellent - restored.

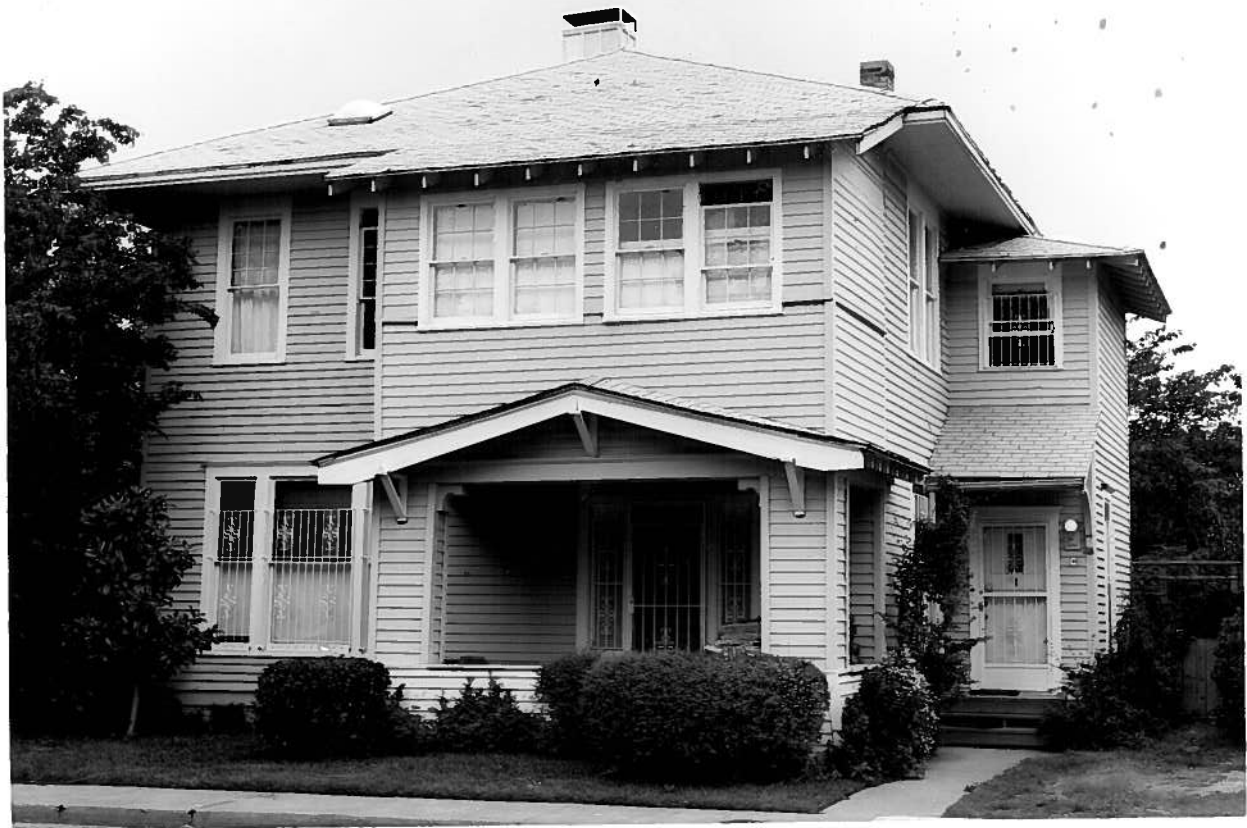
No. 59 - 2601 Hibernia

Approx. 1900-1910;

Description: Main pyramidal roof, inset front porch, gable porch roof extension, 1/1, 12/1, and 6/1 windows, exposed rafter ends, extended eaves, rear chimney.

Condition: Excellent - restored.

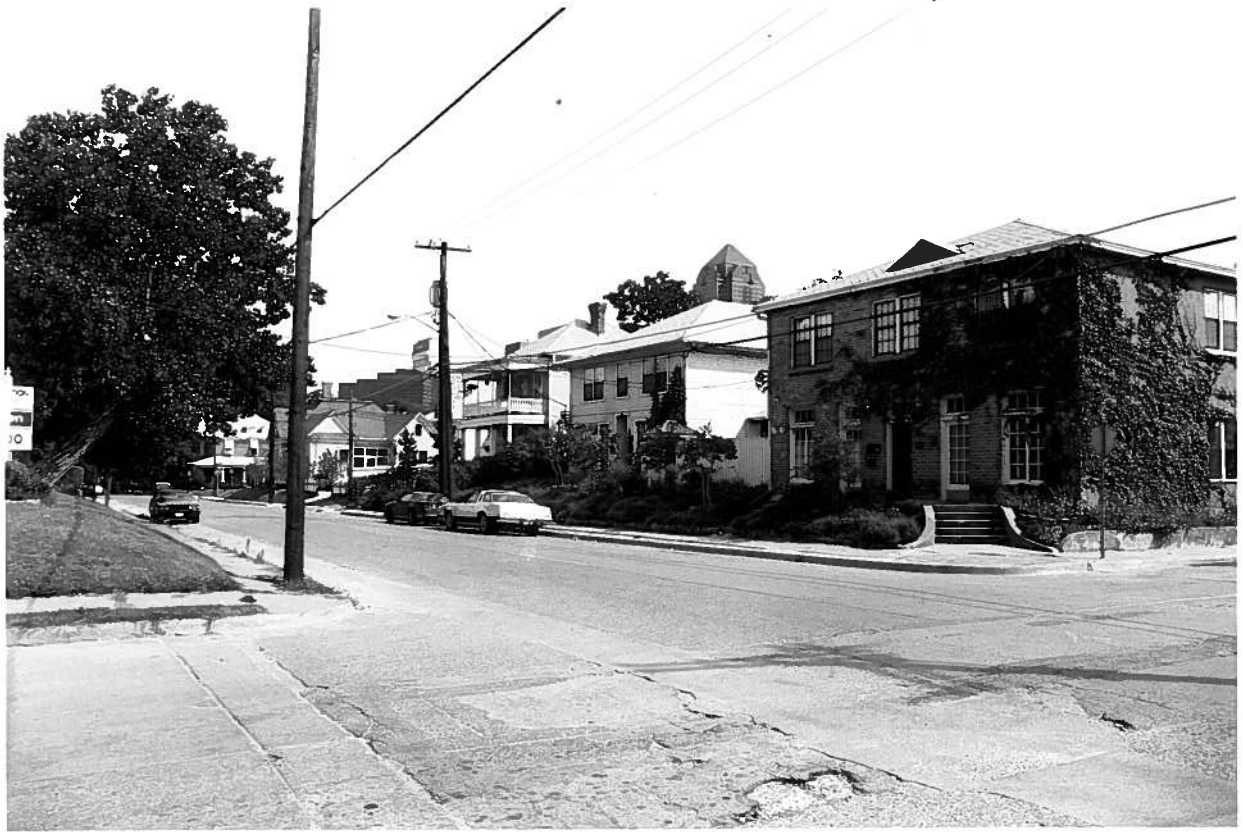
No. 60 - Routh Street

View: Interior of district; facing south on Routh Street at west corner of State Street; building in center background is nearby downtown skyline.
