Lane Plating Works

City of Dallas Community Meeting
April 17, 2017

U.S. EPA Region 6

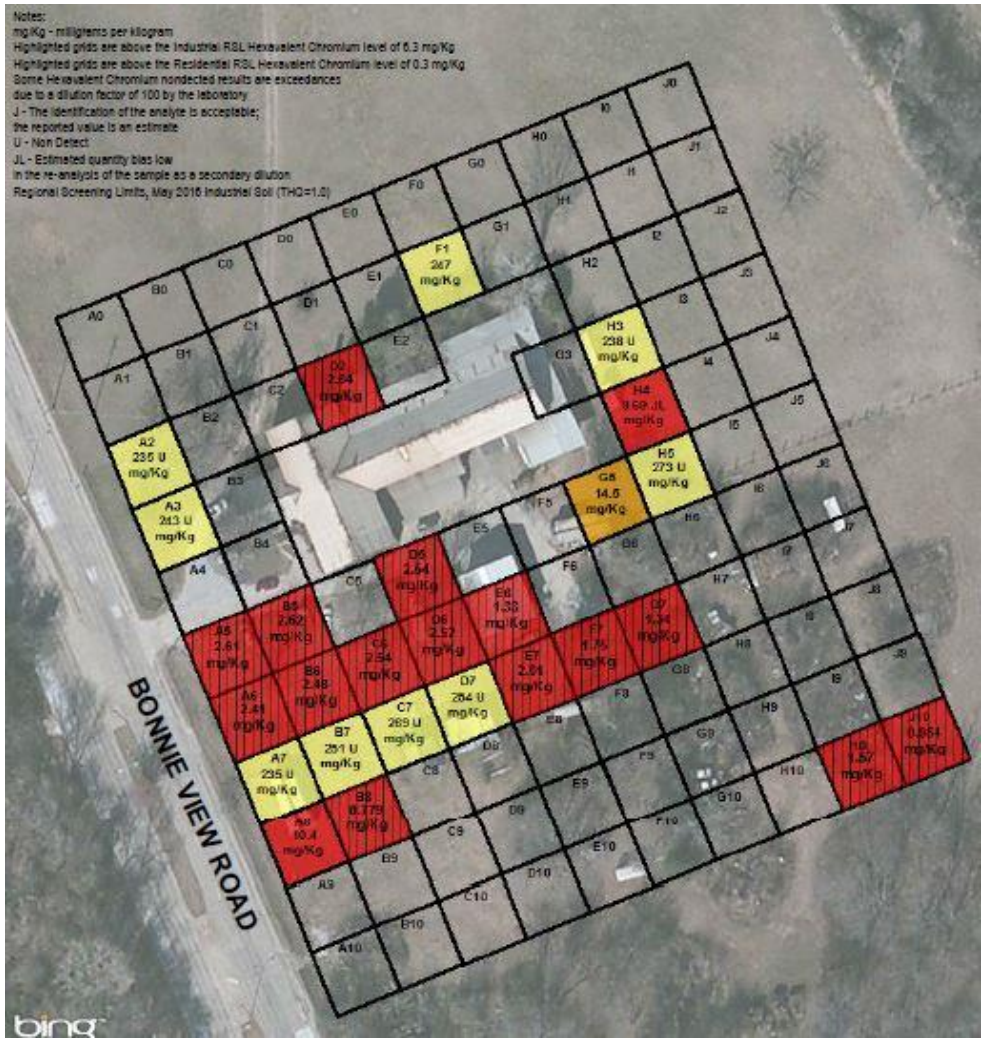
Soil Sampling – Hex Chrome

- Sample results
  - Liquid wastes are characteristically hazardous
  - Soils are contaminated predominantly with hex chrome, lead, and mercury above EPA Risk Screening Levels (RSLs)
