JLL Valuation Advisory Property Condition Assessment

Property: 7800 Ricchi Tower - 7800 North Stemmons Freeway, Dallas, Texas 75247

Report Date: July 21, 2022

JLL VA # VA-22-187206

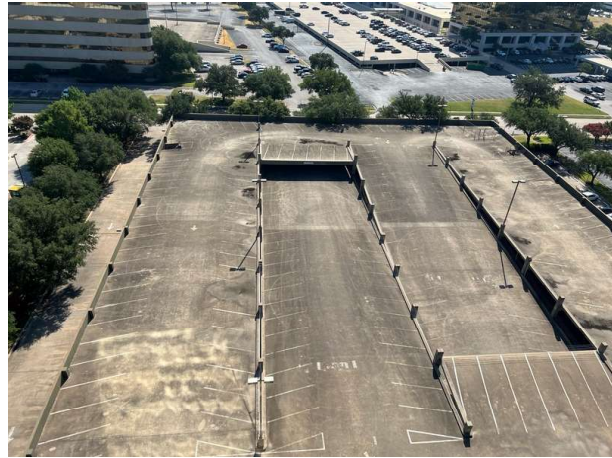
Overall view of parking garage

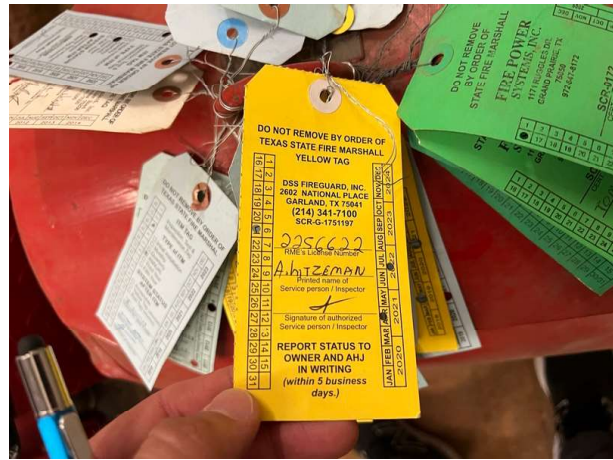
Yellow tags at fire sprinkler system

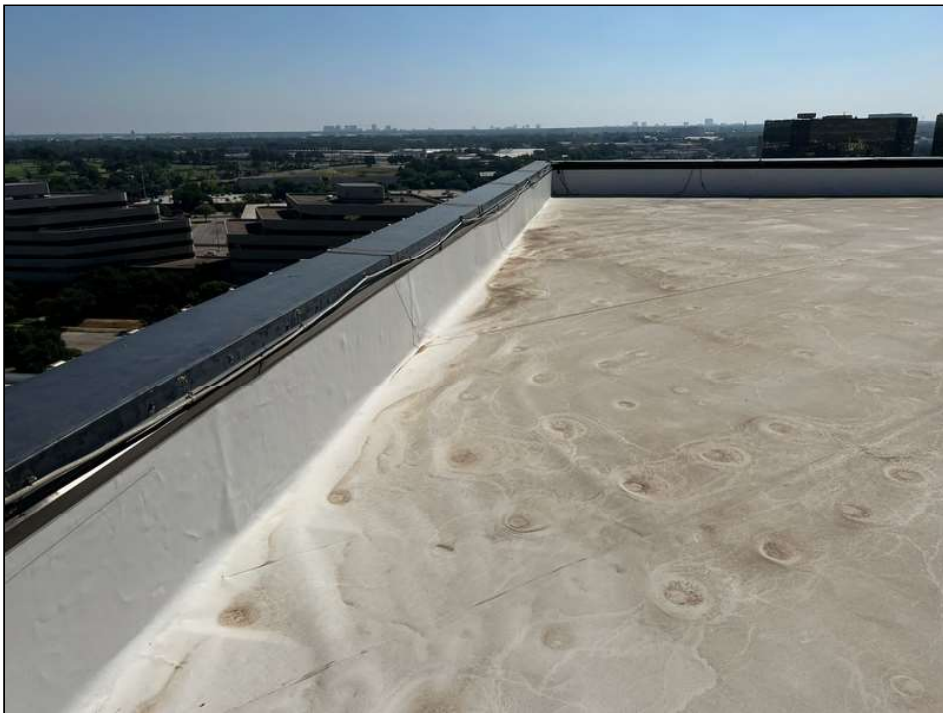
16. Roof parapet and membrane condition

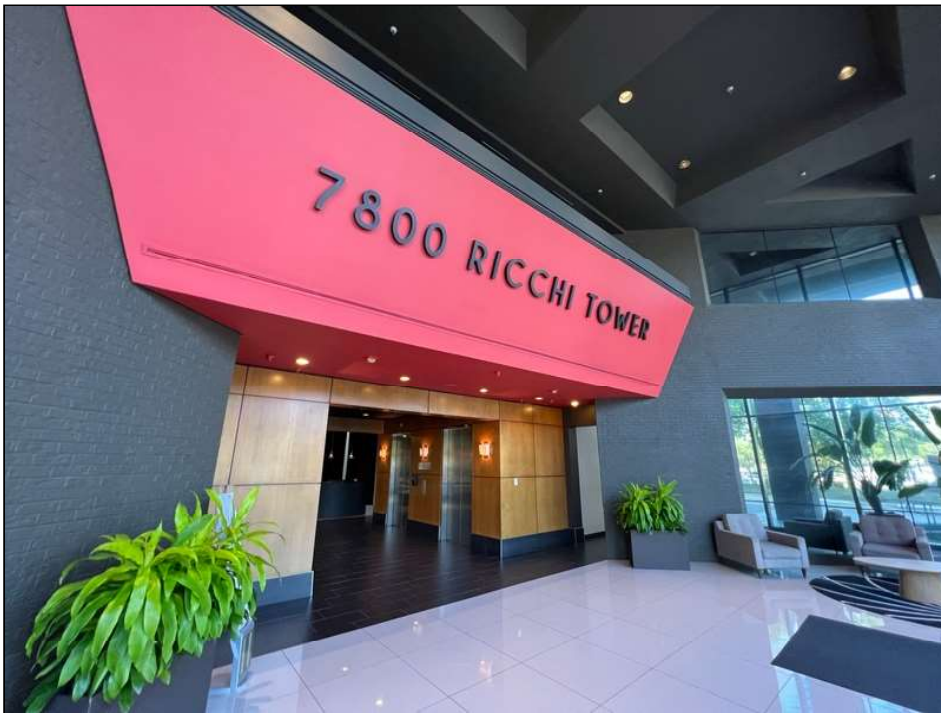
76. Lobby interior finishes

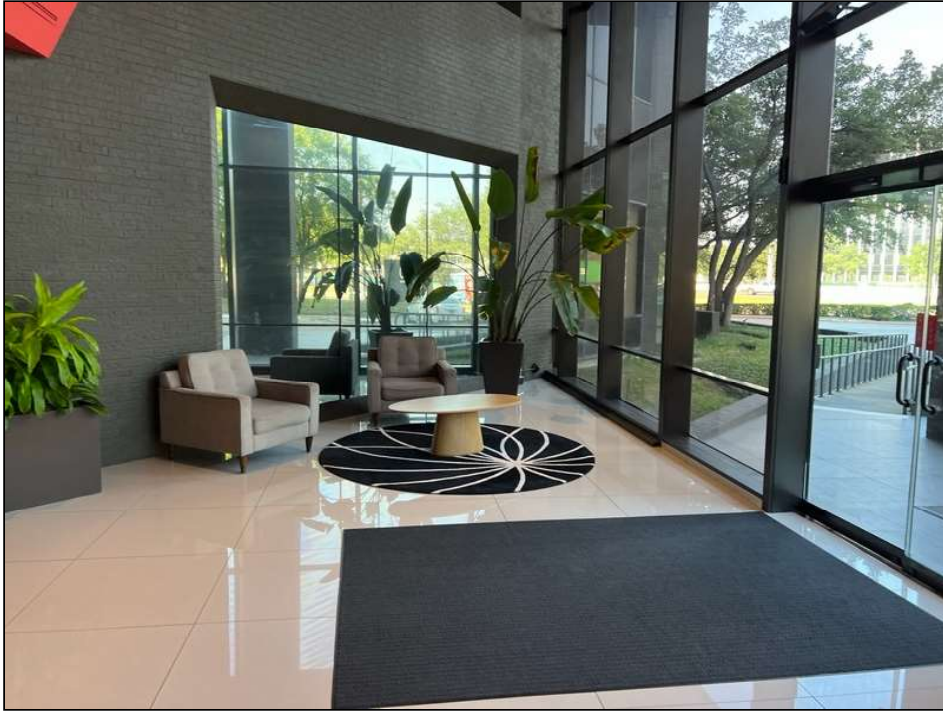
77. Lobby interior finishes

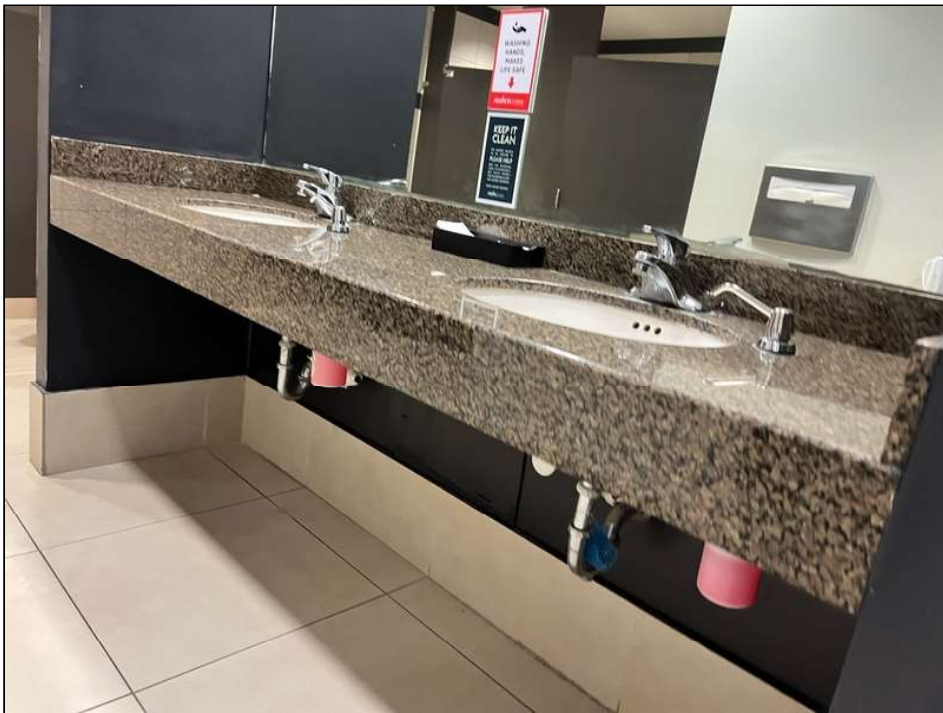
88. Sink pipe protection is needed
