Re: 338 S Fleming Ave, Dallas, TX 75203 (Tenth Street Historic District)

## **BRIEF IN OPPOSITION TO THE LANDMARK COMMISSION'S DECISION**

Project Name: Visual Foundation Evaluation Report

**General Structural Initial Foundation Inspection**

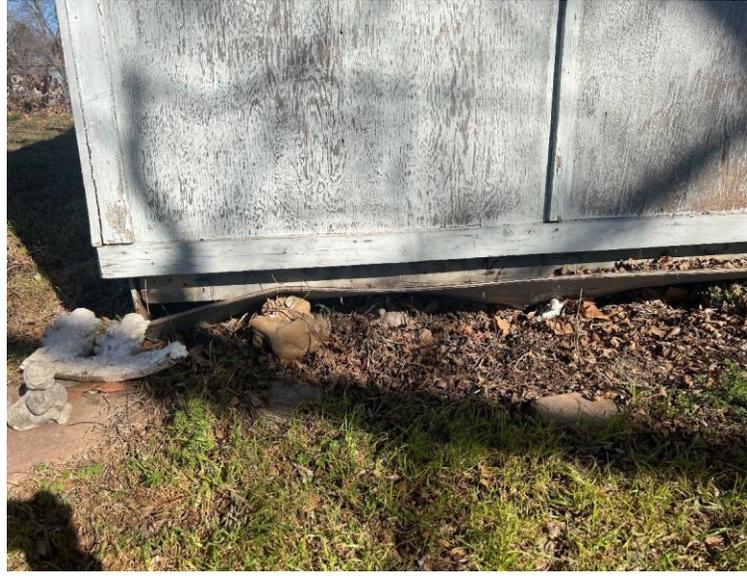
6593

The house is a "1-story" wood siding structure converted into residence with perimeter and interior piers and wood beam type foundation (see pic 6593). The structure appears to have collapsed. Most of the structure is sitting directly on the ground (see pics 6596, 6610 and 6612). Crawl space was not accessible, and any visible members of the foundation were rotten (see pics 6598, 6599 and 6602). None of foundation members are salvageable. The siding, walls and ceiling are in deteriorating condition and contain visible cracks. The walls are made/covered by siding, plywood, and sheet metal (see pics 6603, 6607 and 6608). The walls have large openings to the outside (see pic 6609). Most of the house structural lumber is damaged and not salvageable. Any attempt to lift this structure to repair the foundation might result in total collapse of the building. Our findings are similar to structural report obtained by the owner.

1. A total reconstruction of the foundation will be needed if this building can be raised.
2. There is limited amount of material that could be salvaged.

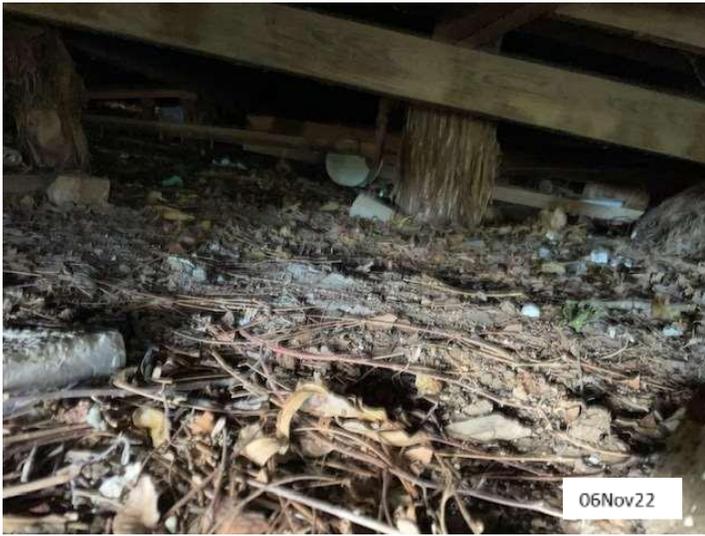
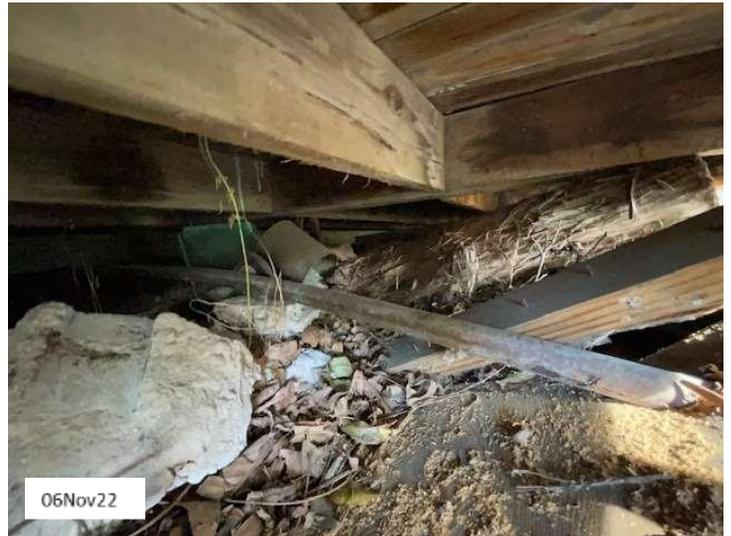
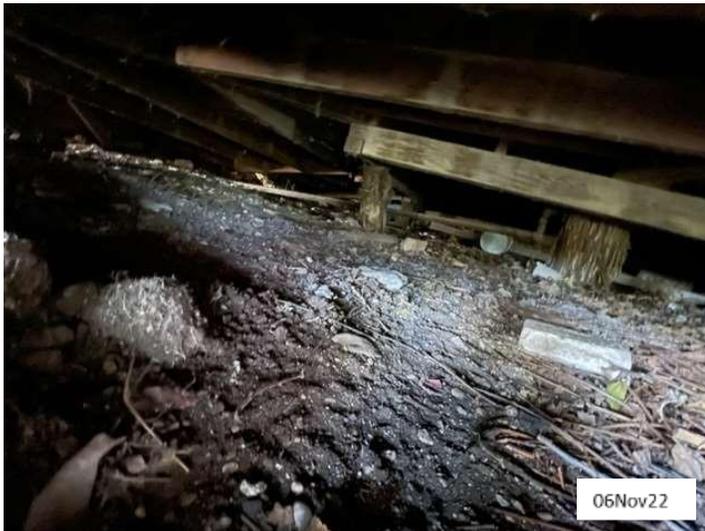
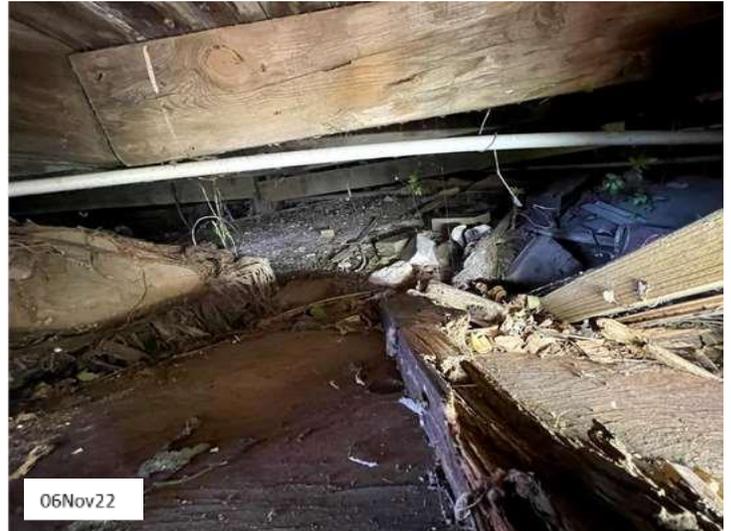
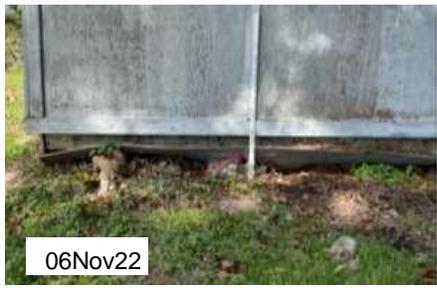
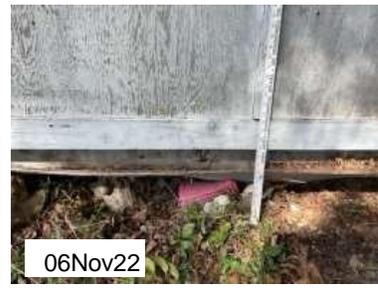
Bois D'arc Foundation Images

The crawl space was not accessible. The structure appears to have collapsed 18" +/- . Most of the structure is sitting directly on the ground. Some area of the crawl space was visible. A lot of the structural members visible were rotten. The piers are wood post/bois d'arc.

The distress noted is attributed to failure of the piers causing the collapse of the structure. The pier failure was caused by neglect and the normal volume change of the soil due to moisture fluctuations. The soil in this area is predominantly clay. Clay soil swells when wet and shrinks when dry. The piers are not salvageable. Approximately 80% of the structure is sitting directly on the ground. The visible structural lumber for the foundation was rotten. It is concluded that most, if not all, of the lumber is damaged and not salvageable. If lifting the structure is attempted, the rotten lumber will crush, therefore, it is concluded the structure will need to be demolished and reconstructed from the ground up. The foundation can't be reconstructed with the structure left in place.

Reconstruct the foundation with reinforced concrete perimeter grade beams and reinforced concrete interior piers.
