West Colorado Blvd at Tyler St/Sylvan Ave

Intersection Improvements

Public Meeting

City of Dallas

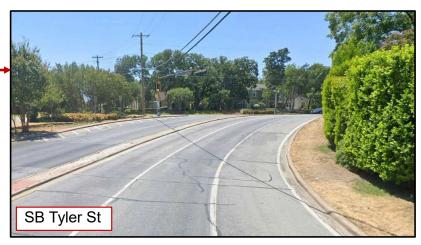
Intersection Visibility

Horizontal curves on northbound and southbound Tyler St lead to poor visibility for vehicles approaching the intersection

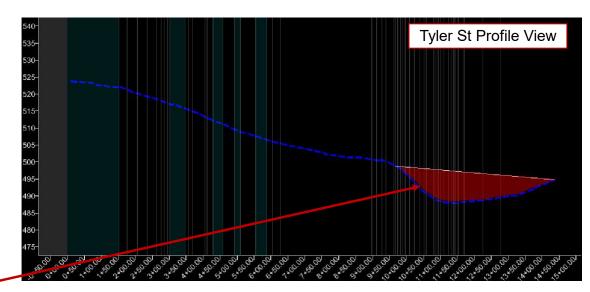
Speeds and Elevation Change

In addition to the poor sight distance, significant elevation change on Tyler St causes vehicles to drive too fast through the intersection, making it difficult for vehicles to remain in the correct lane.

Major elevation dip on SB approach of Tyler St

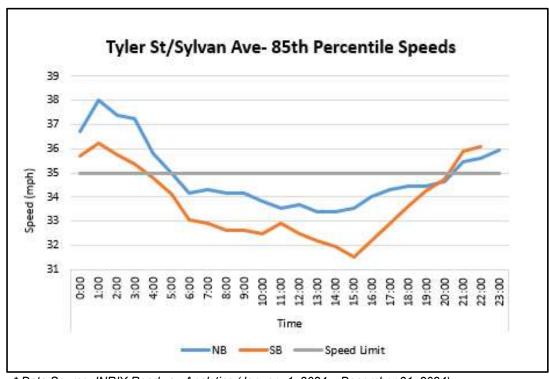
Existing Speeds

Based on existing speed data, vehicles are not consistently traveling over the posted speed limit (35 mph) on Tyler St/Sylvan Ave.

However, as shown in the historical crash data, vehicles do seem to be traveling at a higher speed through the intersection than is conducive for the existing conditions and geometry.

* Data Source: INRIX Roadway Analytics (January 1, 2024 – December 31, 2024)

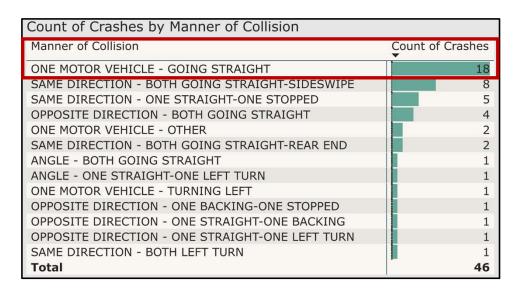
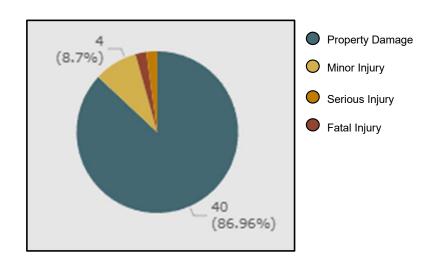
Historical Crash Data

The historical crash data reflects the observed existing safety challenges:

- Poor visibility approaching the intersection and
- Vehicles traveling too fast through the intersection

^{*} Data Source: TxDOT CRIS Database (January 1, 2020 – December 31, 2024)

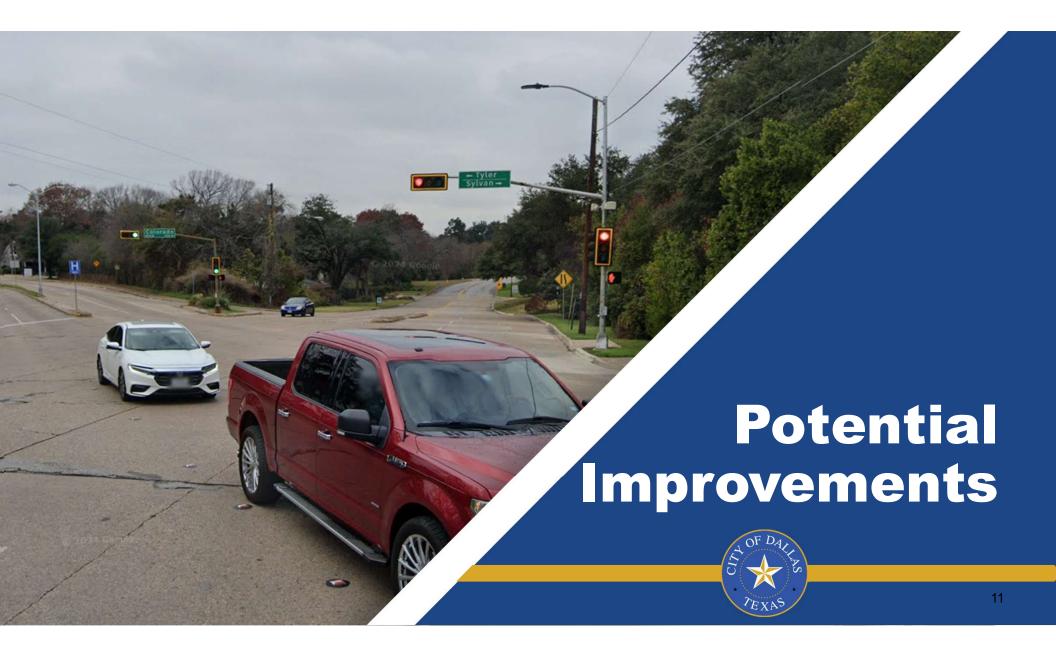
Alternative 1 Intersection Enhancements

- Install advanced overhead warning signals on Tyler St
- Allow dedicated left turn lanes on Tyler St
- Install wider medians on Colorado Blvd to allow for narrower lanes and shorter pedestrian crossings
- Install new traffic signal equipment and safety lighting
- Install on-street bike lanes on Colorado Blvd
- Remove free right movement on Sylvan Ave, giving westbound vehicles their own receiving lane on Tyler Str.
- Additional green space on northeast corner

Intersection Level Of Service (LOS)*: LOS B

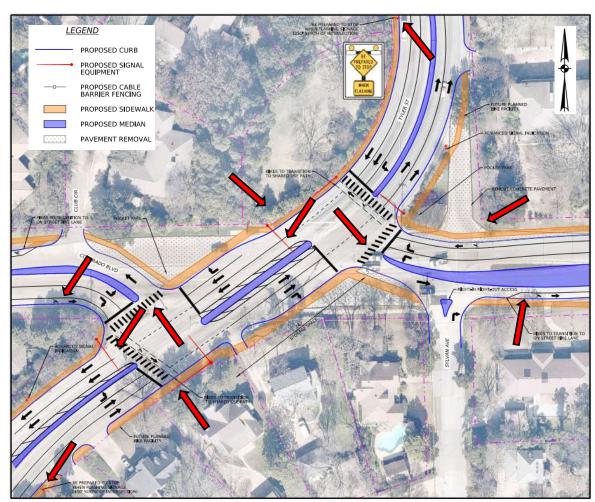
Alternative 2Offset T-Intersection

- Reconfigure intersection to act as two separate intersections (similar to diamond intersection)
- Install new traffic signal equipment and safety lighting
- Install on-street bike lanes on Colorado Blvd
- Install flashing warning signals
- Improves intersection visibility along Tyler St and allows for shorter pedestrian crossings
- Remove free right movement on Sylvan Ave
- Additional green space on almost all corners

Intersection LOS*: LOS C

*LOS shown for 2045 critical peak hour traffic conditions and most critical side of the intersection.

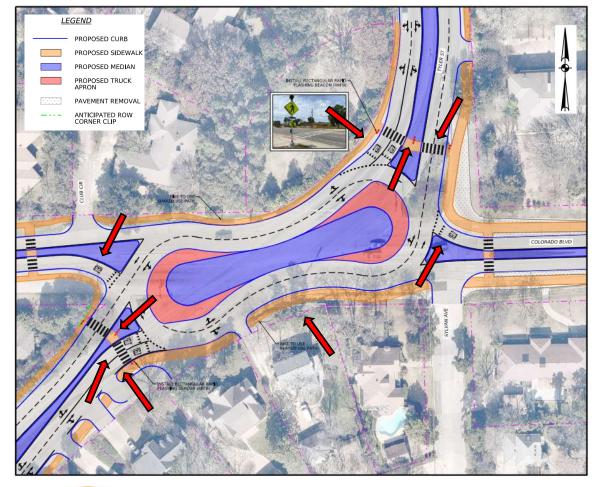
Alternative 3 Peanut Roundabout

- Install Roundabout to allow free flow of traffic around intersection
- Reconfigure intersection approaches to slow down traffic in all directions
- Install Rectangular Rapid Flashing Beacons (RRFBs) at pedestrian crossings on Tyler St
- Improves intersection visibility along Tyler St and allows for shorter pedestrian crossings
- Additional landscaping and green spaces

Peak Hour Intersection LOS*: LOS C

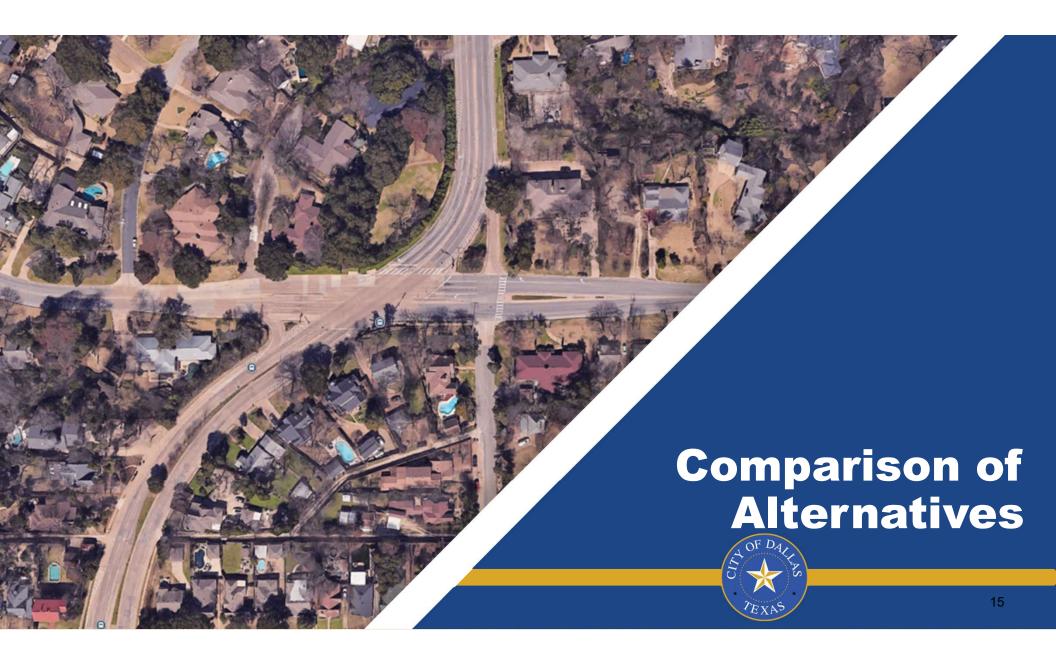
Conflict Point Comparison

⁻ Conflicts at Sylvan Ave. (residential street) and Colorado Blvd. included in total conflict point count.

⁻ Conflict point count is approximate and subject to change based on lane configuration and intersection geometry.
