425 N Rosemont Avenue

Exterior Landmark Commission Appeal

October 1, 2020

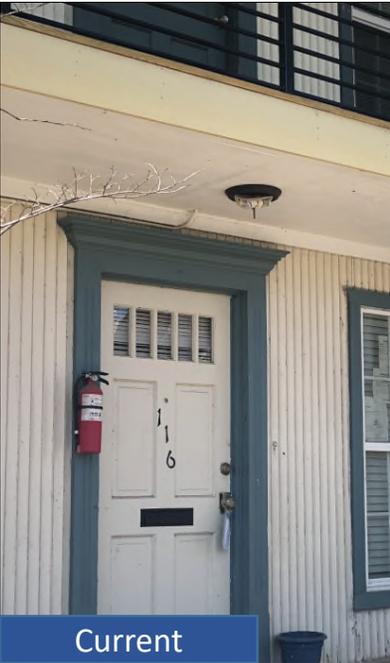
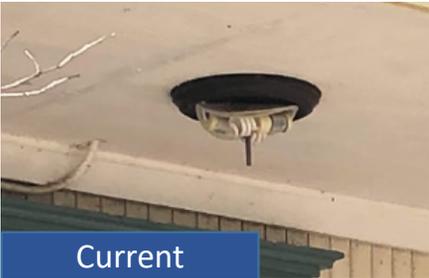
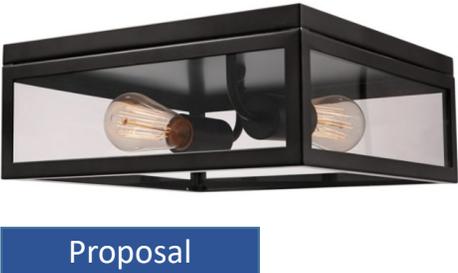
FLUSH MOUNT:

The current lights on the exterior of the building are disparate, some are non-operational, and provide very little lighting to the residents. For those reasons, we'd like to replace the existing lights with the below proposals. We'd like the property to be well-lit, safe, and cohesive for the residents which is currently not being accomplished by the existing lighting.

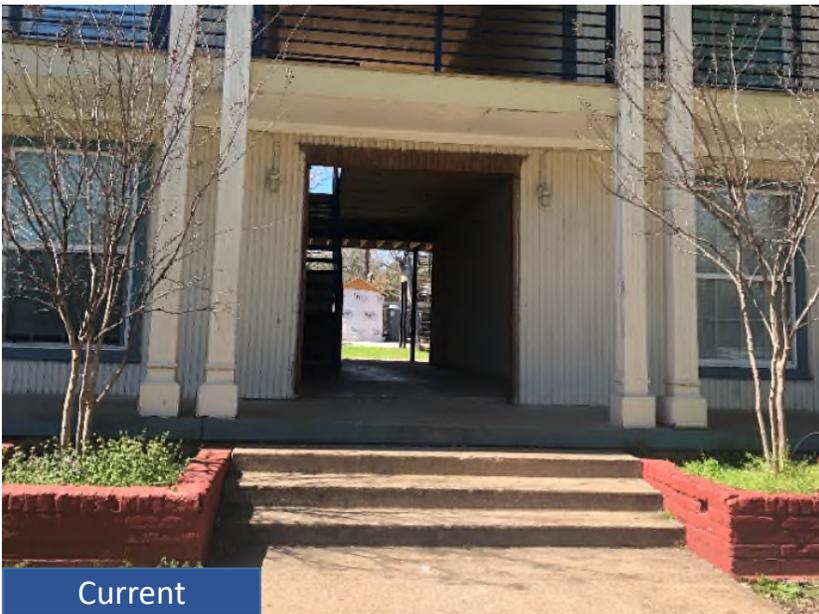
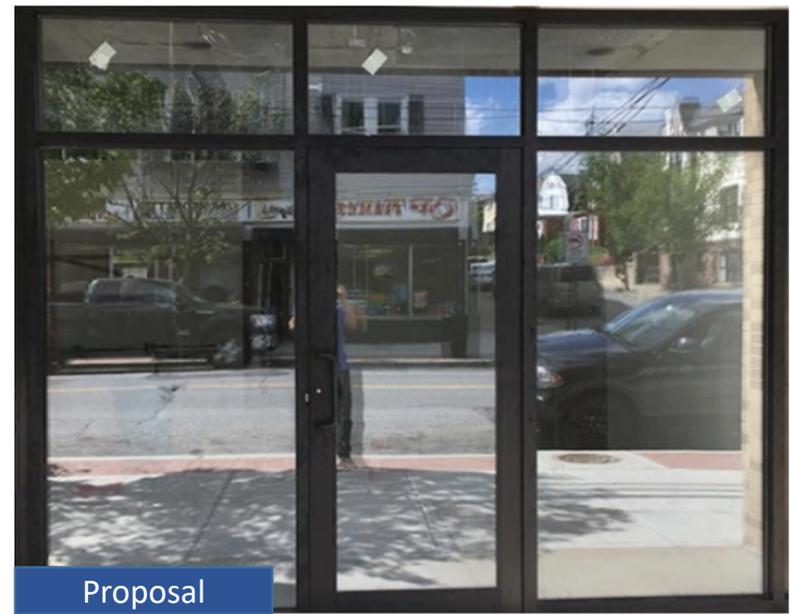
Front Entrance Addition

- The main entrance of the property is completely open and unsecure which leaves our residents feeling unsafe. The proposal includes adding a front door with two glass panes on each side. The front door would include a community lock that would be accessible to only our residents.
