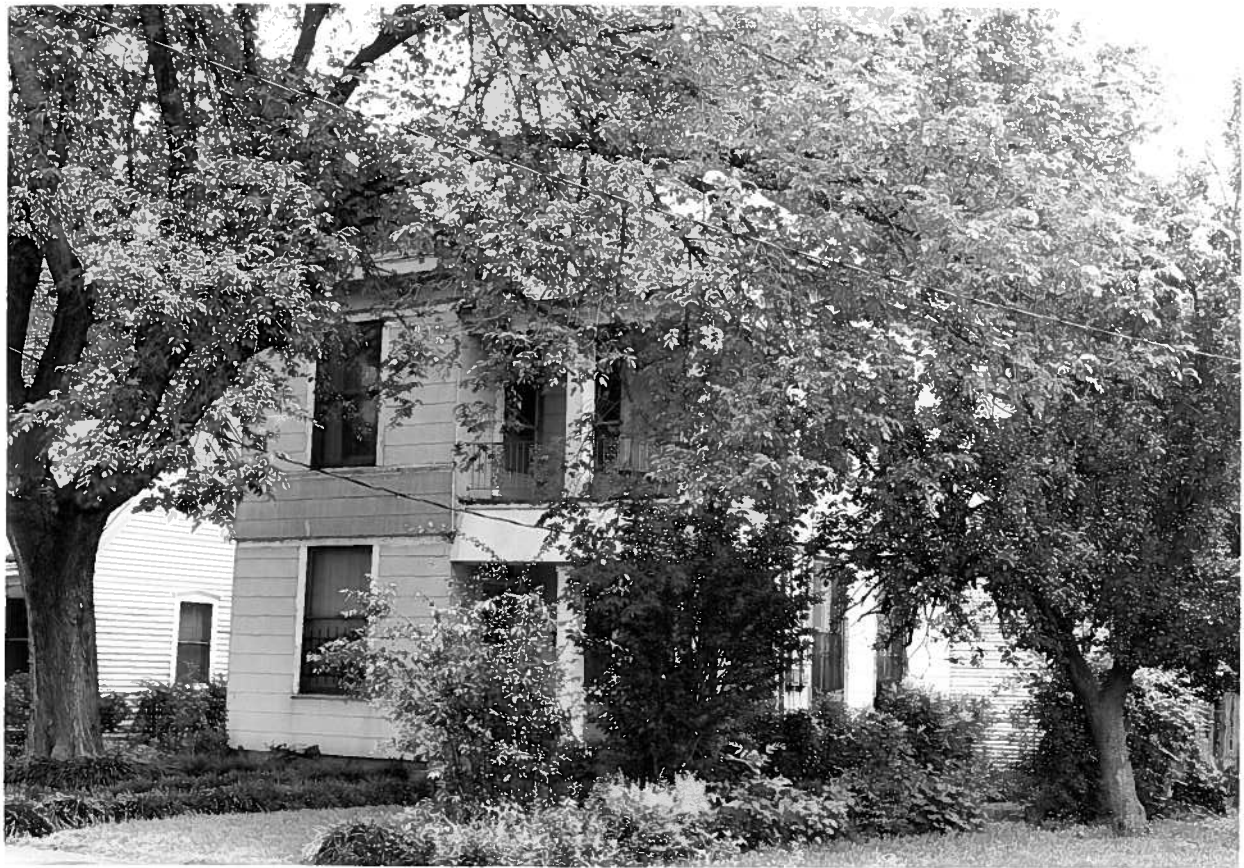
No. 41 - 2608 Hibernia

Approx. 1885-95;

Description: Victorian, 2 story, main hip roof, inset front porches, both floors, 1/1 windows, decorative shingle, wide stringer and cornice under siding, large square porch posts;

Condition: Good - covered but restorable.

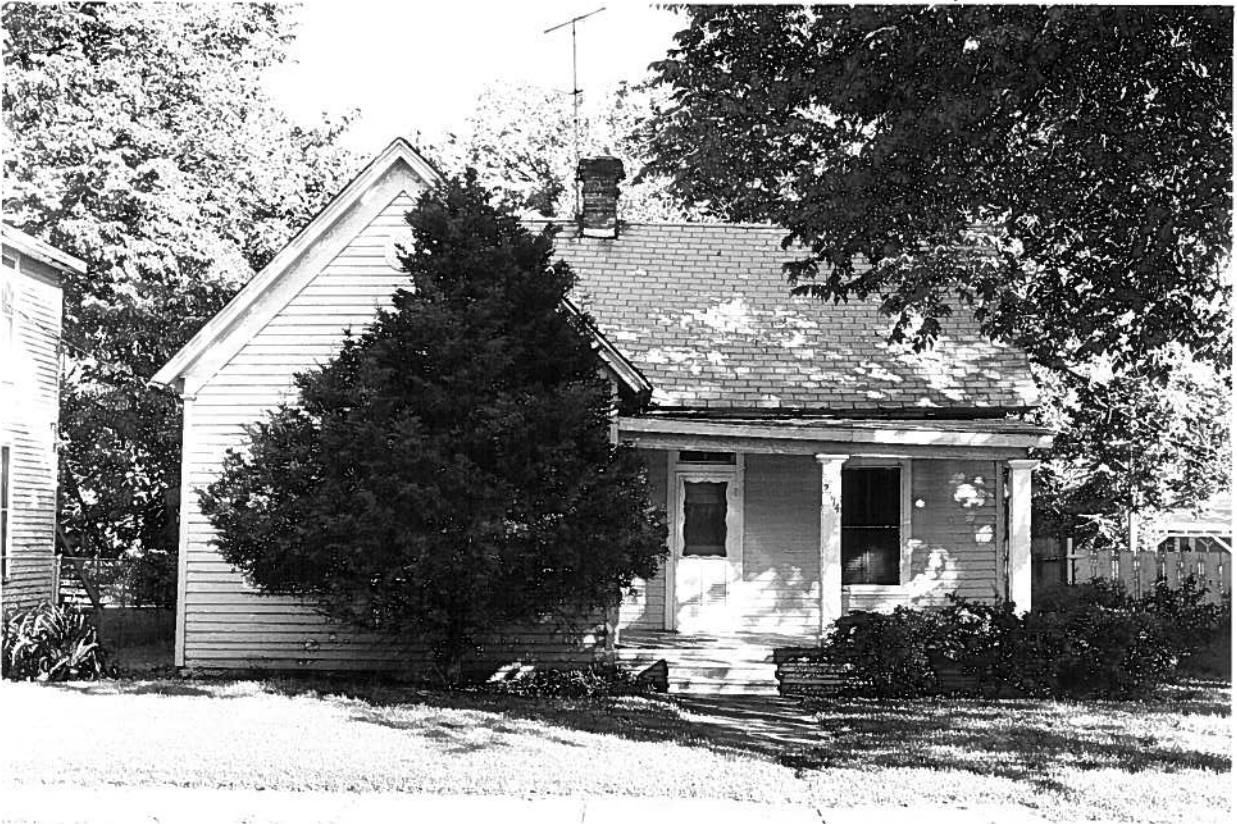
No. 42 - 2614 Hibernia

Approx. 1880-90;

Description: Greek Revival, original 'L' plan with 'L' addition to back, intersecting gables, punch tin vents in gable ends, central chimney, pediment window heads, 2 front doors with transoms, square Doric porch columns, 2/2 windows, corner boards, barge board.

Condition: Excellent - one of kind in area.

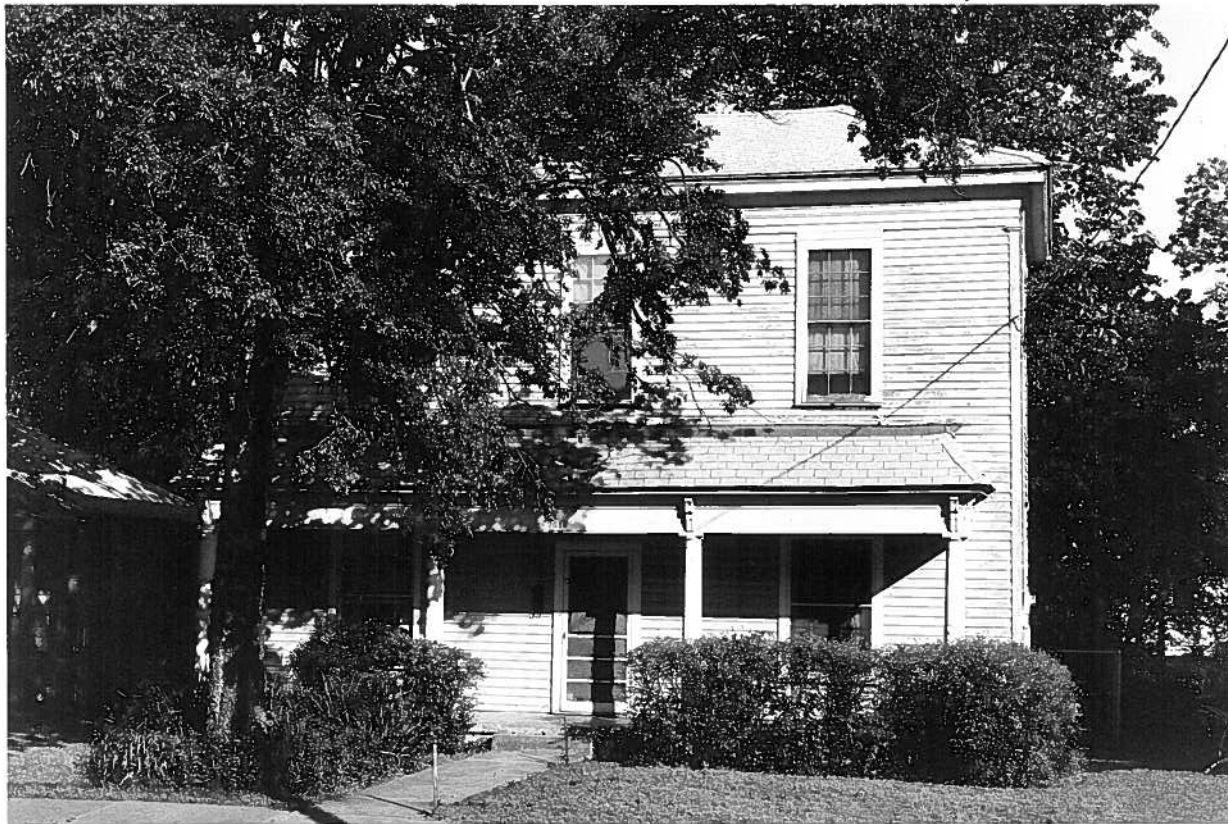
No. 43 - 2616 Hibernia

Approx. 1885-90;

Description: 'I' house, 2 story with shallow hip roof, shorter 2 story section on rear with hip roof, angled cornice, mansard roofed front porch with Doric column deep cornice and decorative brackets, 1/1, 9/9 windows, central front door, narrow lap.

Condition: Excellent.

Significance: one of kind in area.

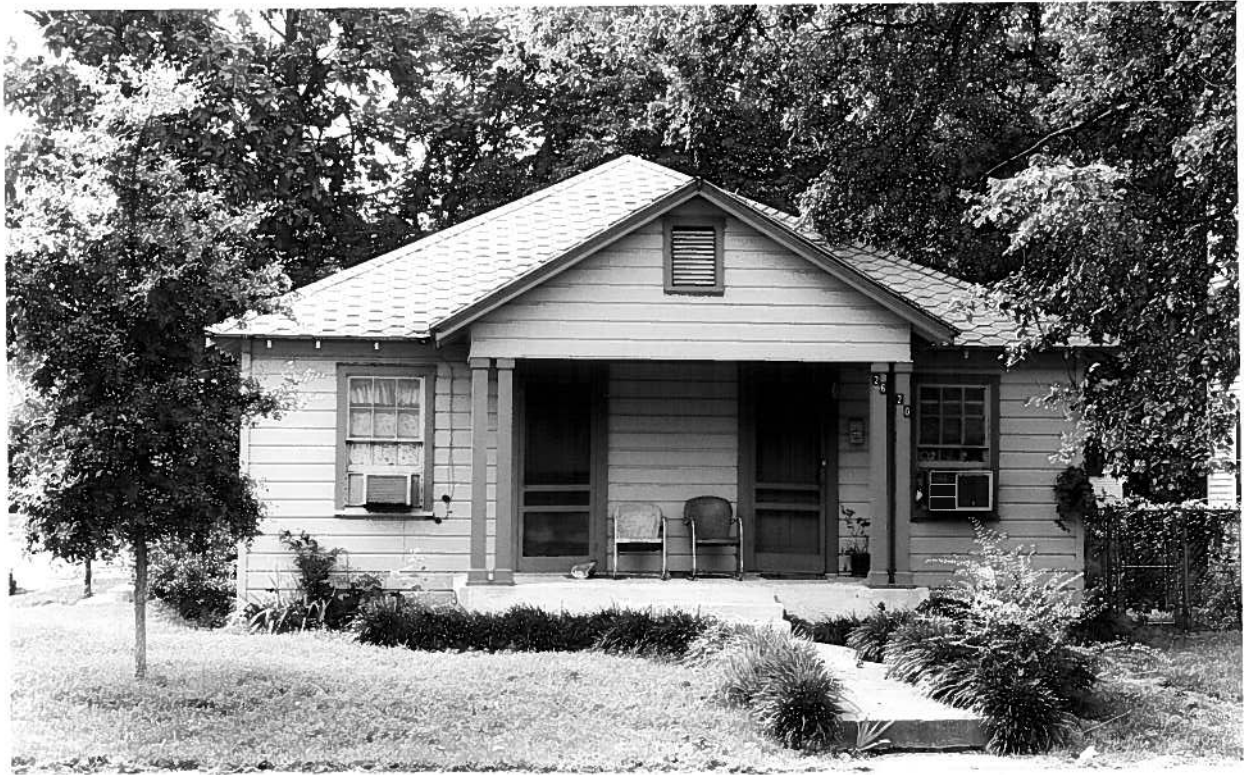
No. 44 - 2618-20 Hibernia

Approx. 1915-1925;

Description: Planbook style, pyramid roof, gable porch roof, 2/2 windows, exposed rafter ends, 3 square porch posts at each corner, paired windows on each side.

Condition: Good.

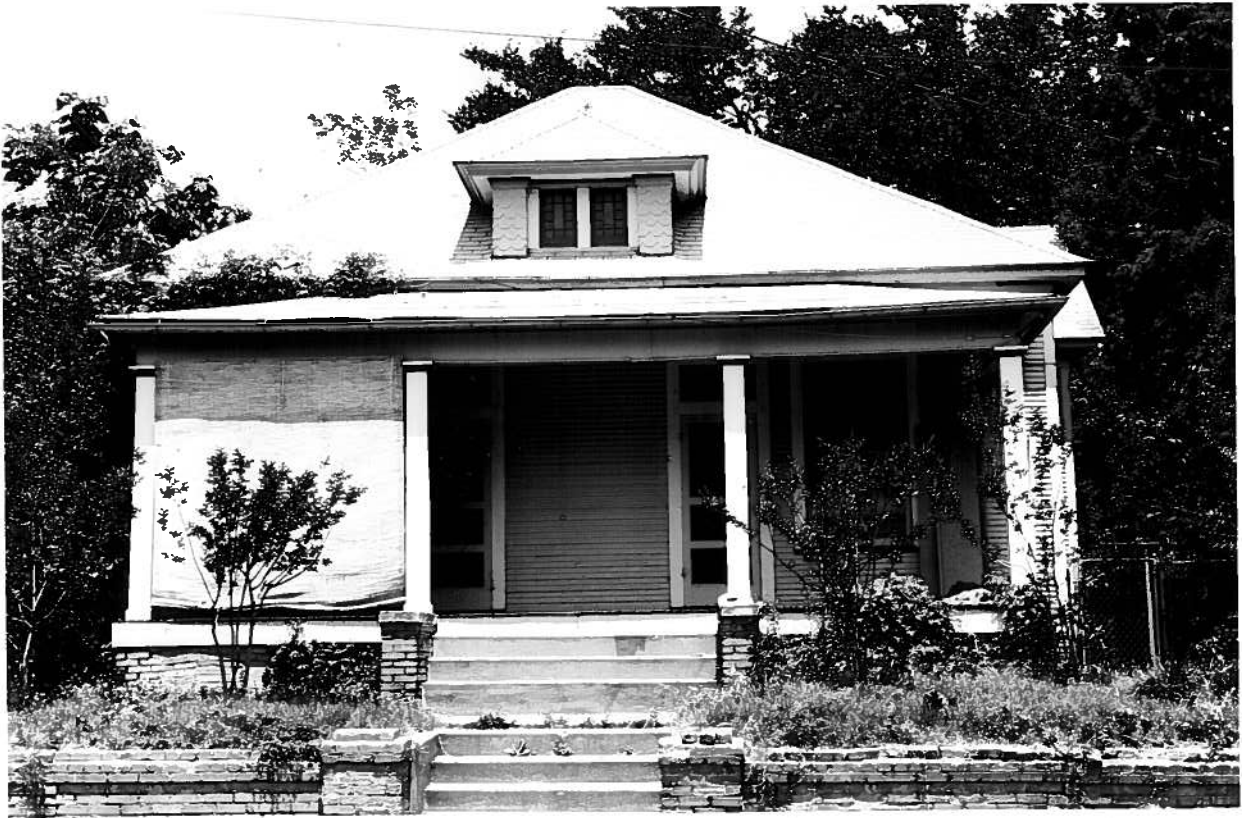
No. 46 - 2508-10 Boll

Approx. 1905-15;

Description: Planbook, main hip roof, narrow
lap board siding, exposed rafter ends.

Condition: Good.

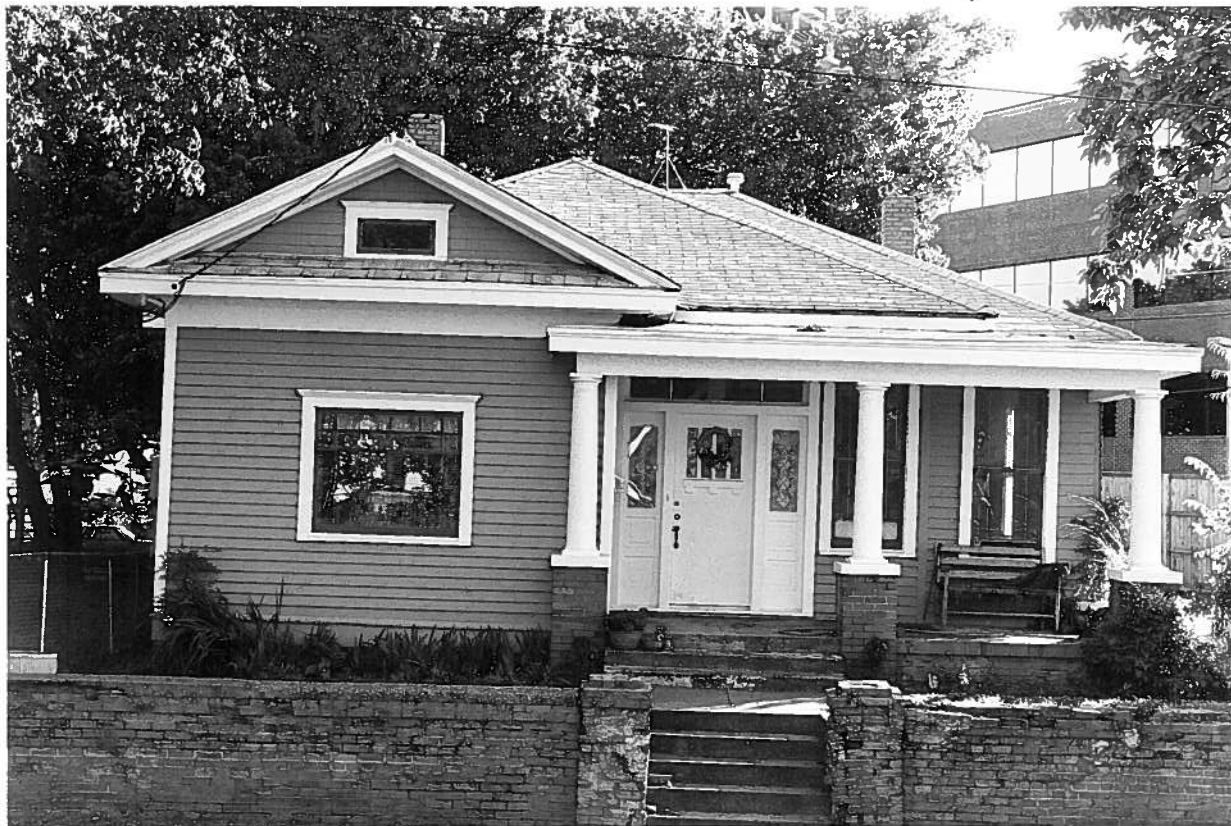
No. 47 - 2511 Boll

Approx. 1900-10;

Description: Planbook, intersecting gables, shakes in gable end, narrow lap siding, side-lights and transom, cornice window heads, brick porch piers, Doric columns.

Condition: Excellent - recently restored.

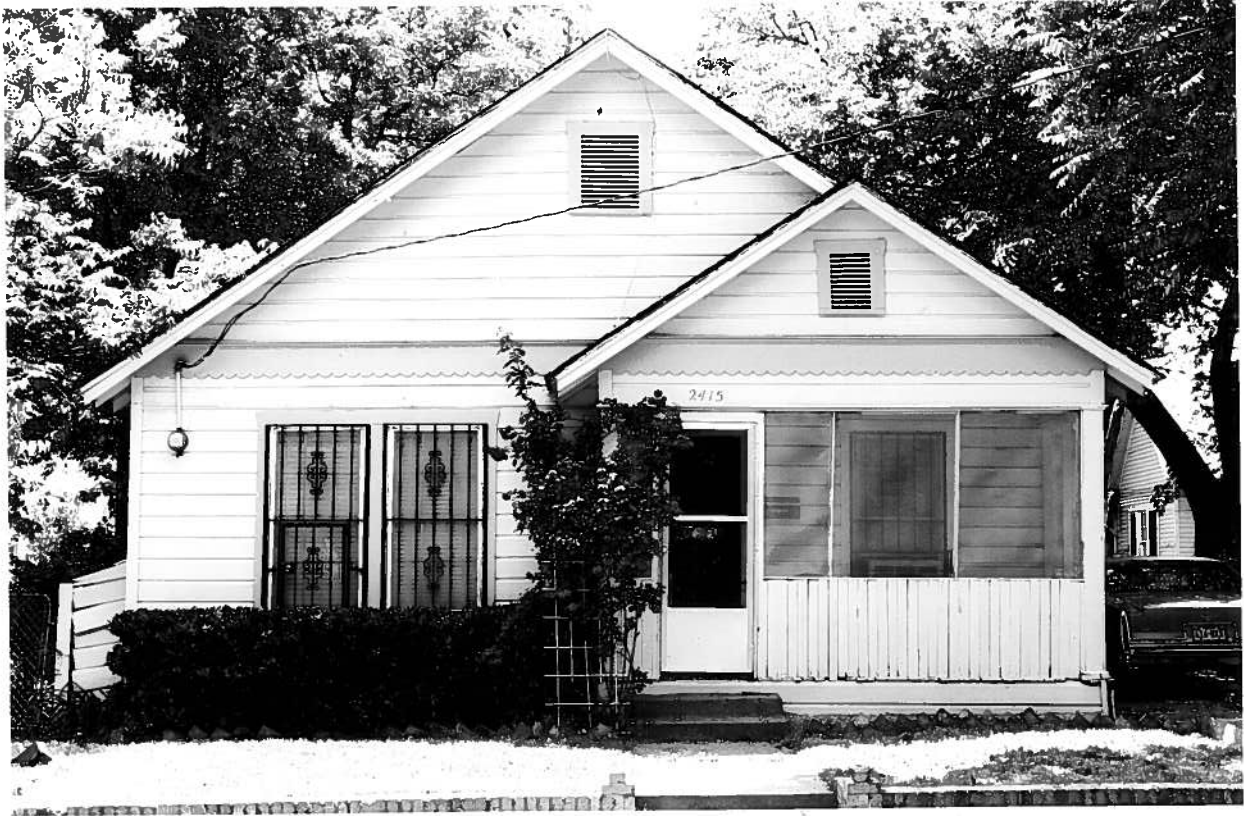
No. 48 - 2415 Boll

Approx. 1910-15;

Description: Planbook, main gable roof with smaller porch gable roof extension, 1/1 windows, exposed rafter ends, narrow wood trim.

Condition: Good.

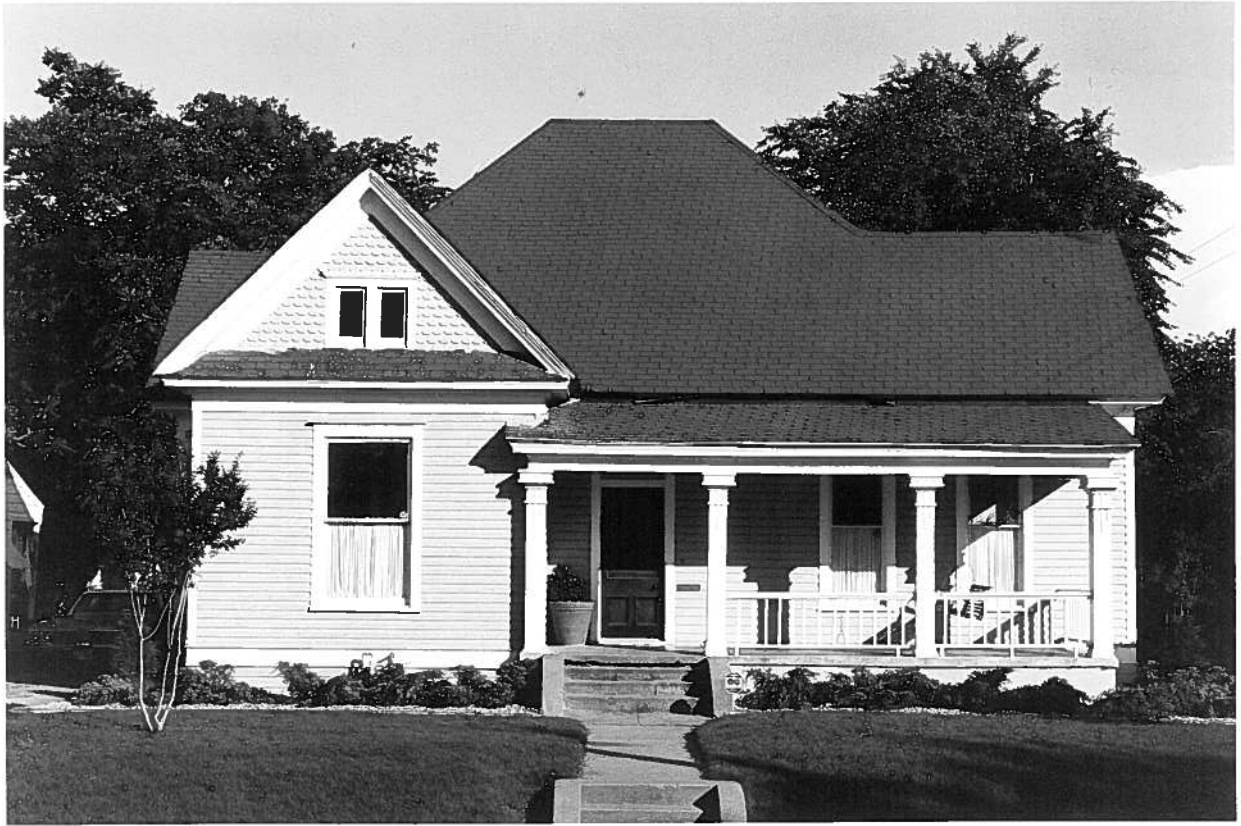
No. 49 - 2700 Hibernia

Approx. 1890-95;

Description: Victorian planbook, steep hip roof, front gable extension with fishscale shingles in gable end, transom over front door, 1/1 windows, shed porch roof with heavy square porch columns, simple layered barge board.

Condition: Excellent - recently restored.
