JLL Valuation Advisory Property Condition Assessment

Property: 7800 Ricchi Tower - 7800 North Stemmons Freeway, Dallas, Texas 75247

Report Date: July 21, 2022

JLL VA # VA-22-187206

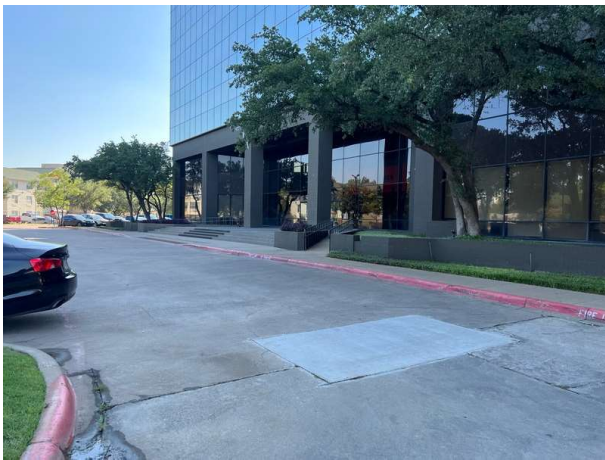
Concrete driveway

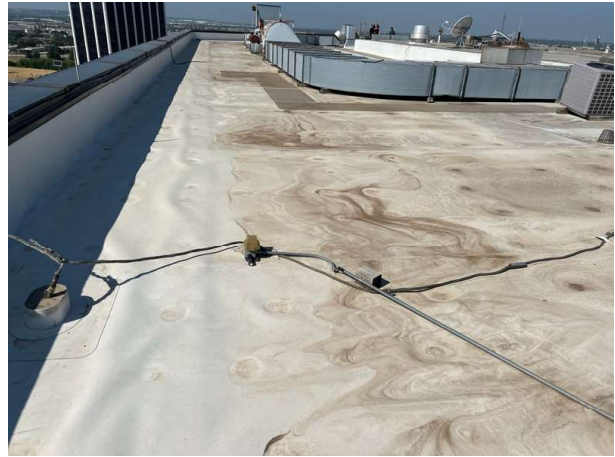
Roof tear

3.2.4 Roof Systems																						
Roof replacement	15	6	9	21,000	SF	\$15.00	\$315,000	100%									\$315,000				\$315,000	
3.3.1 Water Distribution and Domestic Hot Water																						
Plumbing: water heater	12	6	6	5	EA	\$2,500.00	\$12,500	100%		\$2,500		\$2,500		\$2,500		\$2,500		\$2,500			\$12,500

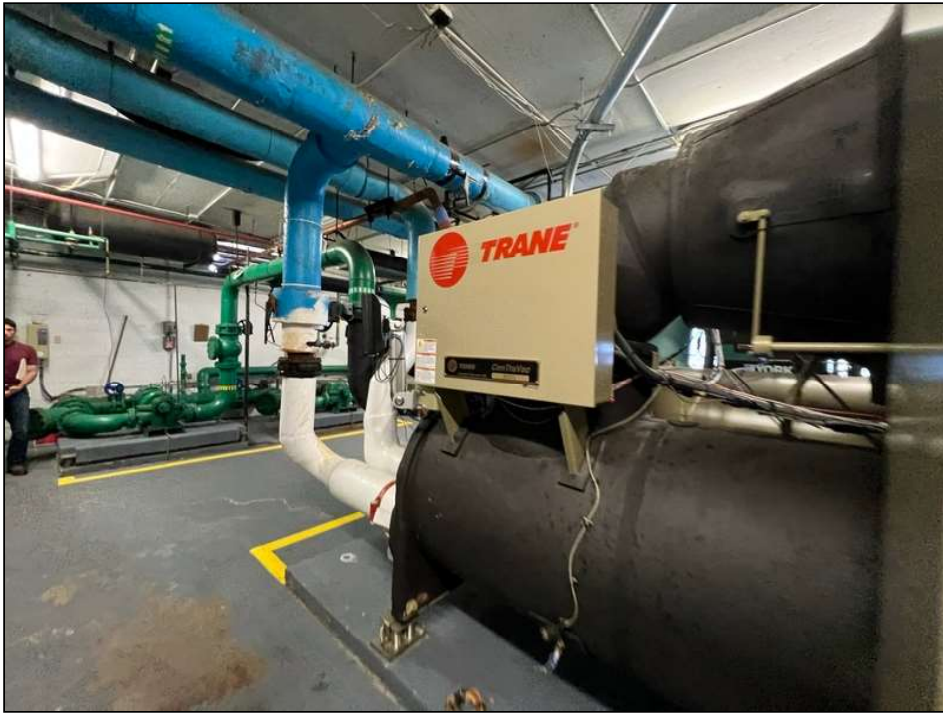
23. Chiller

3.3.3 Heating/Cooling System and Controls																						
HVAC: central AHU overhaul	25	20	5	3	EA	\$30,000.00	\$90,000	100%		\$30,000		\$30,000		\$30,000							\$90,000	
HVAC: chiller unit replacement, original unit	40	35	5	1	EA	\$250,000.00	\$250,000	100%					\$250,000								\$250,000	
HVAC: fan boxes overhaul, allowance	25	20	5	1	Allow	\$8,000.00	\$8,000	1200%	\$8,000	\$8,000	\$8,000	\$8,000	\$8,000	\$8,000	\$8,000	\$8,000	\$8,000	\$8,000	\$8,000	\$8,000	\$8,000	\$96,000

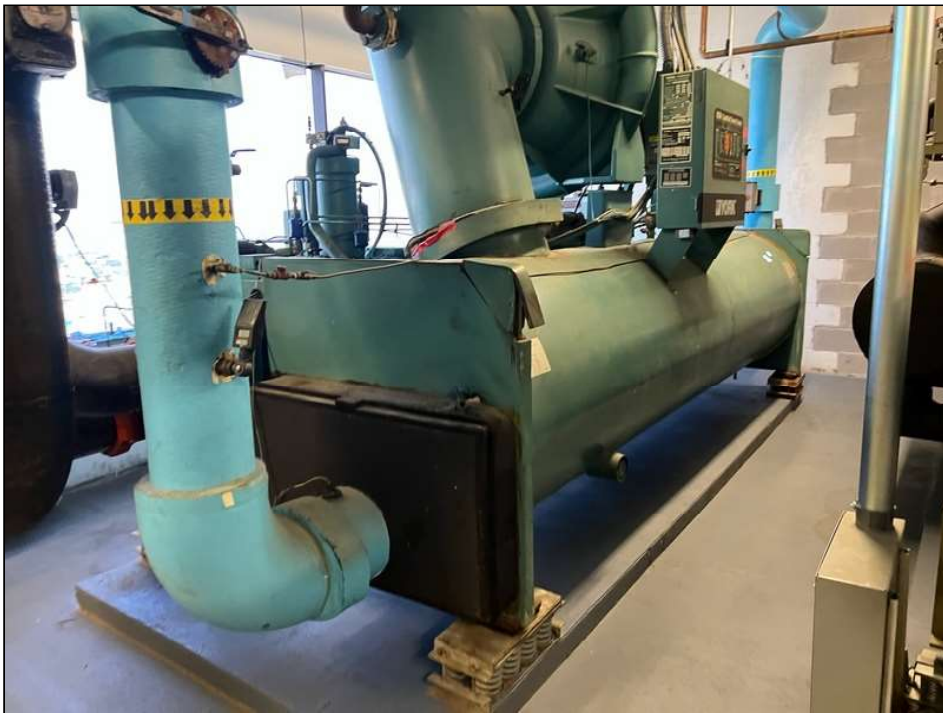
24. Chiller

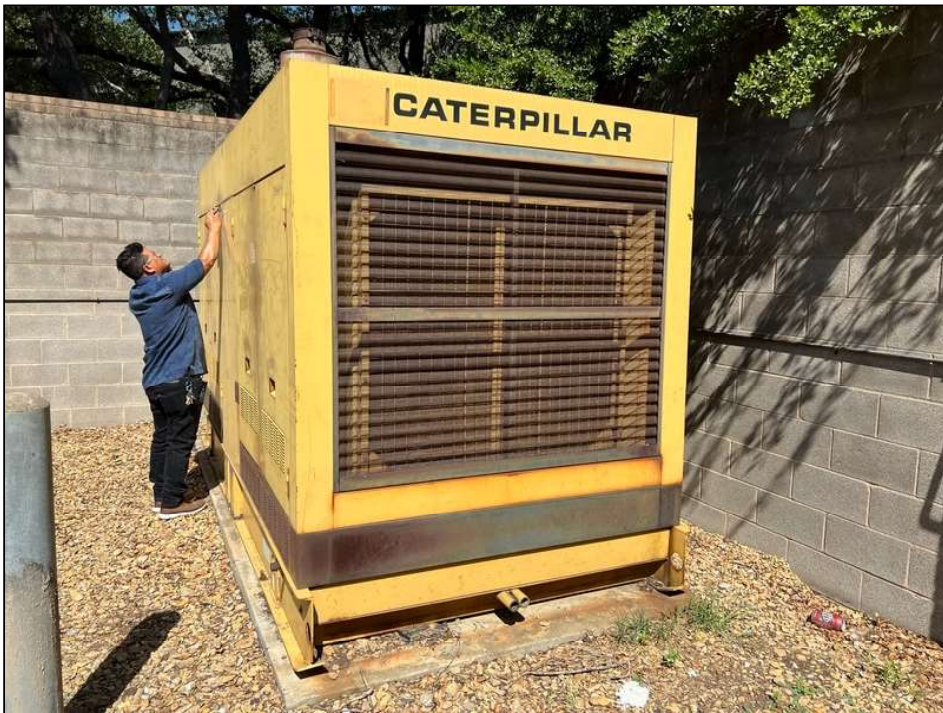
32. Emergency generator

3.3.5 Electrical Service																						
Electrical generator replacement	40	37	3	1	Allow	\$60,000.00	\$60,000	100%			\$60,000										\$60,000	
3.4.1 Common Area Interiors and Common FF&E																						
Common area: carpet	7	5	2	1,500	SY	\$35.00	\$52,500	200%		\$52,500							\$52,500				\$105,000	
Common area: wall re-paint	7	5	2	100,000	SF	\$0.65	\$65,000	200%		\$32,500	\$32,500						\$32,500	\$32,500			\$130,000	
Total (Uninflated)									\$8,000.00	\$125,500.00	\$250,500.00	\$190,500.00	\$291,660.00	\$40,500.00	\$8,000.00	\$10,500.00	\$408,000.00	\$76,660.00	\$8,000.00	\$8,000.00	\$1,425,820.00	
Inflation Factor (2.5%)									1.0	1.025	1.051	1.077	1.104	1.131	1.16	1.189	1.218	1.249	1.28	1.312		
Total (inflated)									\$8,000.00	\$128,637.50	\$263,181.56	\$205,147.66	\$321,938.07	\$45,822.03	\$9,277.55	\$12,481.20	\$497,108.38	\$95,737.84	\$10,240.68	\$10,496.69	\$1,608,069.16

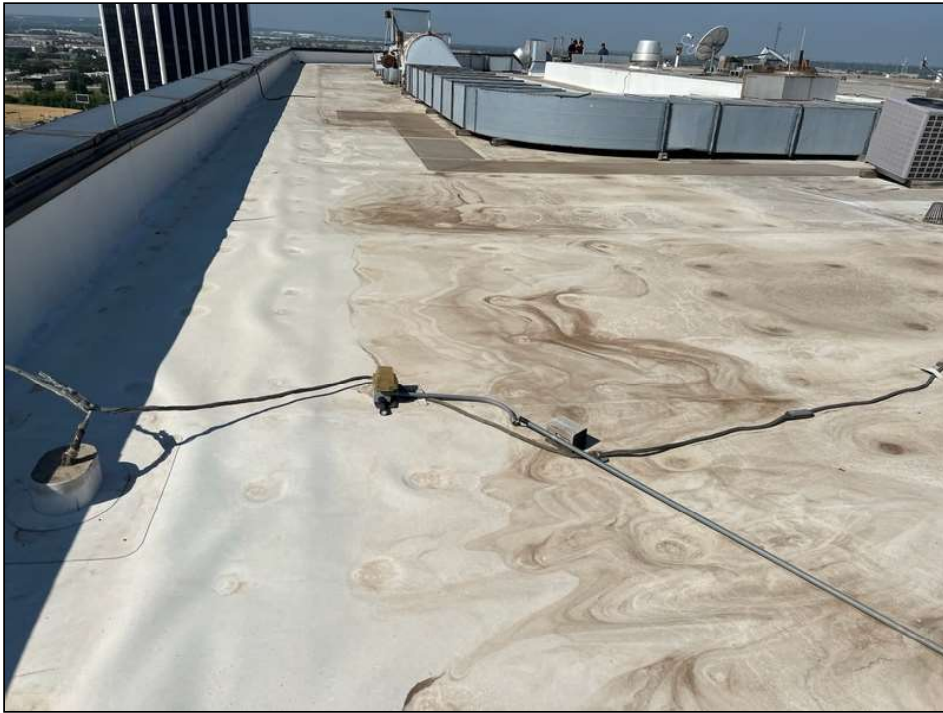
87. Roof tear
